Oconto Falls School District **FACILITY ASSESSMENT**

Oconto Falls School District
FACILITY ASSESSMENT

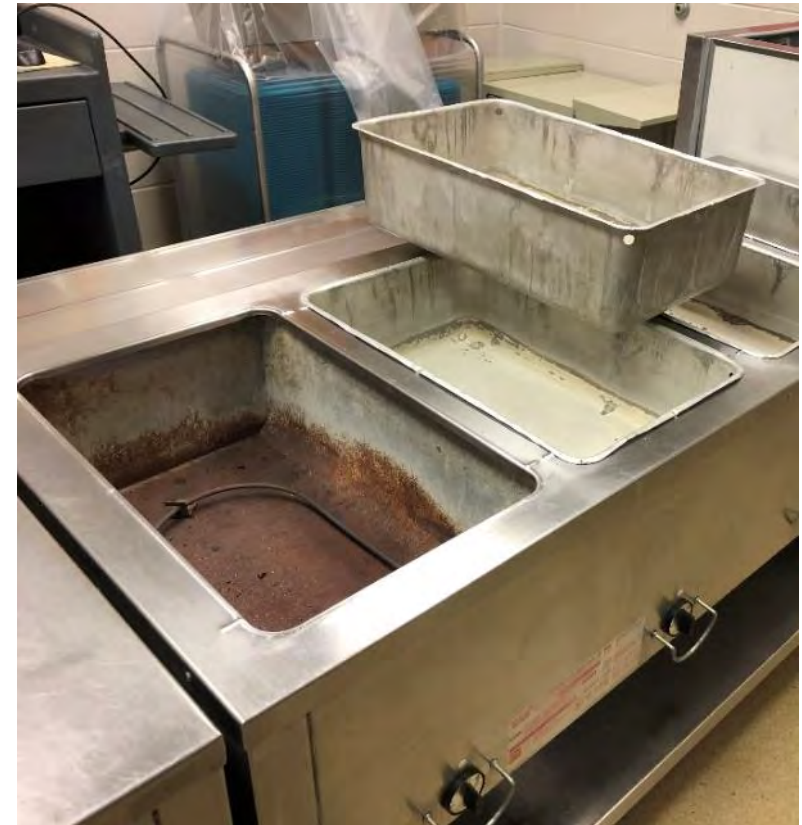
- Walk-In Cooler / Freezer had some epoxy coated shelves but some of the uprights were chrome plated and rusting.
- Epoxy floor inside cooler and freezer is failing in certain locations of cooler / freezer especially around door jamb.
- Drop ceiling is showing age with rust on grid and discolored tiles.
- Floor Mixer – Blakeslee - is very old and does not have bowl guard.
- Convection ovens – Hobart – are no longer manufactured and may be difficult to get parts should they become unreliable in future.
- Serving line hot well unit has pans with exposed heating elements that are rusting.

- Replace ceiling grid and vinyl coated tiles – (see interior finishes recommendations.)
- Repair of epoxy flooring – patching where necessary – (see interior finishes recommendations.)

- Replace rusted shelving in walk in cooler & freezer with epoxy coated units
- Replace Floor Mixer (assuming it is still utilized as part of meal service program)

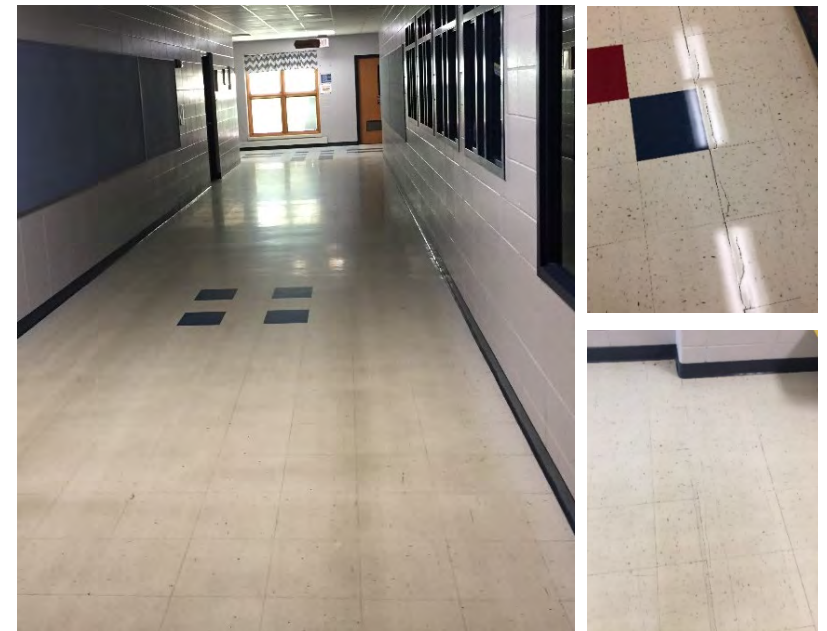
There are multiple locations where the VCT has cracks in it. VCT is a hard and brittle product. If there are cracks in the concrete below the VCT, it is likely to transfer through the VCT; if the cracking below the VCT is not addressed (filled or stopped) replacing the existing VCT with new VCT will likely result in the same type of cracking. A more flexible, resilient flooring product (like a solid vinyl or rubber) or polishing the concrete, is recommended.

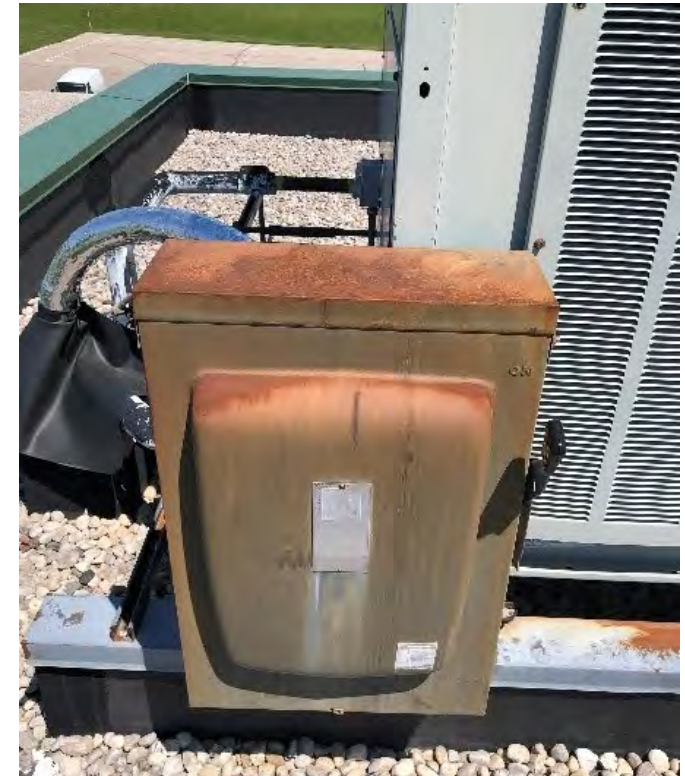
Most existing distribution and branch electrical equipment is original to the building. This electrical equipment includes, but is not limited to, disconnect switches, branch panelboards, and distribution panelboards. These pieces of equipment are approaching their BOMA life expectancy of 30 years. Assuming equipment has been properly maintained, we do not necessarily recommend full equipment replacement throughout the building. However, we recommend a thorough inspection and evaluation of all electrical equipment installed in the original 1995 building construction. This will limit the chance of failure by identifying equipment or parts that may need cleaning, re-torqueing, or replacement. Additionally, this offers an opportunity to re-evaluate the availability of replacement parts for continued maintenance. Repair or maintain deficient equipment. If equipment is defective or cannot properly be maintained because of the inability to source parts, replace immediately.

FIG 3: Disconnect switch on rooftop showing signs of major degradation

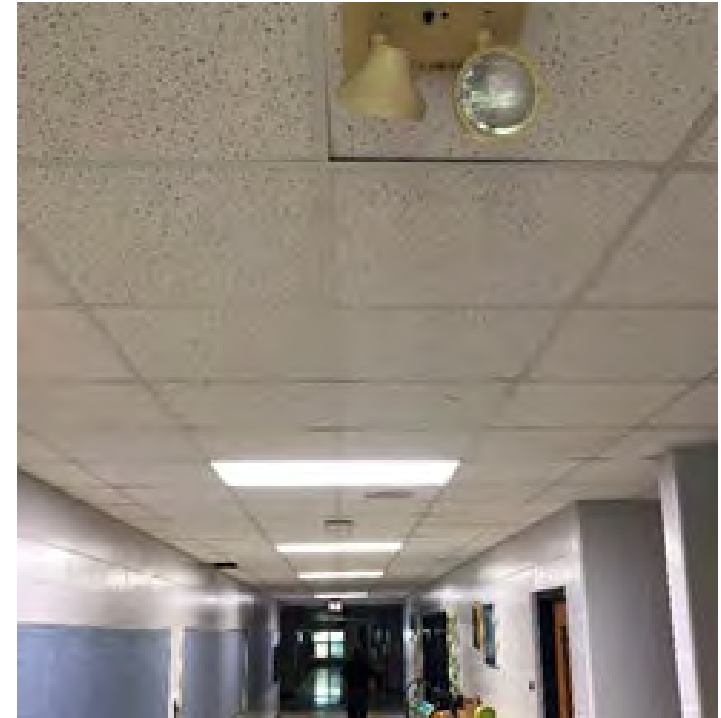
Hallway ceiling emergency lights like the one shown in Figure 6 to the right are installed with spacing exceeding 70 feet in some cases. We expect that the minimum lighting requirements as defined by NFPA 101 section 7.9.2.1.1 would not be met. We recommend performing a detailed walkthrough with a light meter to assess the existing emergency lighting installation and installing new emergency fixtures as required.

FIG 6: Typical hallway ceiling emergency light

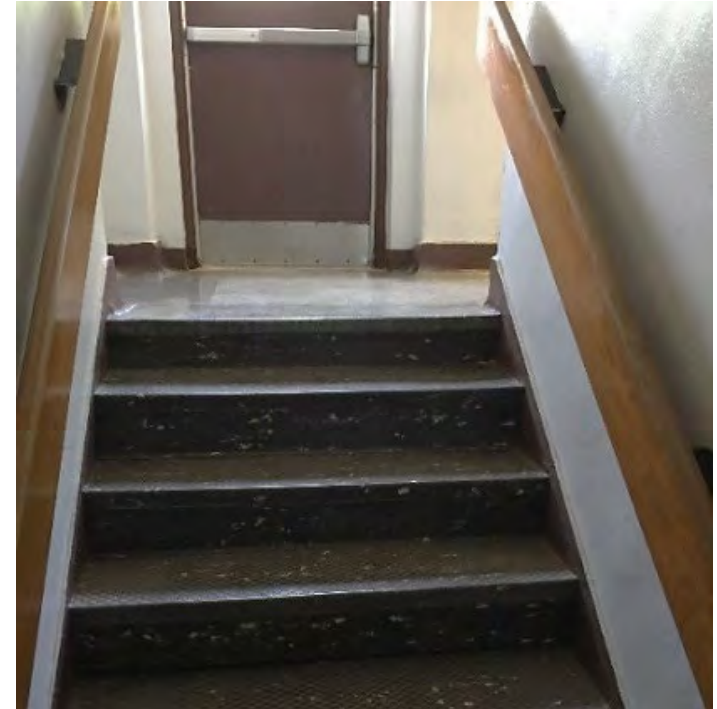
The stairs in this two-story portion of the building are not code compliant. The main stairs do not meet the code required riser/run dimensions and the handrails do not have the proper code complaint extensions. The stairs and handrails should be reworked to meet code compliance.

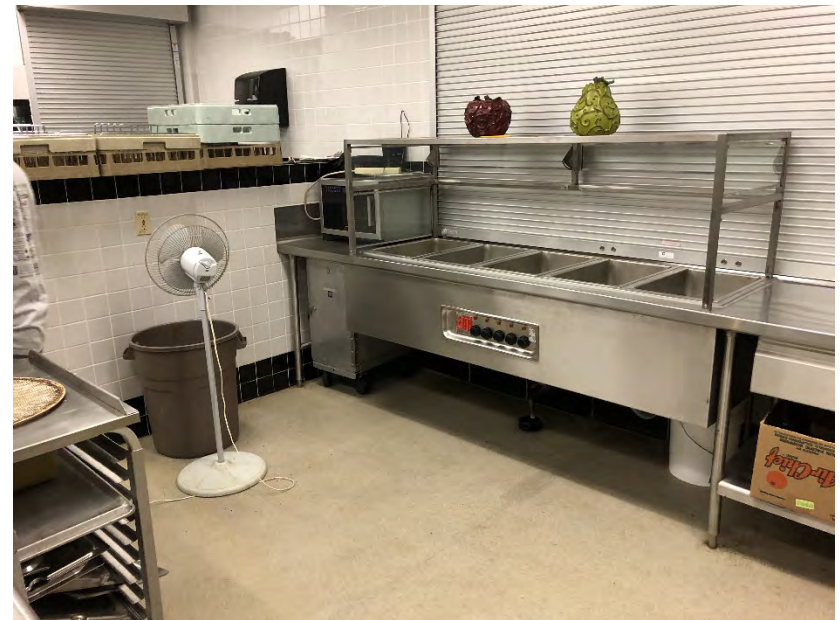
- Drop ceiling is showing signs of age with discolored tiles & grid.
- Walk-In Cooler epoxy floor is showing signs of cracking due to age.
- Walk-In Freezer door has been icing up (when in operation). This could be due to fault door heater, door gasketing, door sweep. Could also be a problem with heated air vent and / or defrost cycles for evaporator on unit.
- Existing two burner range has trouble keeping burners running.
- Larger island prep table and wood top (laminated) both have galvanized legs which are rusting due to age.
- Steam tables on main serving line do not hold water in pans (leaking).

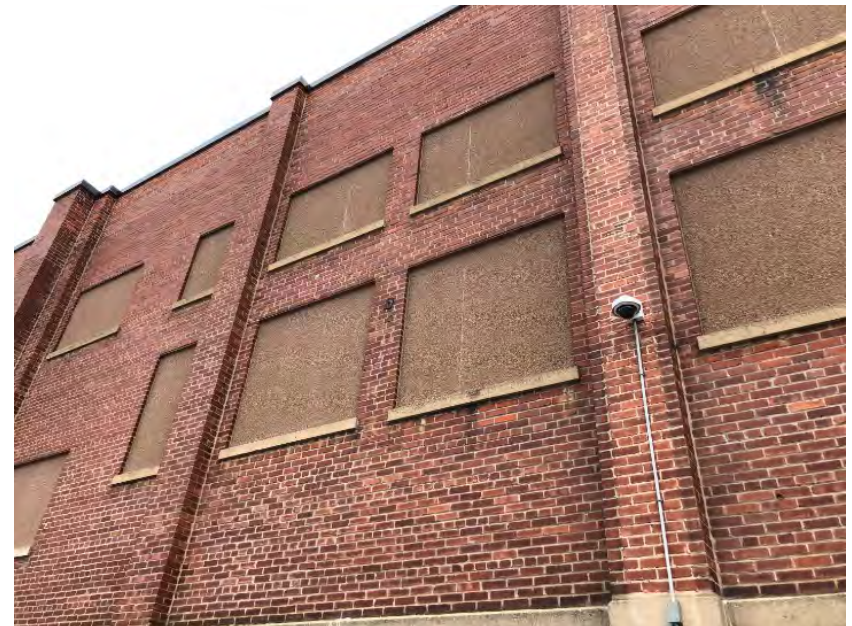
No splash blocks are installed at grade at downspouts along east elevation on north side of building at new gymnasium. Moisture has been known to leak into building along grade.

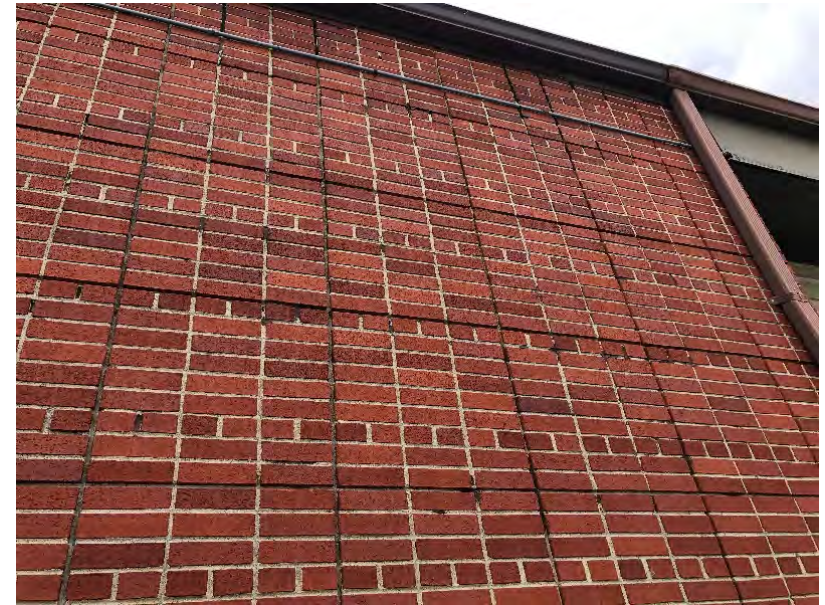
Tuckpointing required along south (front) elevation, as well as along the entire east and north elevation of old gymnasium

FIM #	Building Envelope Repairs
WMS-BE-1	Replace Ballasted EPDM Roofing Area in Poor Condition with New Insulation and EPDM Membrane <ul style="list-style-type: none"> Replace roof system with new insulation and fully adhered EPDM membrane. Incorporate a thermal barrier and vapor retarder prior to installation of the roof insulation and membrane. Incorporate slope into roof system design to improve drainage. Adhere all insulation layers down. Fully-adhere new EPDM membrane, properly install edge details and gutter.

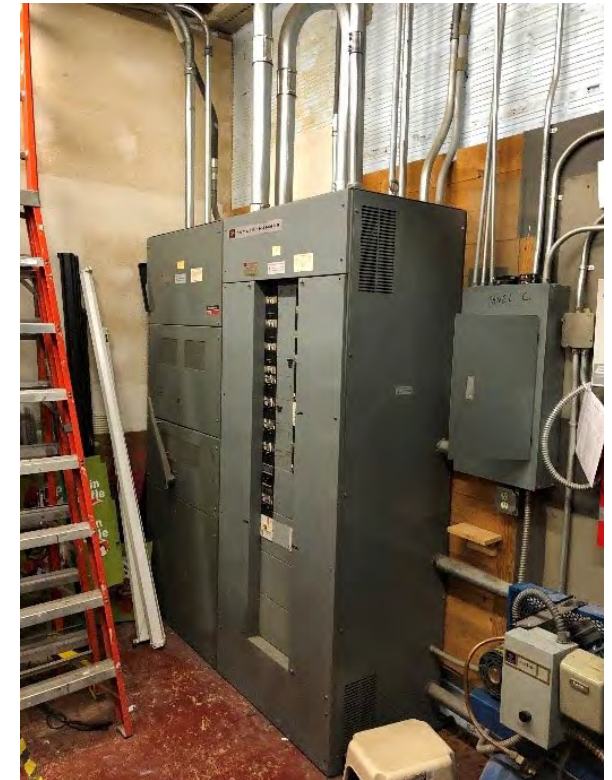
FIGURE 1:
Main Electrical Service Equipment

We recommend that a fault current/arc flash study be performed, and appropriate arc flash labels installed to the required electrical equipment. This will bring the existing installation into compliance with current code requirements and provide clear safety guidelines for persons performing maintenance on equipment.

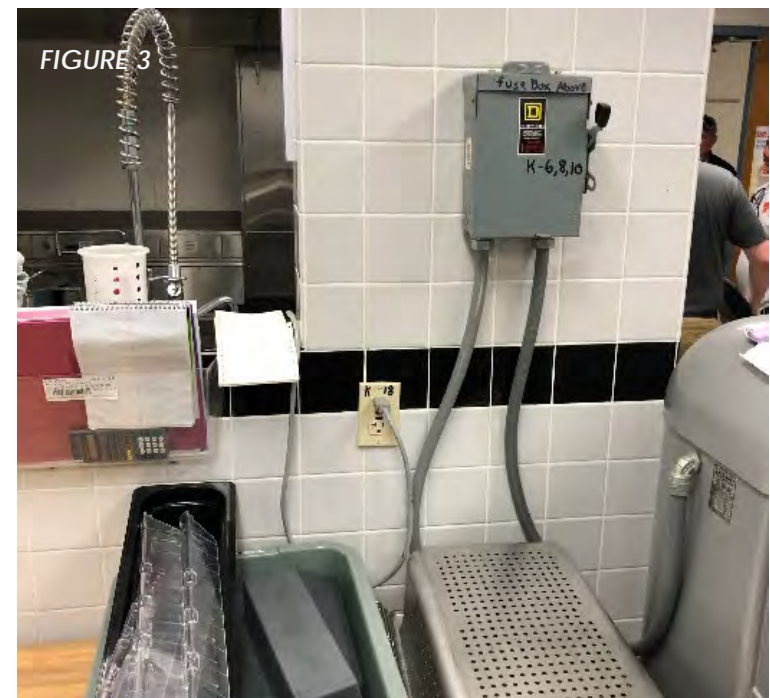
Cafeteria mixer disconnect switches are located near the washdown/mop sink area but in a NEMA 1 enclosure (see Figure 3, right). Per NEC Table 110.28, this enclosure should be type 4X for this installation. We recommend replacement with equivalent devices in NEMA 4X enclosures or relocating further away in an area safe from splashing.

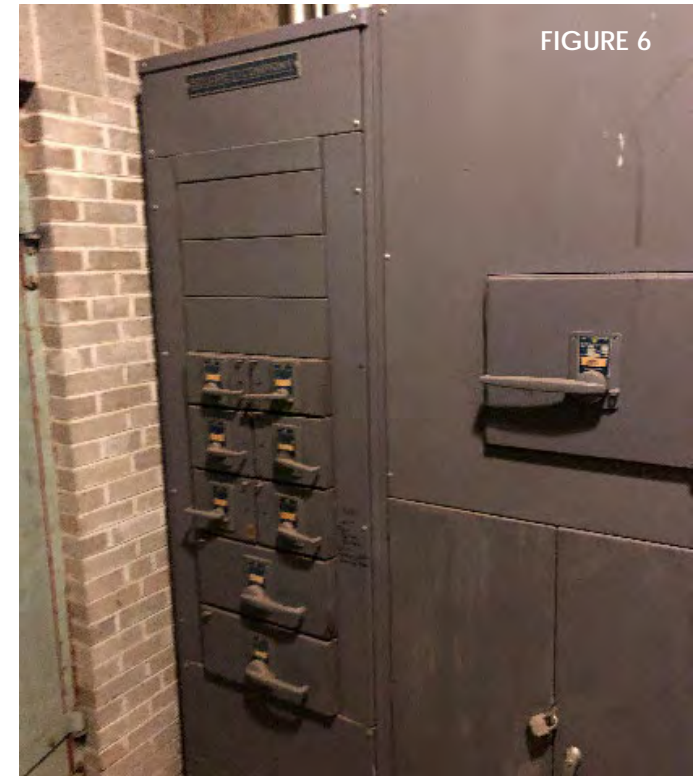
FIGURE 6

Assuming equipment has been properly maintained, we do not necessarily recommend full equipment replacement throughout the building. However, we recommend a thorough inspection and evaluation of all electrical equipment. This will limit the chance of failure by identifying equipment or parts that may need cleaning, re-torquing, or replacement. Additionally, this offers an opportunity to re-evaluate the availability of replacement parts for continued maintenance. Repair or maintain deficient equipment if not obsolete. If equipment is defective or cannot properly be maintained because of the inability to source parts, replace immediately.

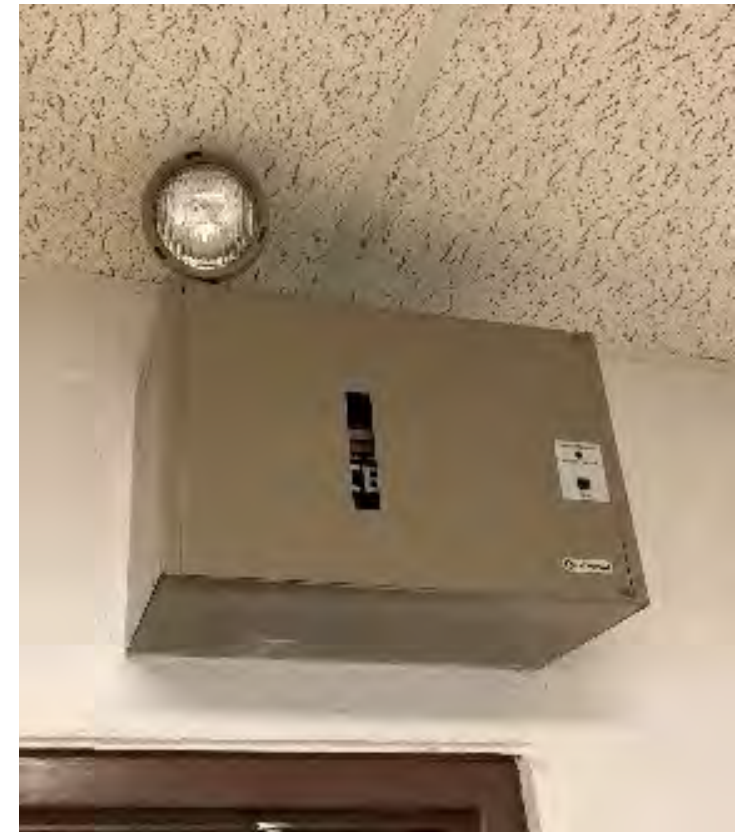
FIGURE 8

Locations throughout the school were noted to be missing emergency fixtures. The gymnasium is lacking a fixture over the egress door and the building entrance vestibule has no emergency light. We recommend adding new emergency fixtures over the gymnasium door and in the vestibule as defined by NFPA 101 section 7.9.2.1.1.

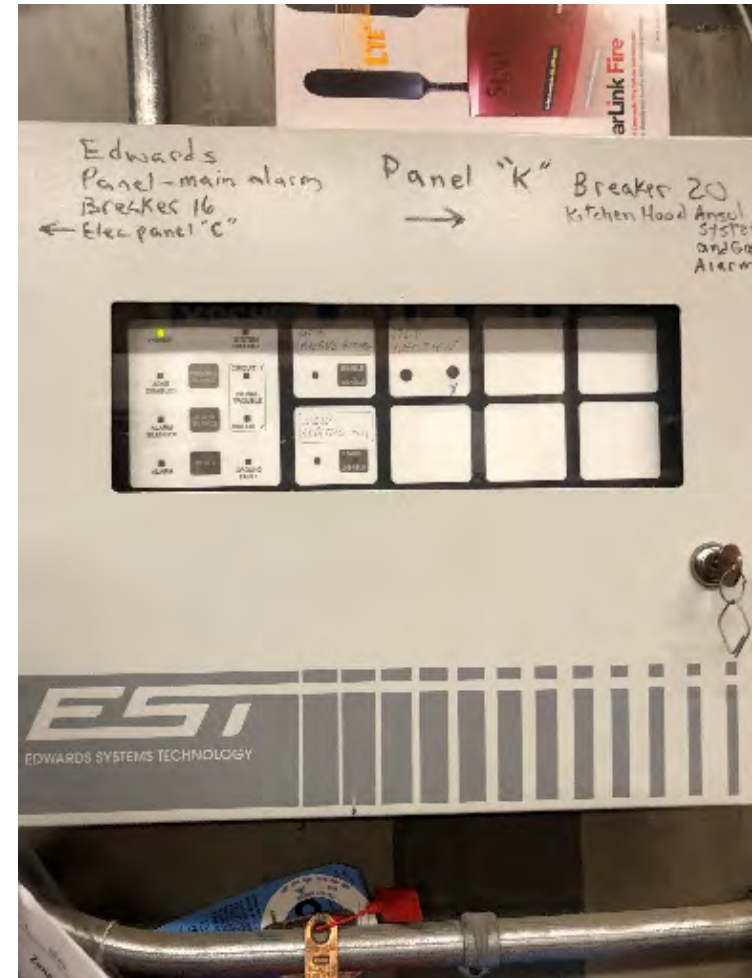
FIGURE 10

Due to the number of devices needing replacement or to be added exceeding 20, the entire system will need to be submitted for state review. This means that the entire fire alarm system will likely need to be brought up to current code (EVAC) requirements. Because of precedent set with other state-reviewed jobs of a similar nature, we recommend a total fire alarm system replacement, as solely replacing the head end or adding and replacing devices will not meet the requirements to pass state review.

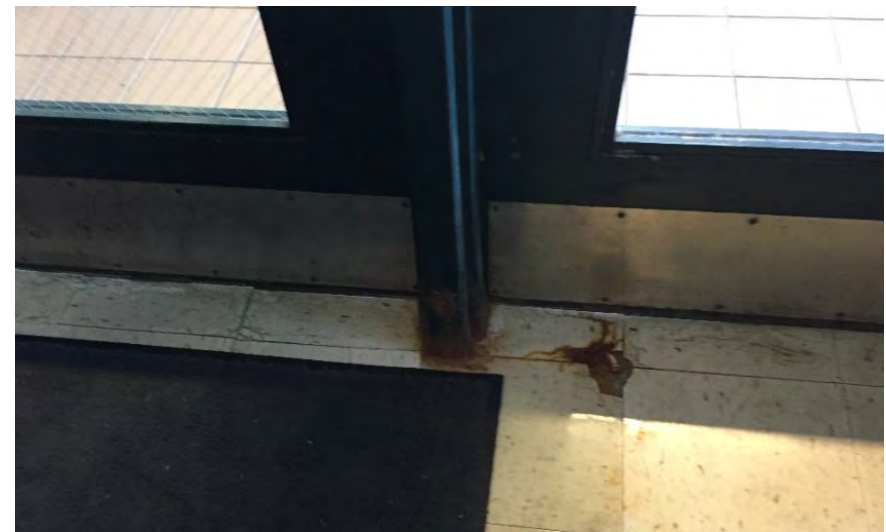
The exterior doors and frames are a mix of aluminum hollow metal. The hollow metal doors and frames are showing wear and rust. The recommendation is to replace the hollow metal doors and frames with aluminum and FRP doors and frames for durability, maintenance, and longevity.

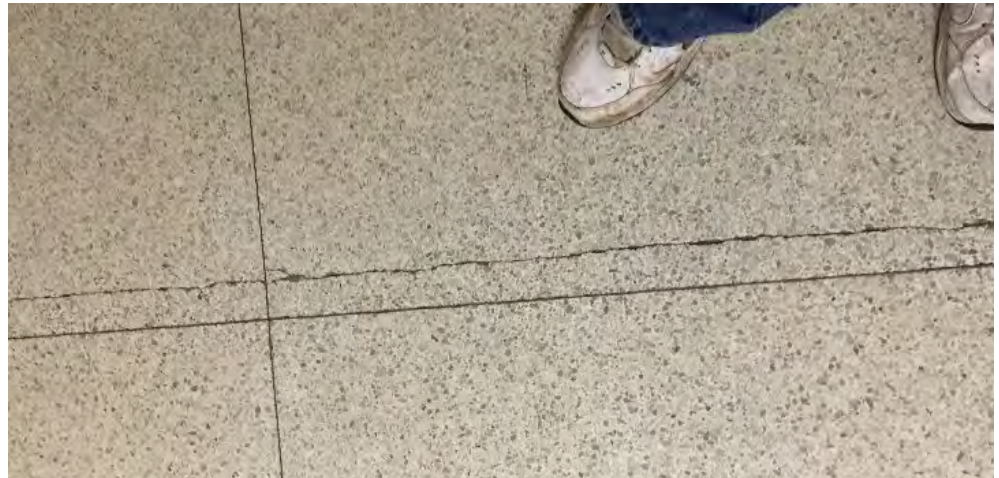
There is a small percentage of flooring that is 9" x 9" flooring tile. This size tile typically tests positive for containing hazardous material (asbestos). This would need to be verified by an environmental testing adjacency. Abating this tile and replace with a new flooring product is recommended.

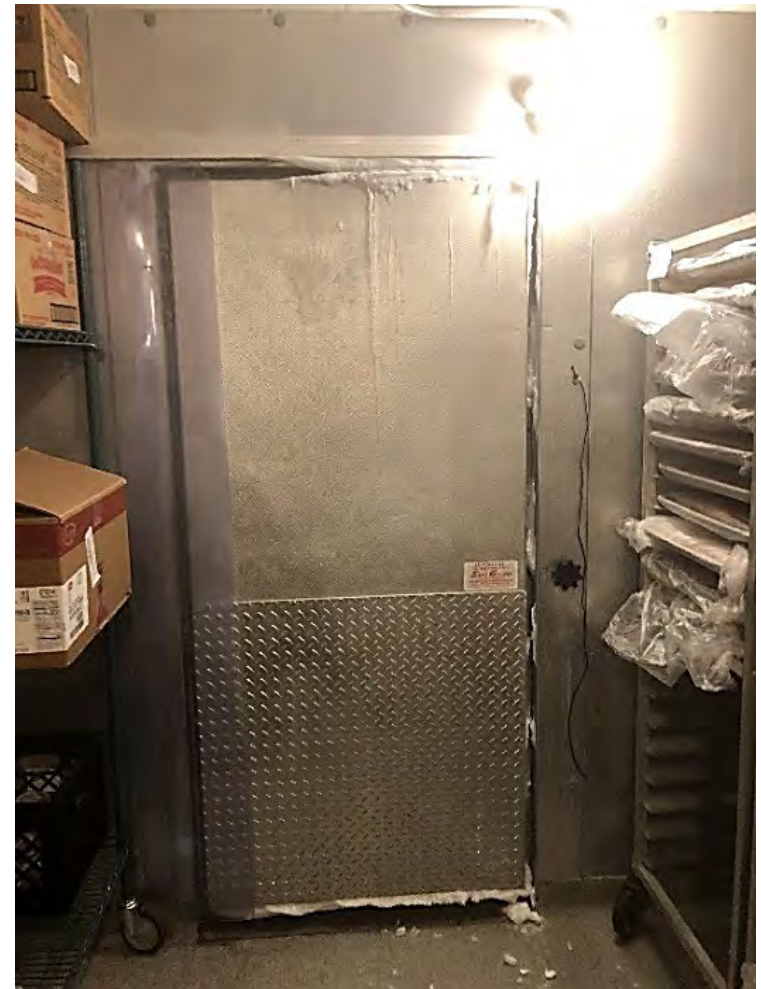
- Kitchen epoxy floor showing some signs of wear with cracking at covered base in some locations (by walk in cooler – freezer).
- Dry storage room light fixtures did not have lens covers over bulbs.
- Walk-in Freezer door was icing up (at time of walk thru). This could be due to faulty door heater, door gasketing, door sweep, door out of adjustment. Could also be a problem with heated air vent and / or defrost cycles for evaporator on unit.
- Bakers table has laminate top with galvanized base that is showing signs of rusting.
- Existing mixers: 60 qt. and 20 qt. do not have bowl guards (potential safety hazard).

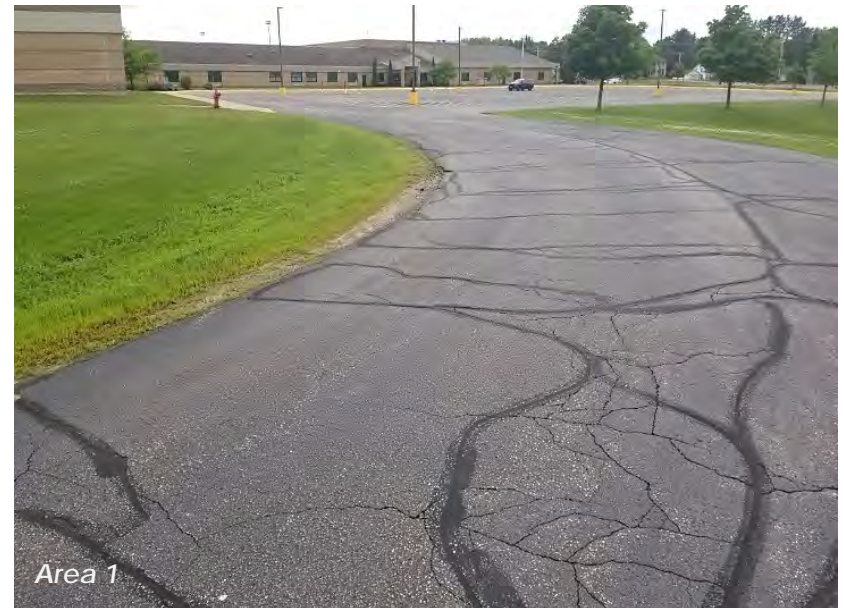
The existing pavement has numerous thermal cracks which have worsened over multiple freeze-thaw cycles. There are some areas of localized base failure, which are evident by the fatigue cracking present. The base failure is a small portion of this area, approximately 10%. Edge failure and surface weathering are also present.

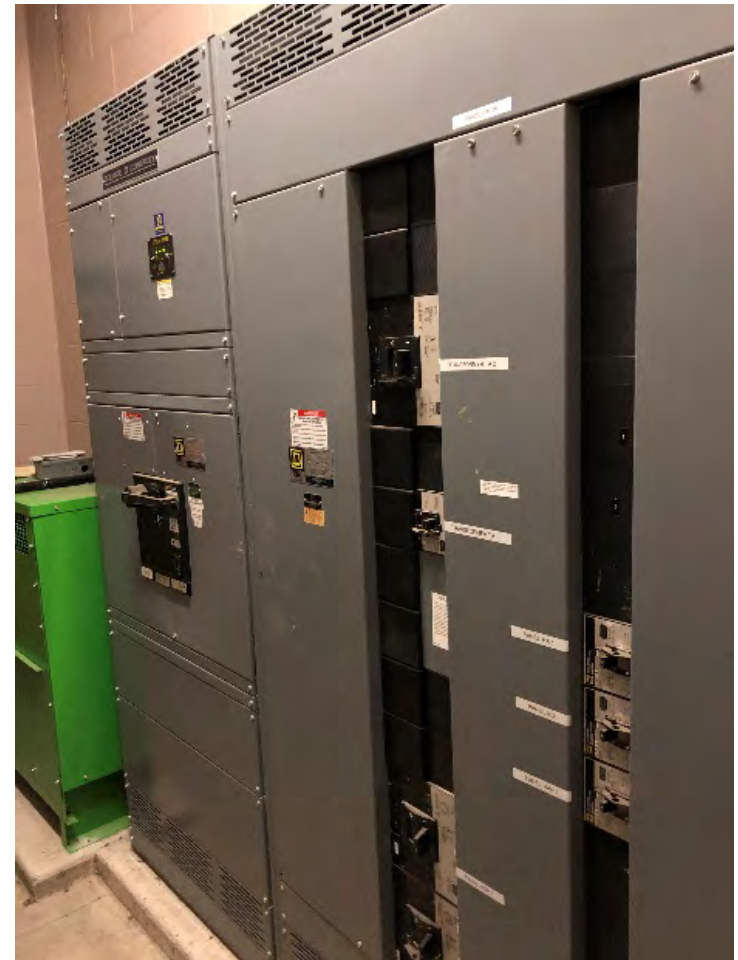
Figure 1: Existing Main Switchboard

The existing building switchboards, panelboards, disconnect switches, and other electrical equipment do not have arc flash labels installed, so it is unclear if an arc flash study has been performed. There is inherently an increased hazard of working on live equipment due to possible buildup of energy being released in an arcing incident. This arcing incident can occur due to failing conductors or even tools incidentally touch live bus bars or contacts causing short circuits. These arcing incidents can cause severe burns and injuries.

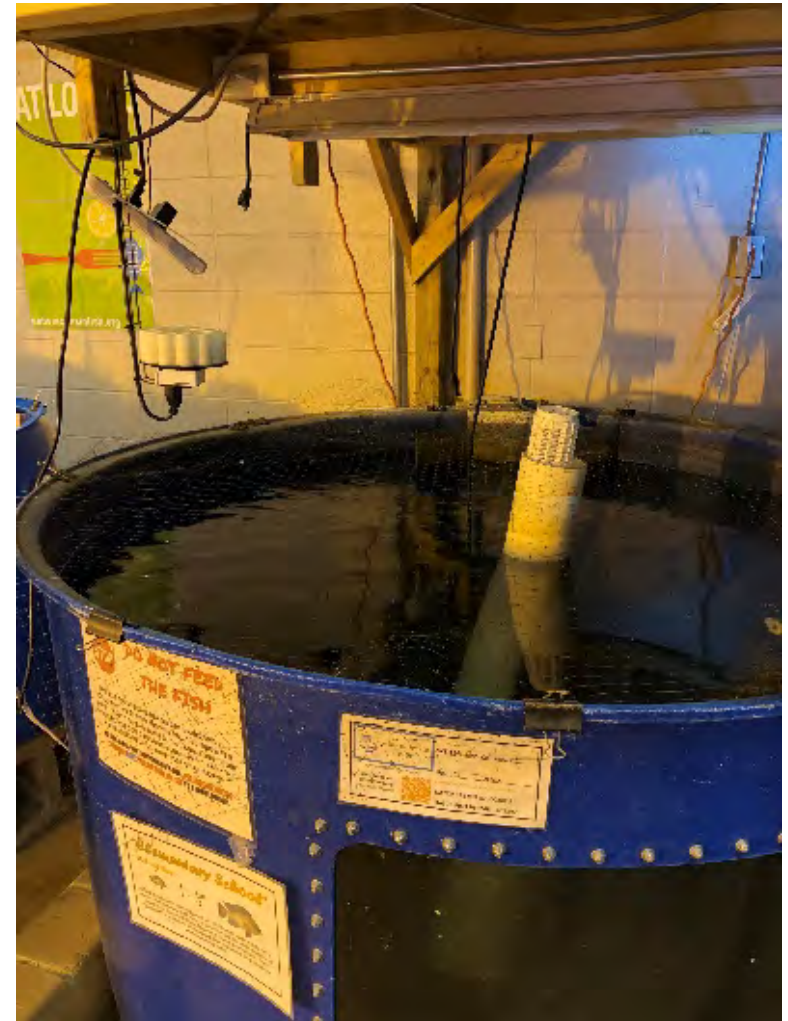
FIGURE 12

If fixtures need to be cord and plug, we recommend moving the receptacles further away from potential splash area.
