Oconto Falls School District **FACILITY ASSESSMENT**

Oconto Falls School District
FACILITY ASSESSMENT

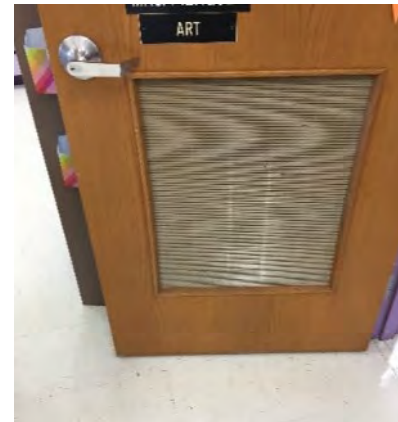
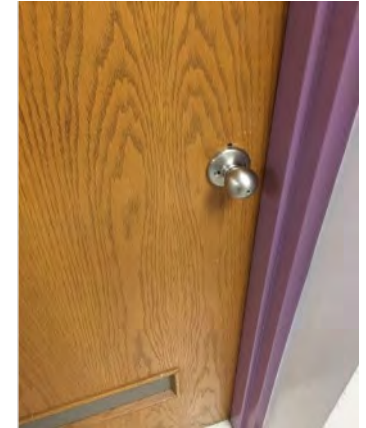
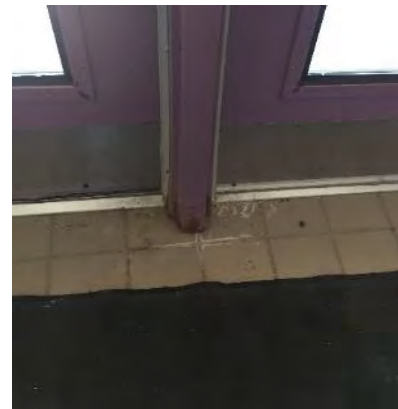
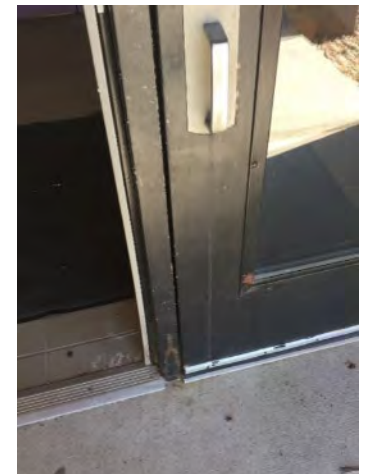
Throughout the school the interior wood doors and frames are in good shape, there are a few that are chipping and damaged.

All the exterior doors and frames are hollow metal. The doors and frames are showing wear and rust.

Approximately six doors should be replaced with new wood doors. Only one door was identified without an ADA compliant doorknob. This hardware should be replaced with a level style handle. There are door grilles that need painting or replacing due to chipped paint, rust spots, or dents.

Recommendation is to replace the exterior doors and frames with aluminum and FRP doors and frames for durability, maintenance and longevity.

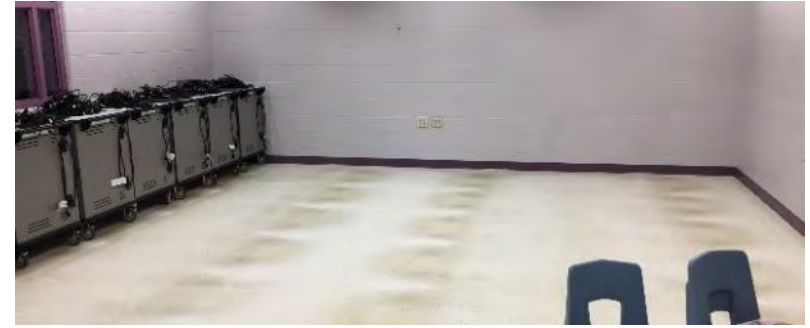
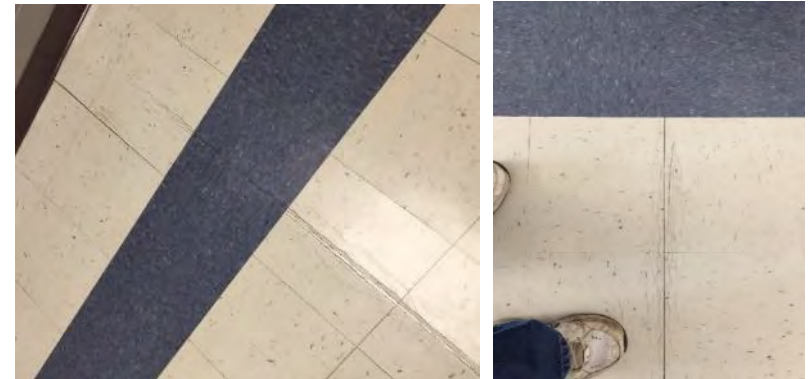
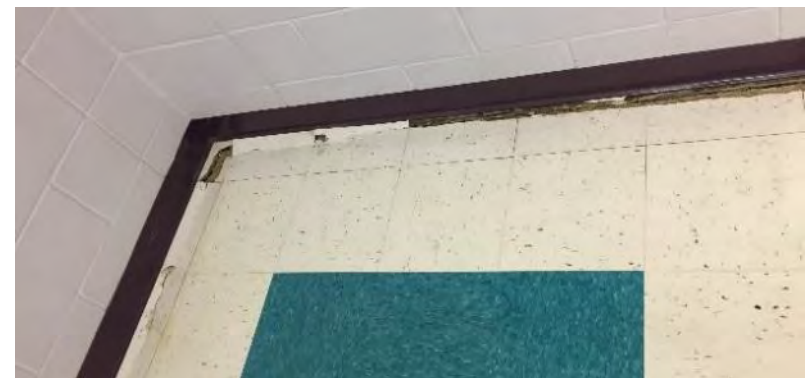
There are multiple locations where the VCT has cracks in it. VCT is a hard and brittle product. If there are cracks in the concrete below the VCT, it is likely to transfer through the VCT; if the cracking below the VCT is not addressed (filled or stopped) replacing the existing VCT with new VCT will likely result in the same type of cracking. A more flexible, resilient flooring product (like a solid vinyl or rubber) or polishing the concrete, is recommended.

There is significant cracking in the east end classrooms where the concrete floor appears to have settled. The flooring should be replaced after the settling issue is resolved.

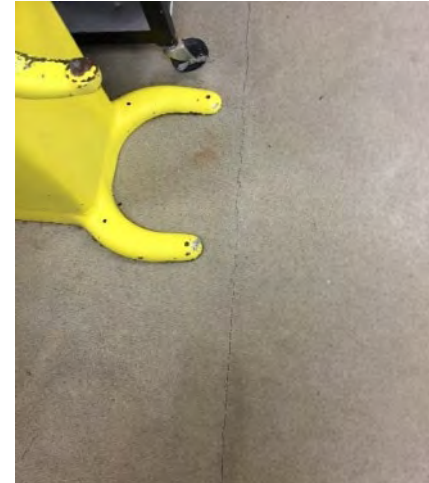
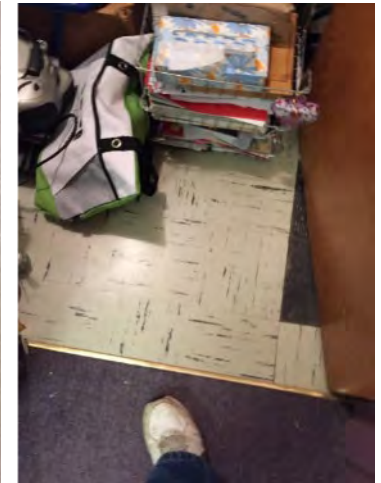
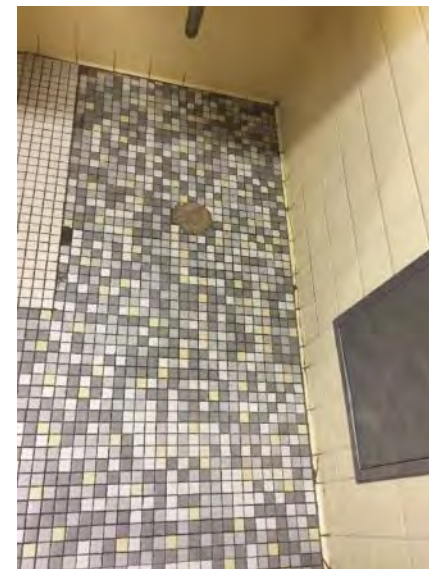
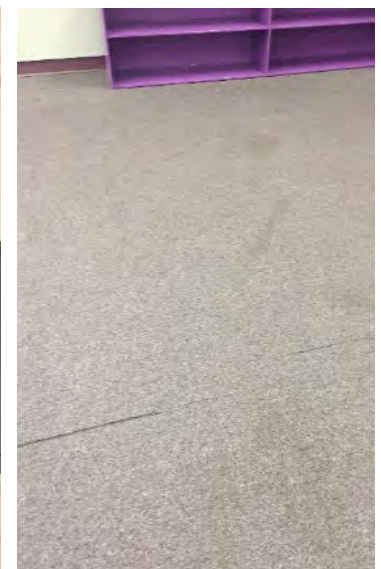
One area had visible indications that hazardous materials may be present. It is possible that there are more areas that have been carpeted over.

The epoxy flooring in the restrooms, kitchen, and lockers has discolored, however, it still functions as designed. There are cracks in the epoxy flooring in the kitchen and associated restroom that should be filled for sanitary reasons.

Ceramic tile flooring and base in the older restrooms has cracking and should be replaced.

There is minimal carpet in the building, however, there are a number of the carpet areas that have significant wear, including tears and rippling.

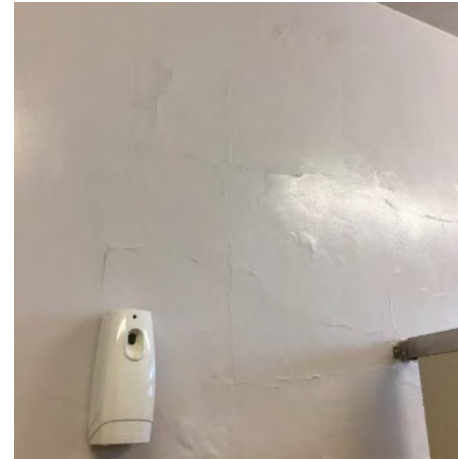
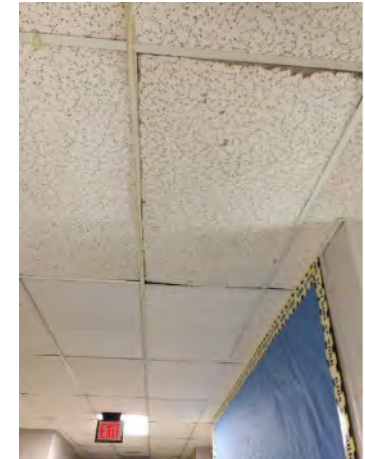
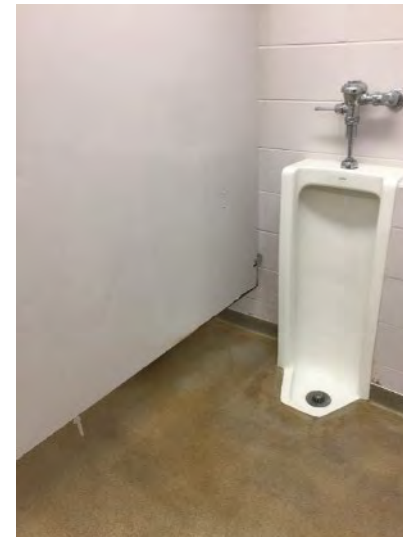
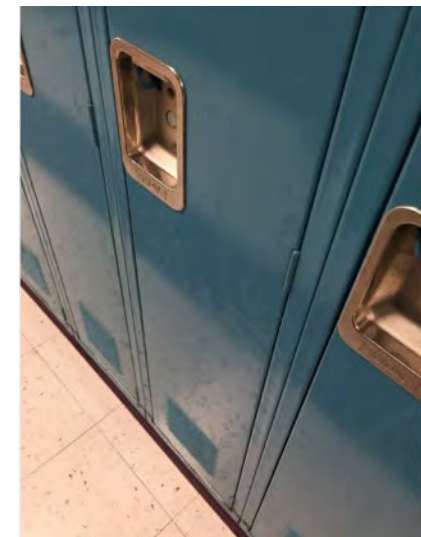
One pair of restrooms has wall damage where there appears to have been water infiltration. The plaster finish should be repaired and the walls repainted.

A portion of the school includes 2 x 4 ceiling tile and grid which is showing age, sagging and discolored. This ceiling should be replaced with 2 x 2 ceiling tile and grid to match the remainder of the school.

One pair of restrooms has metal toilet partitions which are beginning to rust. These partitions should be replaced with solid plastic partitions similar to the other restrooms in the building.

One hallway of metal lockers has visible rust spots on the lockers. These lockers may be able to be repaired and repainted or replaced.

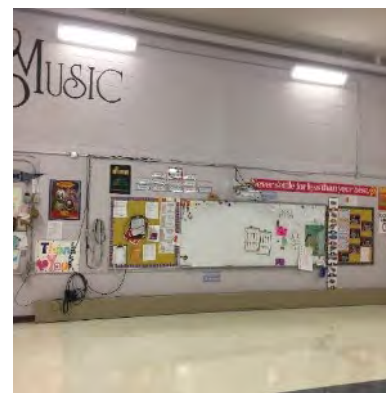
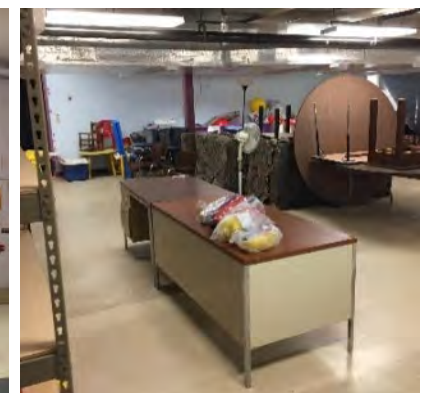
The handrails at the stairs to the lower level do not meet code for the required handrail extensions. Replacing the handrails with code compliant handrails with extensions would be recommended.

Based on the current use and capacity of the school, the addition of a lift or elevator to this section of the school is not recommended. Proper use of these spaces, mechanical and storage areas not occupied by staff or students, is recommended.

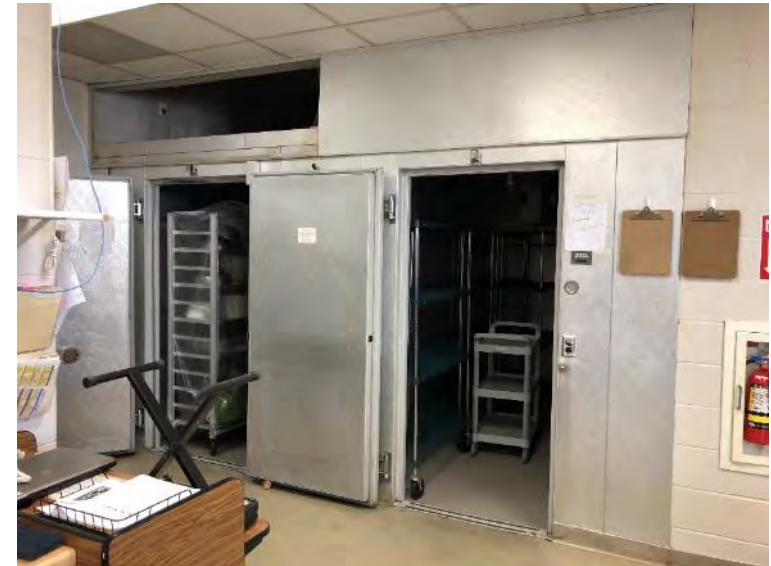
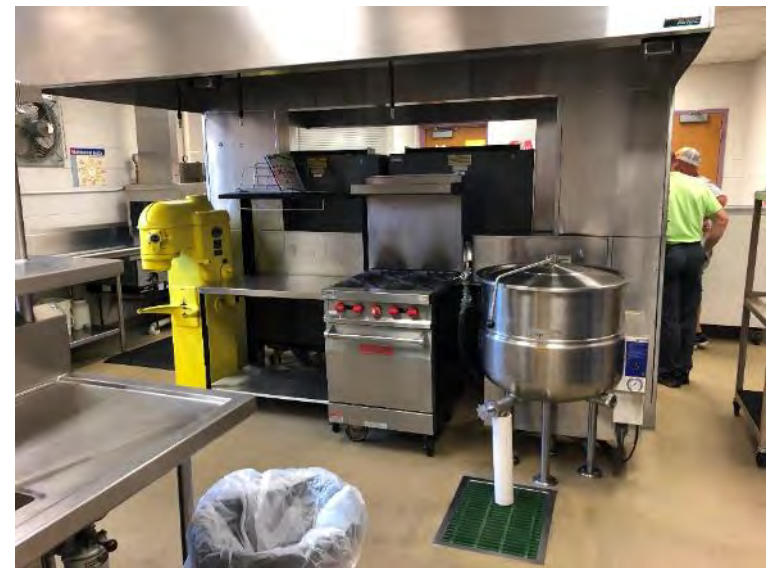
- Walk-In Cooler / Freezer had some epoxy coated shelves but some of the uprights were chrome plated and rusting.
- Epoxy floor inside cooler and freezer is failing in certain locations of cooler / freezer especially around door jamb.
- Drop ceiling is showing age with rust on grid and discolored tiles.
- Floor Mixer – Blakeslee - is very old and does not have bowl guard.
- Convection ovens – Hobart – are no longer manufactured and may be difficult to get parts should they become unreliable in future.
- Serving line hot well unit has pans with exposed heating elements that are rusting.

- Replace rusted shelving in walk in cooler & freezer with epoxy coated units
- Replace Floor Mixer (assuming it is still utilized as part of meal service program)

- Replace gas double stock convection ovens
- Replace hot food well unit in serving line
- Replace baffle for disposer (was missing in Prep Table)
- Consider replacing Dishwasher with newer energy efficient unit.

- Consider replacing Pre-Rinse Spray unit with new.
- Consider replacing Disposer with new unit that has remote start / stop control in lieu of old drum switch.

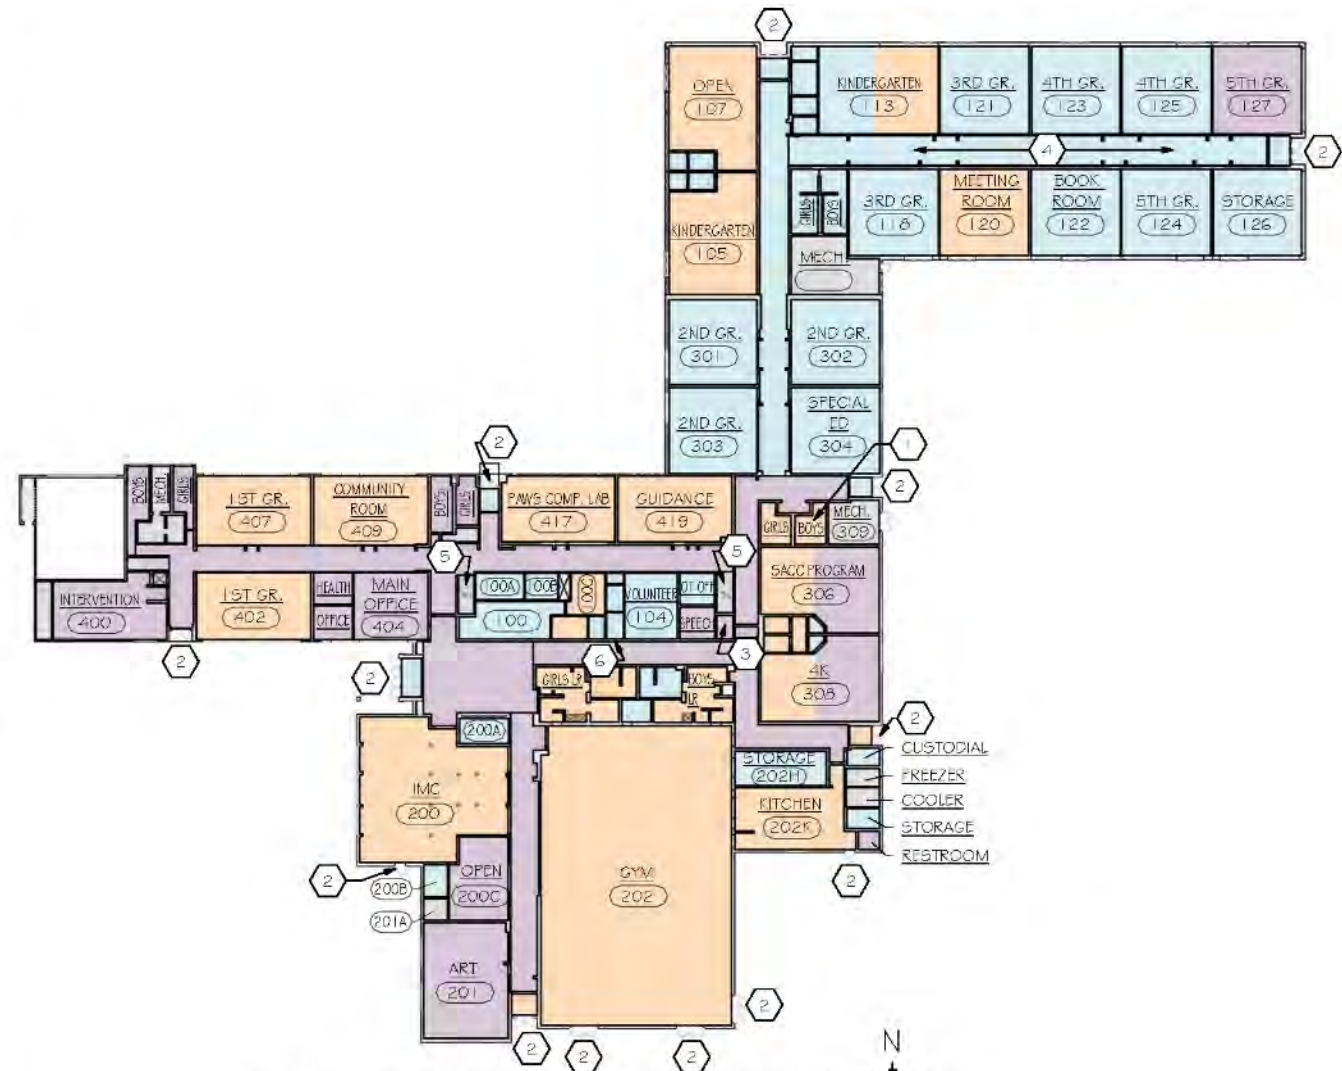
FIRST FLOOR PLAN FLOORING REVIEW

- 1 METAL TOILET PARTITIONS ARE RUSTING.
- 2 HOLLOW METAL DOORS AND FRAMES ARE RUSTING.
- 3 HAZARDOUS MATERIAL MAY BE PRESENT IN FLOORING.
- 4 LOCKERS HAVE RUST SPOTS.
- 5 NO CODE REQUIRED HANDRAIL EXTENSIONS.
- 6 DOOR HARDWARE (KNOB) IS NOT ADA COMPLIANT.

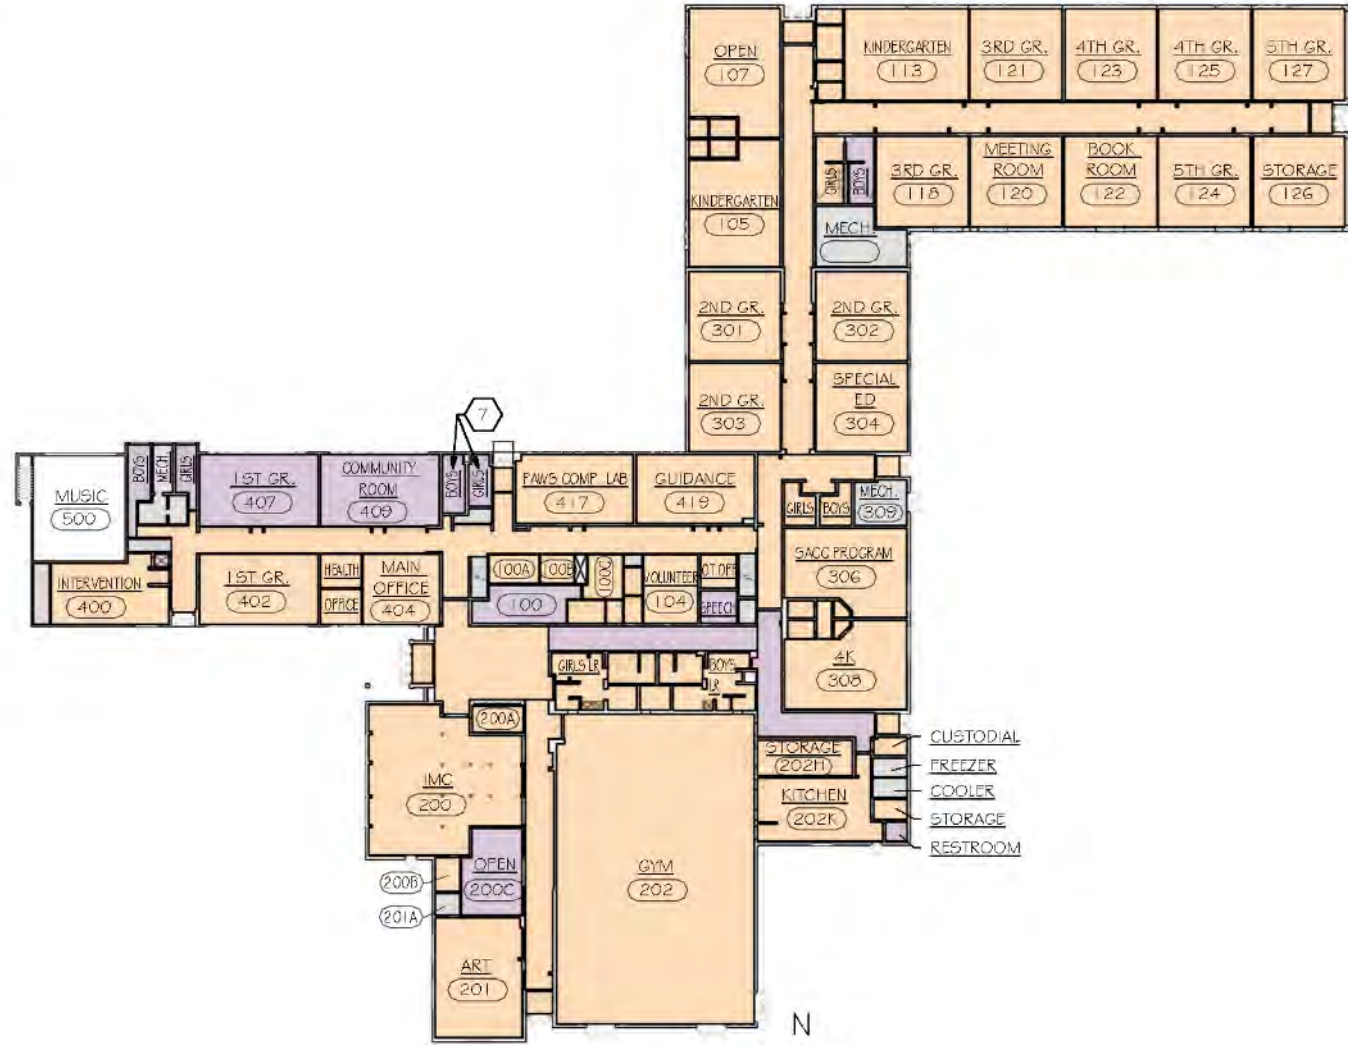
FIRST FLOOR PLAN
WALL REVIEW

7 PAINT FEELING ON WALLS APPEARS TO HAVE WATER DAMAGE.

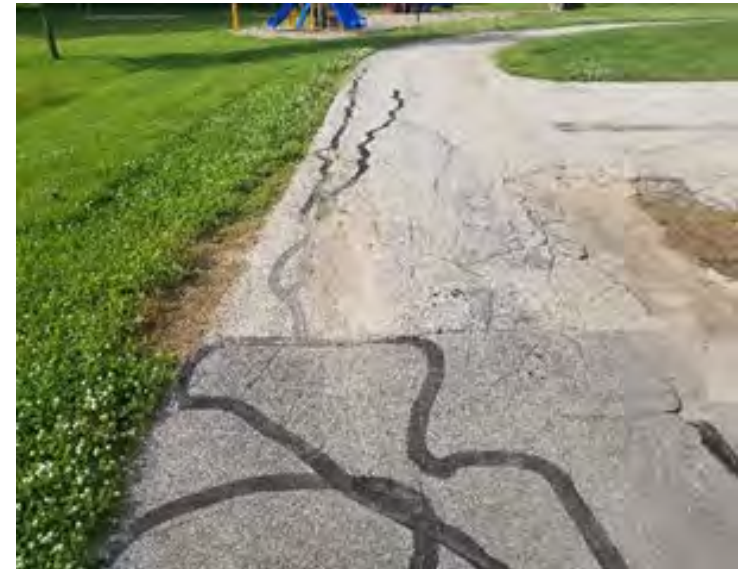
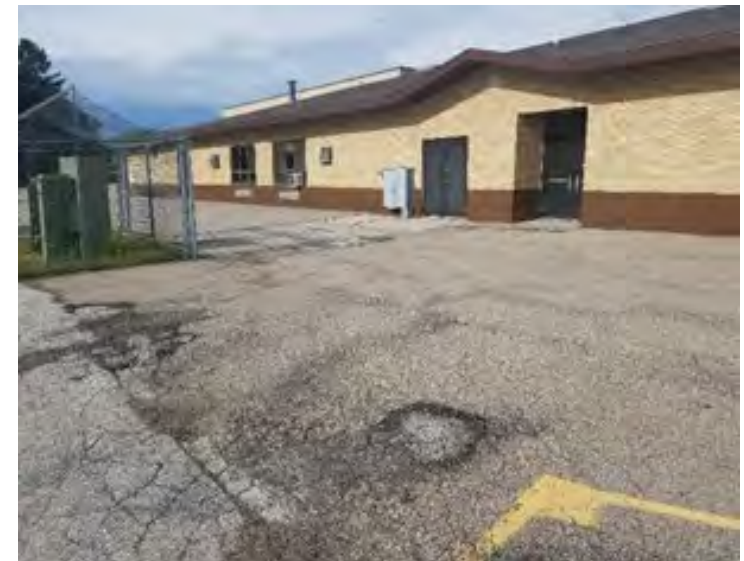
Area 2: Play Area (East Side)

Due to the condition and use of this area, it is recommended to remove the existing pavement and return it to green space. The playground equipment should be relocated as part of another recommendation (AES-EDA-5).

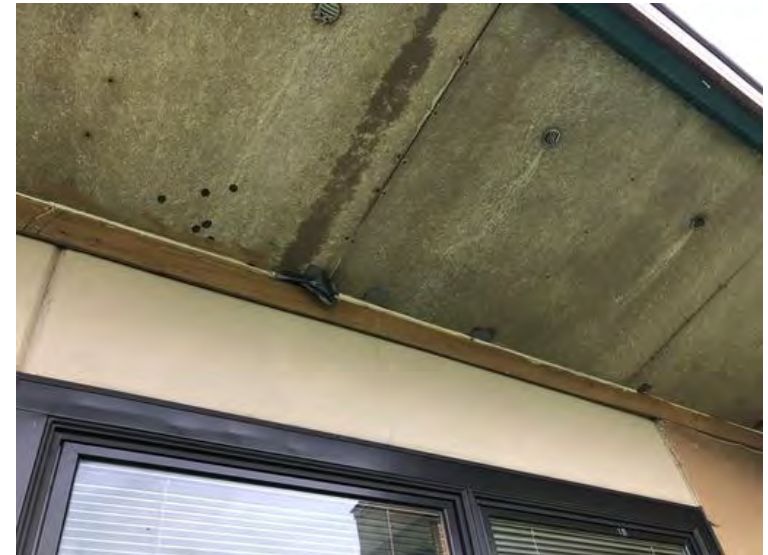
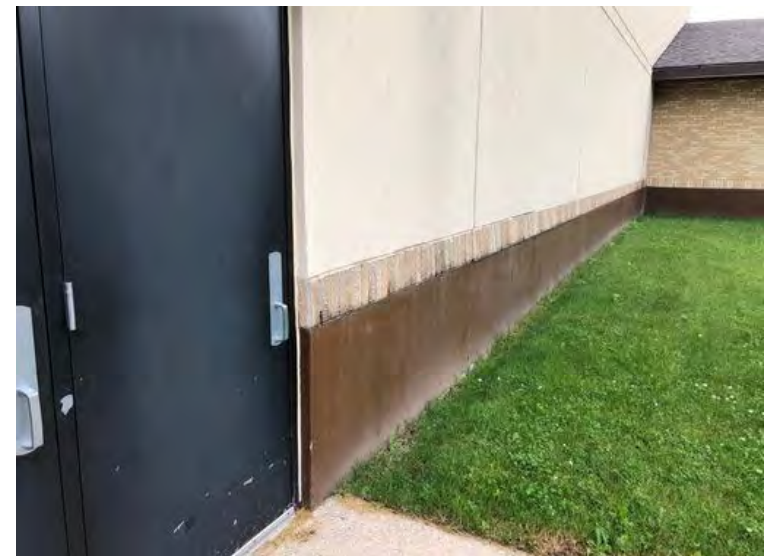
Structural CMU Step Cracks, Masonry/EIFS Movement

There are several step cracks observed in the CMU on the East elevation on the east wing of the school. There is an area on the southeast corner of the building located on the gymnasium where the rowlock bricks have become displaced due to differential movement between the EIFS cladding and brick veneer (@ Door #8)

AES-BE-9	<p>Repair Structural CMU Step Cracks. Address Masonry/EIFS Movement</p> <ul style="list-style-type: none"> Have structural engineer review cracks to determine if structural integrity has been compromised. Have a masonry contractor repair per Structural Engineer's recommendations. Coat with a breathable elastomeric coating system as described and included above. Remove rowlock bricks, install EIFS termination flashing, trim EIFS and reseal per industry practices. Reset rowlock bricks, install sealant/expansion joint at base of EIFS to allow for differential movement. Coat EIFS with elastomeric coating system as described above.

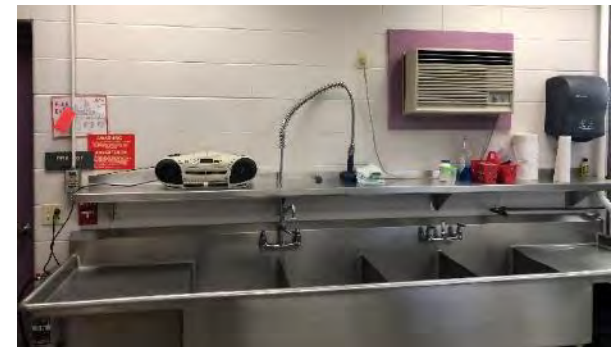
Multiple instances of general-purpose receptacles near sinks (e.g., kitchens or bathrooms) were noted to be regular duty, non-ground fault circuit interrupting (GFCI) type. See Figure 1, right, for an example with multiple instances in one kitchen area. Per NEC section 210.8, GFCI protection must be installed for all 15- and 20-Amp circuits in these locations. We recommend replacing general duty receptacles within kitchen and bathroom areas with GFCI-protected receptacles to comply with code. Additionally, receptacles near mop or washdown sinks and basins should also be replaced with GFCI receptacles.

Figure 1: Existing Non-GFCI receptacles installed in proximity of washdown sink

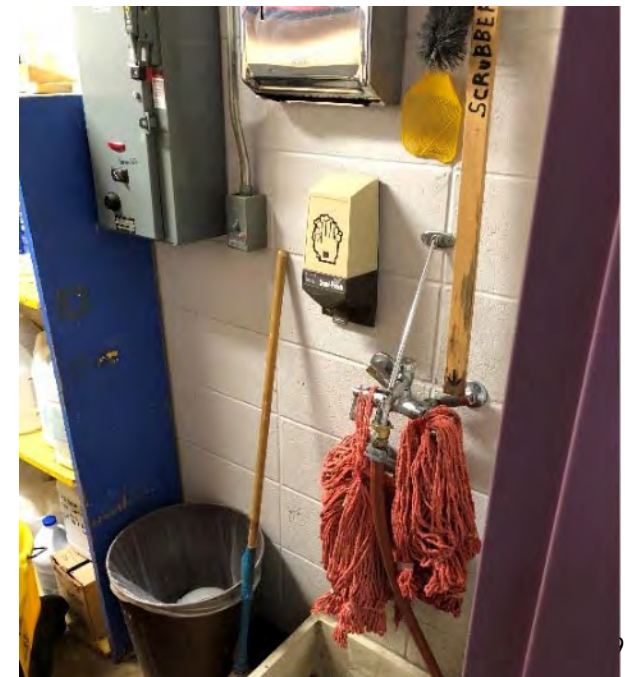
The motor starter for the Café door is located near the washdown/mop sink area but is a NEMA 1 enclosure (see Figure 2, right). Per NEC Table 110.28, this enclosure should be type 4X. We recommend replacing the Café door motor starter with a NEMA 4X motor starter to comply with code and limit safety concerns.

Figure 2: NEMA 1-Rated combination motor starter/disconnect switch adjacent to washdown/mop sink

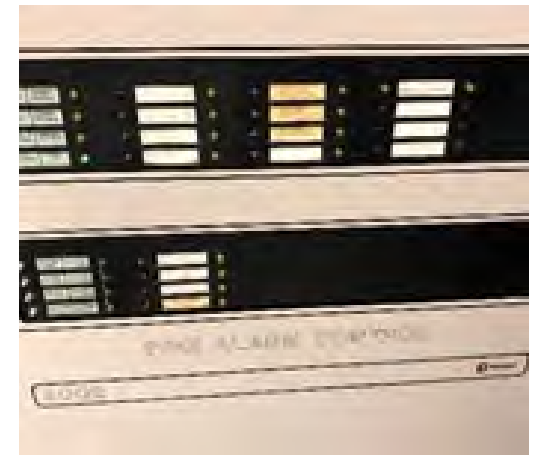
The existing fire alarm control panel (FACP) is a Simplex 4002 non-addressable system, shown to the left in Figure 6. This is a zoned system that has been discontinued by Simplex for many years. It is over 20 years old and past its expected useful life. The parts internal to the FACP are no longer manufactured and cannot easily be sourced. Due to the necessity of maintaining this system for future years, we strongly recommend a replacement of the head end fire alarm control panel with one that meets the requirements of, and is installed in accordance with, NFPA 72 and International Building Code. The new fire alarm system should be an addressable, emergency voice-alarm communications (EVAC) system with capacity for future building expansions. To allow the school district to monitor the site remotely, it should and be networkable to integrate it into the new IT infrastructure.

Figure 6: Existing Simplex 4002 Fire Alarm Control Panel

FIM #	Recommended Electrical and IT Infrastructure Improvements
AES-EE-1	<ul style="list-style-type: none"> • Provide new fire alarm control panel for future expansion and voice capability • Provide entirely new addressable fire alarm system
AES-EE-2	<ul style="list-style-type: none"> • Perform coordination study and adjust circuit breaker trip settings as necessary • Perform fault current/arc flash study and apply arc flash labels to equipment • Install filler plates in panelboards where circuit board spaces are missing covers • Relocate noncompliant existing panelboards to comply NEC clearance requirements • Replace noncompliant general-purpose receptacles with GFCI-type receptacles in kitchens, bathrooms, and near sinks per NEC • Replace electrical equipment in washdown areas with NEMA 4X equivalent • Install floor grounding bar in Tech Room 200B
AES-EE-3	<ul style="list-style-type: none"> • Provide new fire alarm devices to meet current code requirements and replace original building devices beyond their life expectancy.

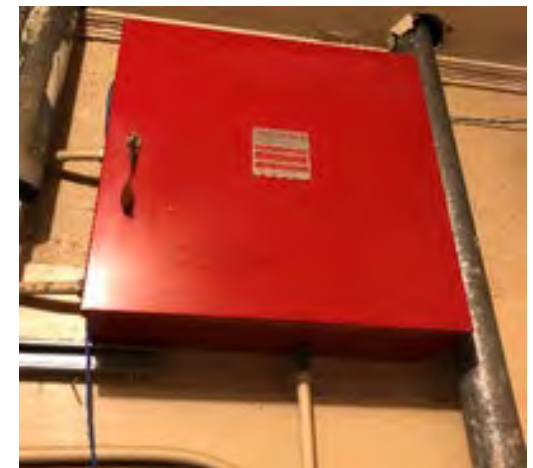
Figure 7: Abandoned-in-place, original fire alarm panel and fire bell

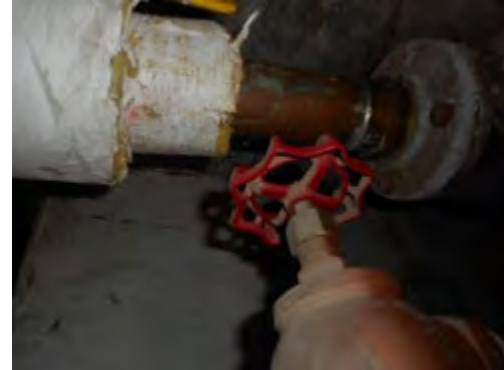
1957 Galvanized Domestic Water Piping Replacement

Nexus recommends replacement of the galvanized domestic water piping with insulated copper piping to eliminate the potential for elevated lead and galvanized contaminants in the water supply.

FIM #	1957 Galvanized Domestic Water Piping Replacement
AES-ME-9	<ul style="list-style-type: none"> • Replace existing galvanized steel domestic water piping and components in the 1957 building areas with insulated copper piping.

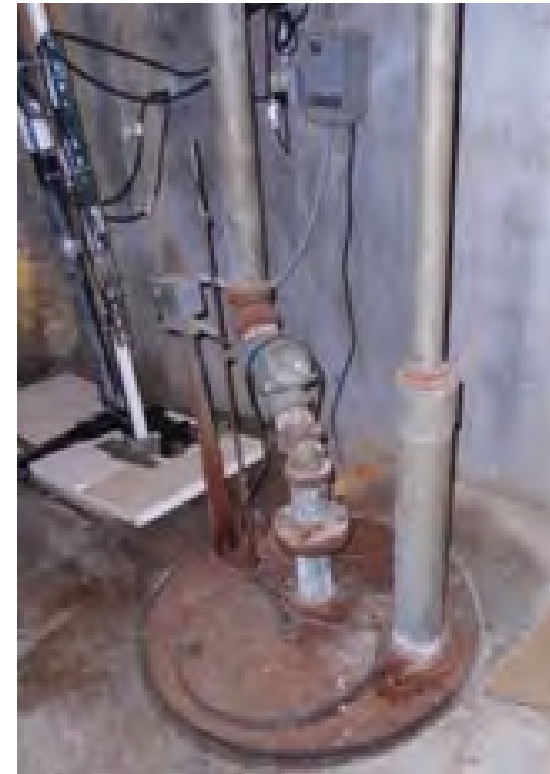
Some existing handwashing sinks, specifically in the 1957 portions of the building do not have domestic hot water. Additionally, some fixtures do not utilize a hot water recirculation system which requires users to waste water to receive hot water. There is currently a sump pump located in the 1957 mechanical room that is used to prevent flooding in the building. This sump pumps are at the end of its useful service life and is in need of replacement. Finally, there is significant iron in the domestic water and the high iron levels stain fixtures over time.

Nexus recommends the domestic hot water system be extended to serve rooms without hot water and the hot water recirculation system be extended to all areas of the building to meet code requirements and basic hot water system operation expectations. Nexus also recommends replacement of the sump pump including all general construction work. Finally, Nexus recommends an iron removal system be installed in the domestic water system.

FIM #	Add Domestic Hot Water and Recirculation to 1957 Sinks, Sump Pump Replacement, Iron Removal System
AES-ME-10	<ul style="list-style-type: none"> • Extend existing Domestic Hot Water systems to Sinks without Hot Water • Connect Domestic Hot Water recirculation systems to all areas of the building • Replace existing sump pump • Provide new iron removal system • Provide associated construction including electrical and controls

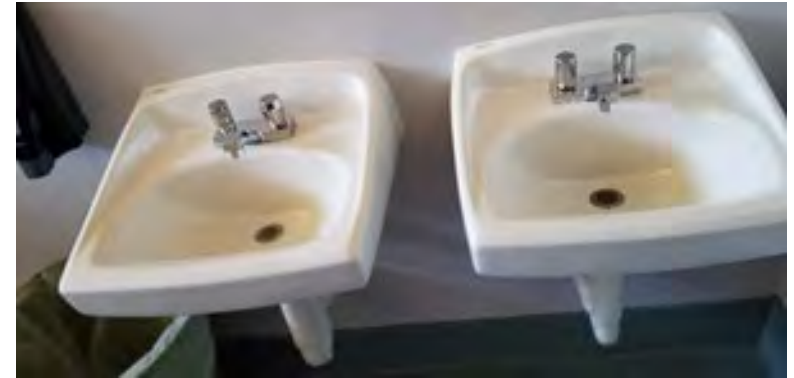
Wash Fountain and Sink Replacement with Sensor Operated

Nexus recommends replacement of the faucets with modern, battery powered sensor operated units that are more water efficient and automatically turn off after use.

FIM #	Wash Fountain and Sink Replacement with Sensor Operated
AES-ME-11	<ul style="list-style-type: none"> • Replace existing manual lavatory faucets with sensor operated faucets

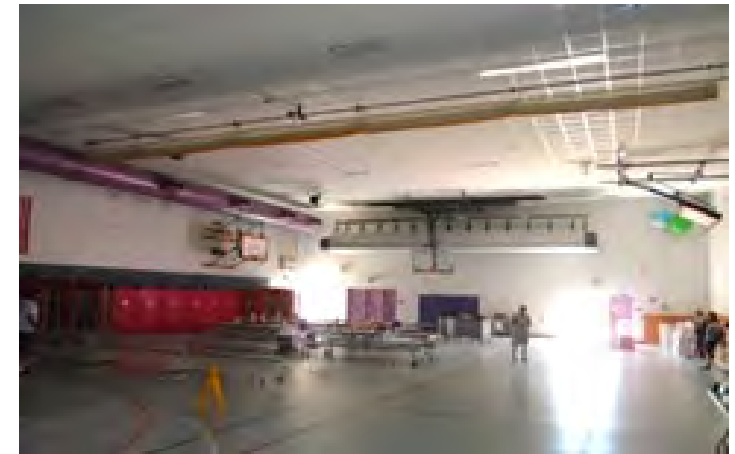
Existing Gymnasium-Cafeteria

The current gym serves as the gym and cafeteria. This limits the scheduling opportunities for the gym when being used for lunch. Furthermore, using the gym as a cafeteria puts additional wear and abuse on the expensive sports floor in the gym. Creating a separate cafeteria will allow for better scheduling and use of the gym, it will also create a large multi-purpose space that can be used for student, staff and community gatherings and activities. The cafeteria, multi-purpose space, could be used for before and after school programming beyond a space for breakfast and lunch.

Relocating the cafeteria would require the kitchen to be remodeled to move the food serving line out of the gym. Remodeling the kitchen would allow for a receiving area to be added to the building. A dedicated receiving area helps to manage the traffic onsite and in the building regarding deliveries to the school. A receiving area would allow for a dedicated space for deliveries, which would result in a safer building and site.

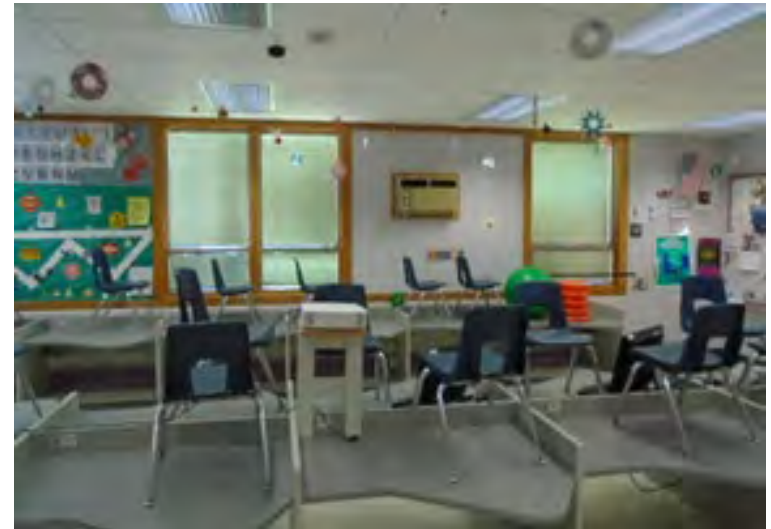
Existing Computer Lab

There is a growing need for more Special Education spaces and different types of spaces for small and large groups as well as more space for specialized and larger equipment.

It is recommended to remodel and centralize several Special Education spaces that are properly sized for certain groups of students and provide amenities and adjacencies for staff.

FIM #	Renovate Computer Lab and Old Office into Special Education spaces
AES-EDA-4	<ul style="list-style-type: none"> • Create more Special Education spaces

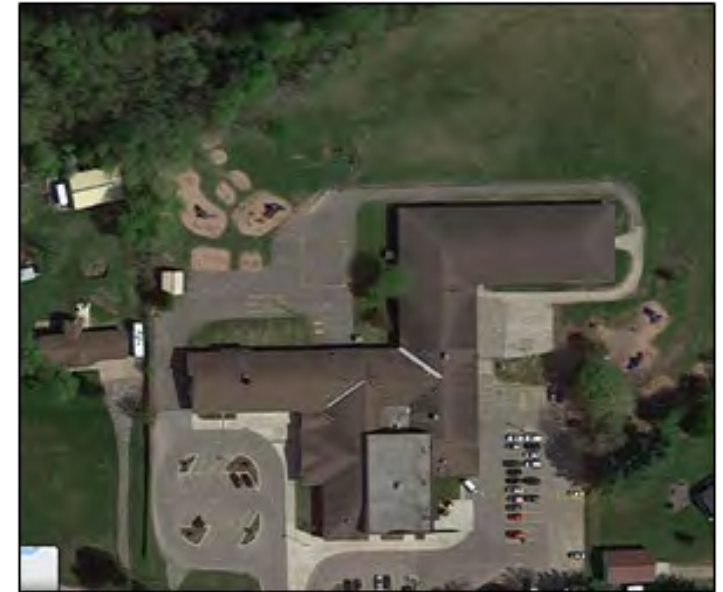
The playground equipment installed on the east side of the building also does not drain well due to a low spot in the grass/dirt, so it accumulates rainwater there and is muddy for student recess.

The recommendation is to relocate the playground equipment to the north of the building near the other playground equipment, so supervision is easier for a single staff member. Also, the area of poor drainage should be leveled and graded so that water does not pond and grass will grow in the area.

FIM #	Relocate Playground Equipment – Drainage Improvements
AES-EDA-5	<ul style="list-style-type: none"> • Relocate playground equipment • Provide positive drainage in existing

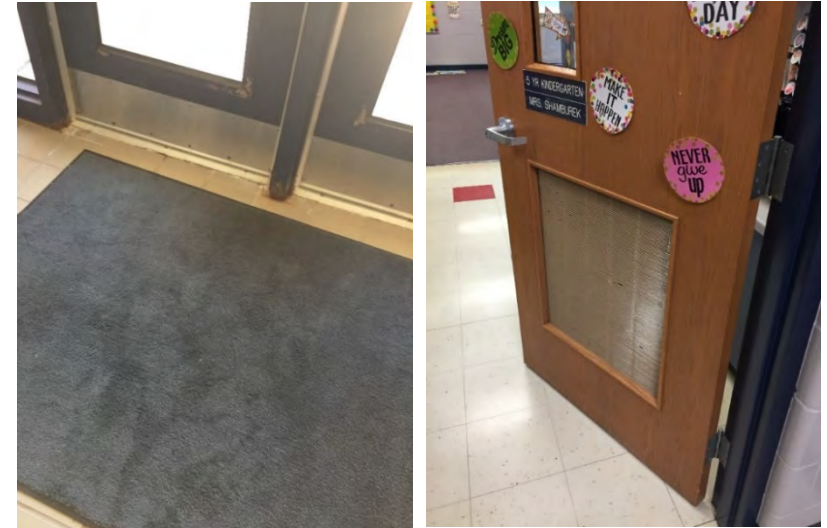
Throughout the school the area of greatest concern is the flooring. The majority of the flooring is VCT (Vinyl Composition Tile). This floor product requires regular stripping and waxing. If the product is not stripped on a regular basis prior to applying the new wax, the dirt will get trapped in the flooring. VCT flooring throughout the school is discolored and appears 'dirty'.

There are multiple locations where the VCT has cracks in it. VCT is a hard and brittle product. If there are cracks in the concrete below the VCT, it is likely to transfer through the VCT; if the cracking below the VCT is not addressed (filled or stopped) replacing the existing VCT with new VCT will likely result in the same type of cracking. A more flexible, resilient flooring product (like a solid vinyl or rubber) or polishing the concrete, is recommended.

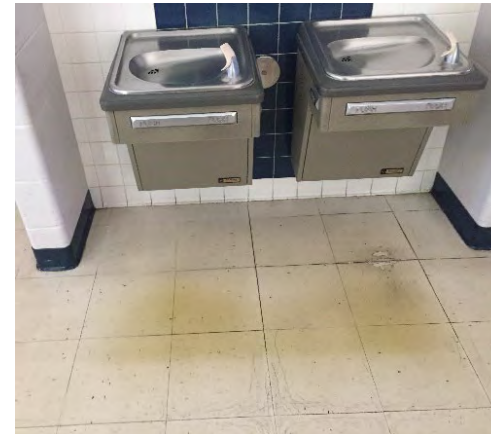
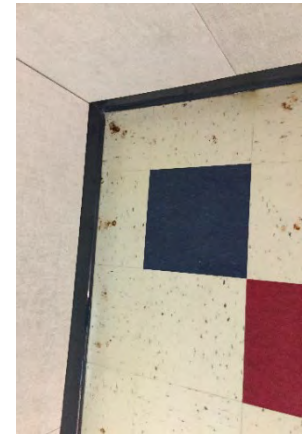
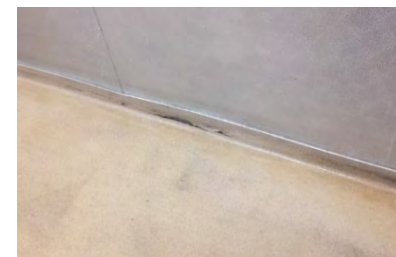
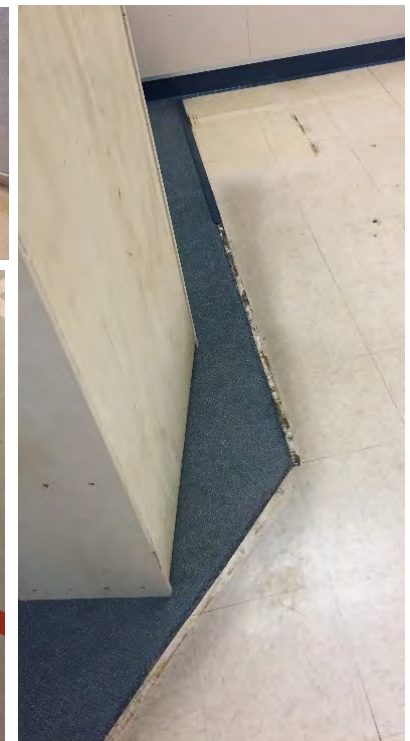
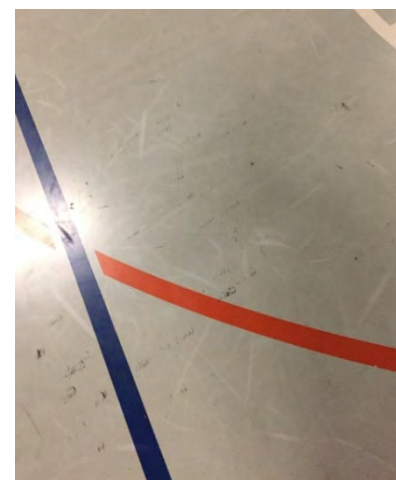
There are areas of the VCT floor that are stained with rust spots. It appears there was metal furniture sitting on the floor, the furniture rusted and stained the flooring.

There are cracks in the epoxy floor base in the kitchen that should be filled for sanitary reasons.

The gym floor is similar to the Abrams Elementary gym floor; however, the Oconto Falls Elementary School gym floor has significant scuff marks from chairs. The floor is not in immediate need of repair, but care should be taken to prevent further damage.

There is carpet throughout the building; there are areas where the carpet is worn and the transition strip between the carpet and VCT flooring is missing.

FIM #	Interior Finishes Upgrades
<p>OFES-INT-1 through OFES-INT-4</p>	<p>Door Hardware</p> <ul style="list-style-type: none"> • Replace or paint grilles on doors with damaged grilles (approximately 6) • Replace exterior hollow metal doors and frames (approximately 4 pair) <p>Flooring Upgrade</p> <ul style="list-style-type: none"> • Replace cracked and discolored 'dirty' VCT • Fill cracks in Epoxy Floor • Replace worn carpet and transition strips (approximately 8 rooms) <p>Walls Upgrade</p> <ul style="list-style-type: none"> • Repair cracks in walls and repaint (approximately 4 locations) <p>Toilet Partition Upgrade</p> <ul style="list-style-type: none"> • Replace rusting metal toilet partitions <p>Locker Upgrade</p> <ul style="list-style-type: none"> • Replace or repair rusting metal lockers

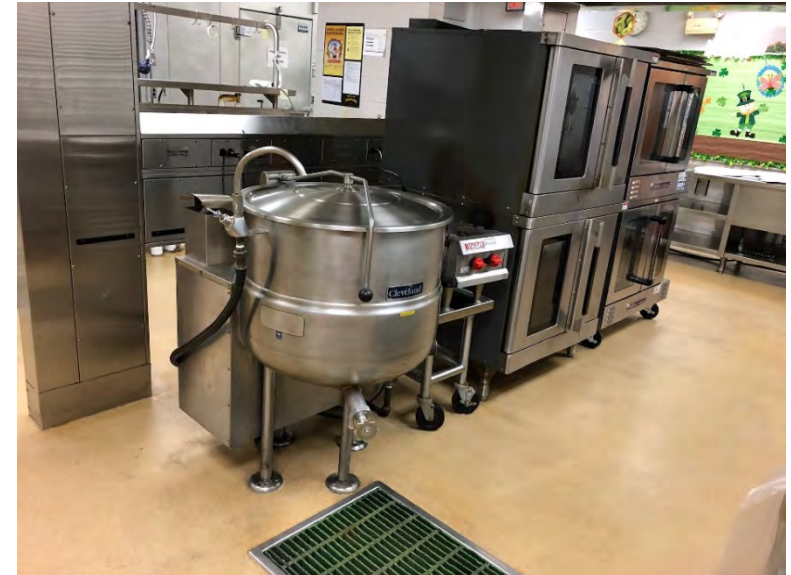
- The drop ceiling is showing age with discolored tiles & grid.
- Walk in Cooler / Freezer floor is showing signs of heaving at floor. This could be due to a combination of age of box and a faulty thermal break.
- Shifting of panels is causing the epoxy flooring to crack and fail.
- Cooler and freezer doors also do not line up properly which prevent proper seal. This is likely caused by panels shifting.
- Cooler / Freezer shelving has a combination of both chrome plated and epoxy coated shelving.
- Some chrome shelving is rusting.
- Disposer has older drum switches that are not recessed inside of table edge which will cause workers to bump into.
- Top oven on double stack convection oven is not working.
- Dish washer is leaking which could be seals failing due to age. Pre rinse spray at dishwashing is showing was problematic.

- Replace ceiling grid and vinyl coated tiles – (see interior finishes recommendations.)
- Repair of epoxy flooring – patching where necessary – (see interior finishes recommendations.)
- Consider replacing walk in cooler/freezer with new box and insulated floor.
- Replace stacked convection ovens.
- Replace dish washer with new energy efficient unit.
- Consider replacing Pre-Rinse Spray unit with new.
- Consider replacing Disposer with new unit that has remote start / stop control in lieu of old drum switch.
- Consider replacing chrome posts for shelving in walk in units with epoxy coated to prevent rusting.

FIM #	Recommended Food Service Improvements
OFES-INT-5	Replace Kitchen Equipment Where Required: <ul style="list-style-type: none"> • Replace ceiling grid and vinyl coated tiles – (see interior finishes recommendations.) • Repair epoxy flooring – patching where necessary – (see interior finishes recommendations.) • Replace walk in cooler/freezer with new box and insulated floor. • Replace stacked convection ovens. • Replace dish washer with new energy efficient unit. • Replace Pre-Rinse Spray unit with new. • Replace Disposer with new unit that has remote start / stop control in lieu of old drum switch. • Replace chrome posts for shelving in walk in units with epoxy coated to prevent rusting.
OFES-INT-6	Replace Walk-In Cooler/Freezer: <ul style="list-style-type: none"> • Replace Walk-in Cooler and Freezer • Replace Condenser, Evaporator, and Controls

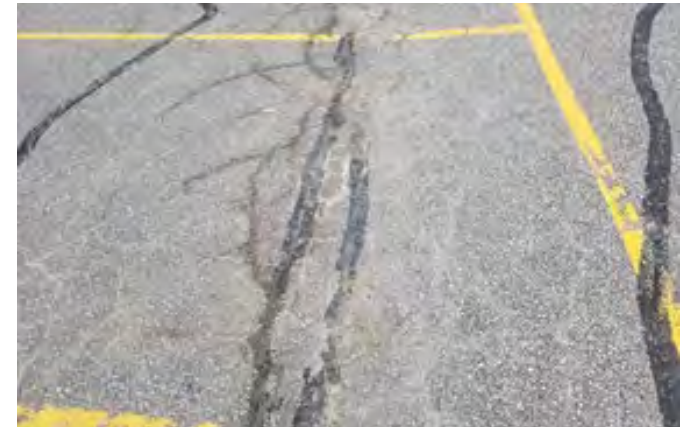
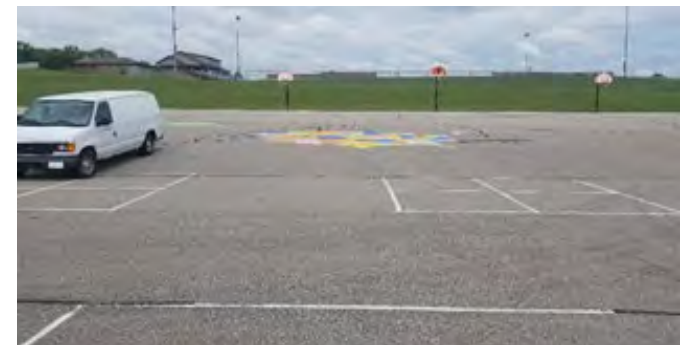
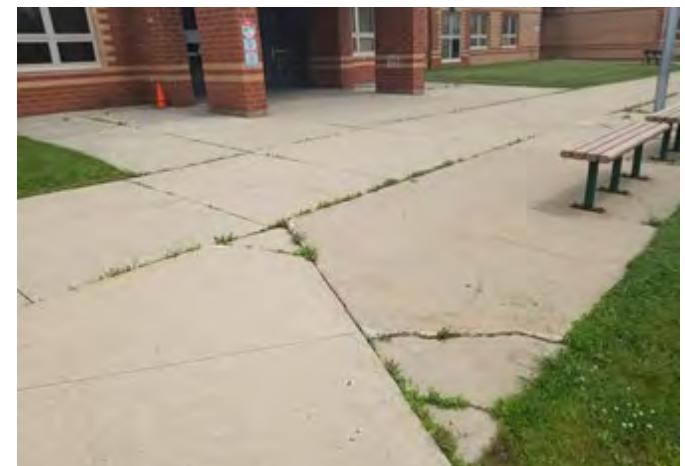
The existing pavement has numerous thermal cracks which have worsened over multiple freeze-thaw cycles. There are some areas of localized base failure, which are evident by the fatigue cracking present. The base failure is a small portion of this area, approximately 5%. Edge failure and surface weathering are also present.

The existing pavement has numerous thermal cracks which have worsened over multiple freeze-thaw cycles. There are some areas of localized base failure, which are evident by the fatigue cracking present. The base failure is a small portion of this area, approximately 10%. Edge failure and surface weathering are also present.

Throughout the site there are sections of sidewalk that have spalled along the edges and it will continue to worsen as the sidewalk ages. There are multiple areas of curb and gutter that have also spalled along the edges and have broken into smaller sections of curb. These become a tripping hazard when stepping down from the sidewalk.

FIM #	Site and Civil Improvements
OFES-SC-1	<p>Area 1: West Parking Lot</p> <ul style="list-style-type: none"> • Remove existing pavement, inspect the base material and patch as necessary. • Add 3 inches of asphalt and mark the new pavement. • Add concrete flume.
OFES-SC-2	<p>Area 2: North Playground</p> <ul style="list-style-type: none"> • Remove the existing asphalt to expose the base material. • Inspect the base material and repair it with base course patching as needed. • Pave 3 inches of new asphaltic surface and paint all pavement markings.
OFES-SC-3	<p>Site Concrete:</p> <ul style="list-style-type: none"> • Remove and replace all areas of damaged or spalling concrete. • Add the detectable warning fields in required location.
OFES-SC-4	<p>Stormwater Management:</p> <ul style="list-style-type: none"> • If more than one acre is disturbed for reconstruction. stormwater management will need to be performed.

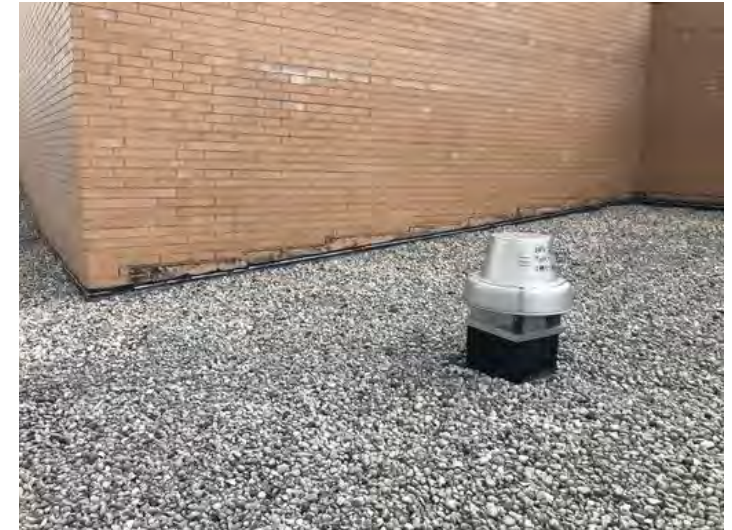
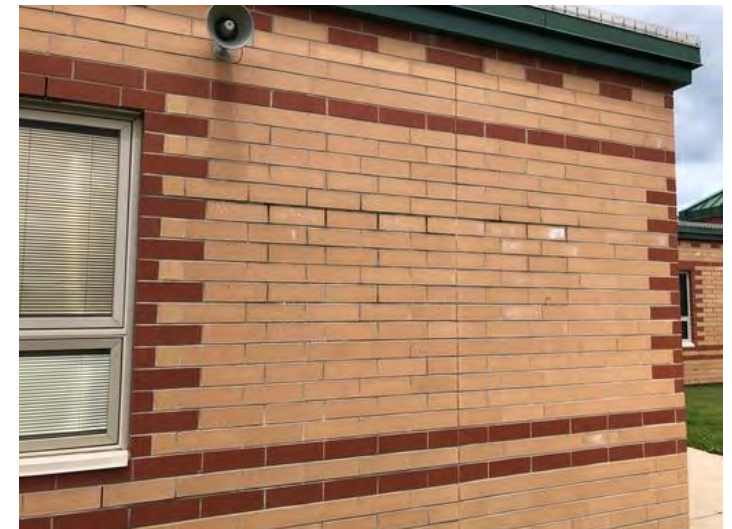
The roof system is beginning to show signs of failure by holes at penetrations. Ballasted system is not appropriate for sloped roof design. No gutters exist at roof perimeter edges which allow excessive moisture to shed off roof and saturate the ground around the perimeter. Stone ballast is in a deteriorated condition.

There is a leak that is occurring along the upper roof to wall transition where some pre-existing through wall flashing appears to have been removed during a past roof replacement.

Efflorescence is exhibited on primarily the south elevation coming from the brick veneer. Excessive moisture is entering the masonry cladding and leeching out fine minerals from the mortar and brick. This is due to most likely to the lack of gutters to divert roof stormwater runoff. Organic growth is also visible on a number of mortar joints which is due to excessive moisture within the wall system.

No gutters exist at roof perimeter edges which allow excessive moisture to shed off roof and saturate the ground around the perimeter. Stone ballast is in a deteriorated condition.

FIM #	Building Envelope Repairs
OFES-BE-1	Replace Ballasted EPDM Roof System with TPO Roofing System (Entire Building) <ul style="list-style-type: none"> • Roof system should be replaced with a decorative PVC roof system.
OFES-BE-2	Replace Deteriorated Windows at South Entrance Cupola <ul style="list-style-type: none"> • Remove and replace window seals and gaskets or replace windows.
OFES-BE-3	Remove and Replace Masonry Control Joints, Install Gutters and Drainage to Prevent Further Masonry Damage <ul style="list-style-type: none"> • Gutters should be installed around the roof edge perimeter to collect stormwater runoff and a drainage system installed to move water to a retention location/storm sewer nearby. • Wash brick veneer with a low-pressure washer to remove efflorescence and organic growth. • Remove existing masonry control joint sealant, rout open joint to properly calculated width, install backer rod, prime, and re-seal
