Oconto Falls School District **FACILITY ASSESSMENT**

Oconto Falls School District
FACILITY ASSESSMENT

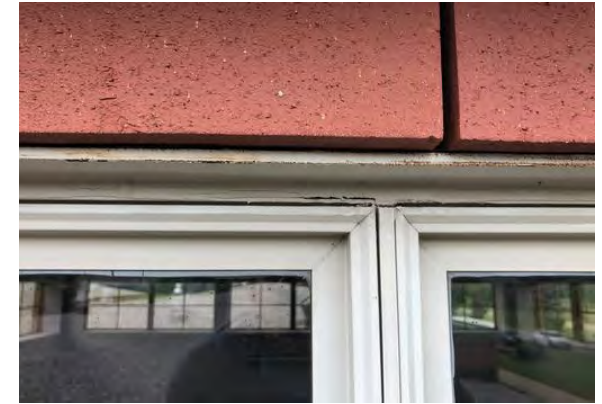
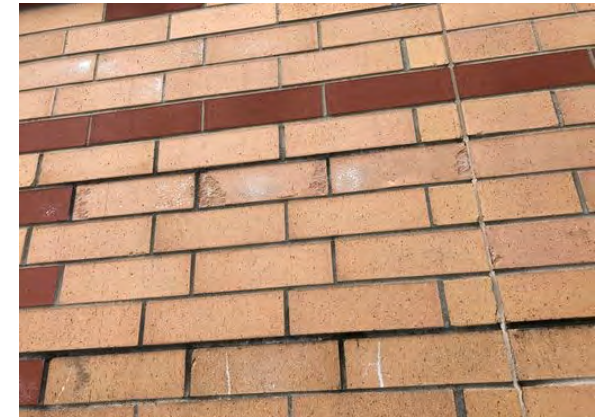
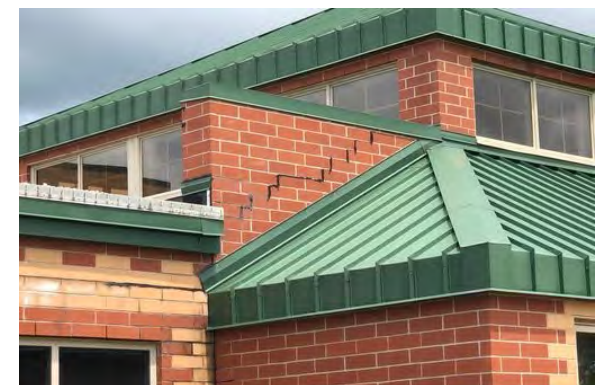
Window gaskets are in a failed or deteriorated state on the roof level at the south entrance cupola. Window seals were observed extruding from exterior in other areas. The windowsill flashings at alcove on east elevation lack proper sealant at lower outside corners. Window perimeter sealant is in a failed condition or deteriorated condition in multiple areas.

Control joints are sized too small which has caused the sealant to extrude from the joint and has cohesively failed. Lintels are exhibiting rust due to excess moisture contact and lack of properly installed drip edge flashings.

Bricks were observed with face delamination at several locations about the building. This is due in part to too hard of mortar. Mortar that is harder than the brick will not allow the brick to expand when it warms up or absorbs moisture therefore cause shear stress at the outer face of the brick which results in the face delaminating.

Cracked masonry was noted at the north east corner of the building. Step cracks were observed at the two south entrance locations with brick veneer parapets above.

FIM #	Building Envelope Repairs
OFES-BE-1	Replace Ballasted EPDM Roof System with TPO Roofing System (Entire Building) <ul style="list-style-type: none"> • Roof system should be replaced with a decorative PVC roof system.
OFES-BE-2	Replace Deteriorated Windows at South Entrance Cupola <ul style="list-style-type: none"> • Remove and replace window seals and gaskets or replace windows.
OFES-BE-3	Remove and Replace Masonry Control Joints, Install Gutters and Drainage to Prevent Further Masonry Damage <ul style="list-style-type: none"> • Gutters should be installed around the roof edge perimeter to collect stormwater runoff and a drainage system installed to move water to a retention location/storm sewer nearby. • Wash brick veneer with a low-pressure washer to remove efflorescence and organic growth. • Remove existing masonry control joint sealant, rout open joint to properly calculated width, install backer rod, prime, and re-seal

OFES-BE-4	Remove, Repair, Coat, and Reinstall Rusting Masonry Lintels <ul style="list-style-type: none"> • Remove lintels, remove rust and corrosion, epoxy coat, and re-install.
OFES-BE-5	Replace Roof Flashing at Wall Transitions, Replace Through-Wall Flashing <ul style="list-style-type: none"> • Remove roof flashing in order to tie in new roof-to-wall flashing. Reuse or remove brick and replace through wall flashing membrane to rehabilitate original through wall flashing.
OFES-BE-6	Replace Spalling Brick where Damaged, Repair Crack at N.E. Corner, Repair Cracks and Tuckpoint at South Entrance <ul style="list-style-type: none"> • Remove and replace bricks as necessary. • Around north east crack, remove and replace brick and mortar. Rout out existing mortar joints and tuckpoint at area showing step cracks.
OFES-BE-7	Replace Failed Window Seals and Gaskets, Remove and Replace Window Perimeter Sealant where Deteriorated <ul style="list-style-type: none"> • Remove and replace window seals/gasket • Remove existing sealant, install backer rod, prime, and re-seal

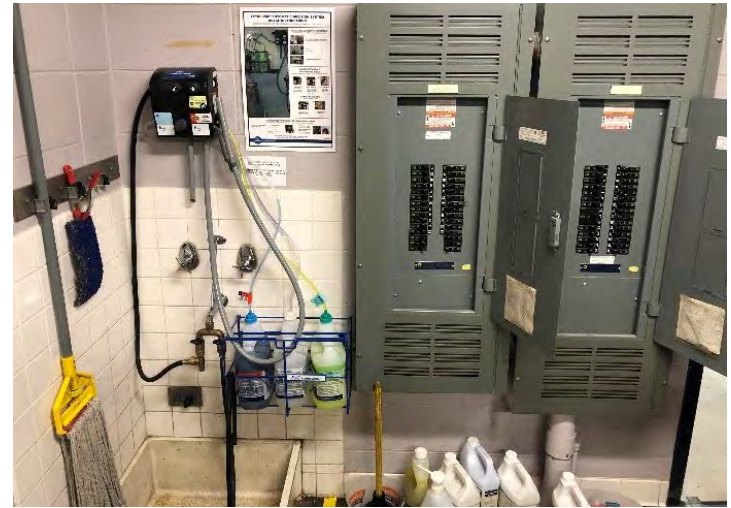
FIG 1: Existing Panelboard adjacent to washdown/mop sink

Existing panelboard 'B' is located near the washdown/mop sink area but is a NEMA 1 enclosure (see Figure 1, right). Per NEC Table 110.28, this enclosure should be type 4X for this installation. Since an immediate replacement of the panelboards with NEMA 4X enclosures or relocating will be difficult and/or costly, we would recommend installing a solid partition from the floor to a height greater than the panelboards to reduce the chance of splashes. Additionally, the BOMA useful life expectancy of this panelboard is about 30 years. Since these panelboards are assumed to have been installed as part of the original construction, we would strongly recommend replacement within 5 years with a NEMA 4X enclosure, a single 60-pole panel, or entirely relocated away from the potential splash area.

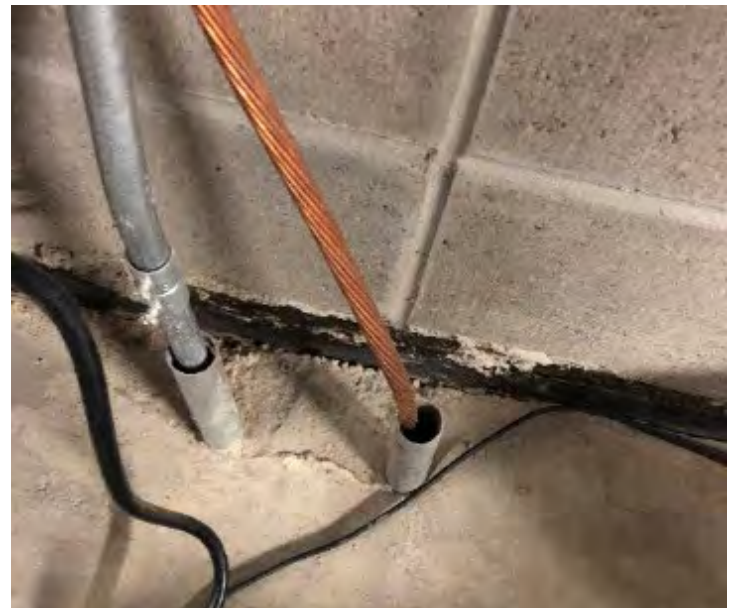
FIG 2: Bare copper ground lead in metal sleeve

Audio/Visual Room 153B currently has a metal sleeve installed around the bare copper ground lead as shown in Figure 2 to the right. We recommend replacing this metal sleeve with a non-metallic sleeve or other NEC-approved stress relief solution to prevent the potential of unwanted current on the ground sleeve.

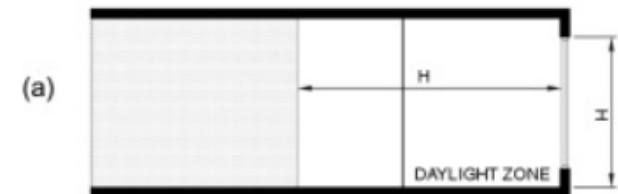
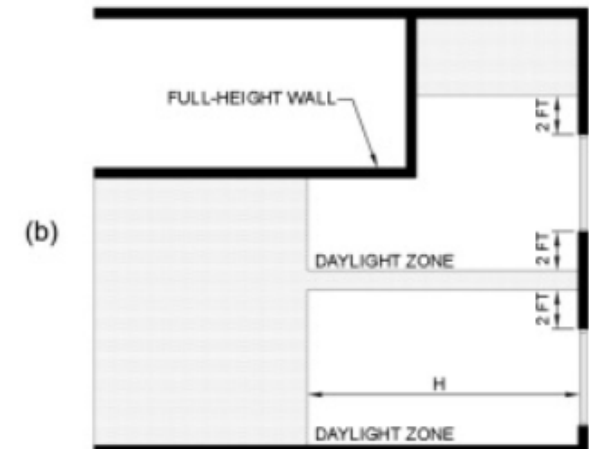
FIG 5:

Classrooms throughout the building are controlled by a single switch. Per IECC 2018 Section C405.2.3, spaces with over 150W of lighting must have separate daylight-responsive controls. This means fixtures in the daylighting/sidelit zone (defined in IECC Figure C405.2.3.2, shown at right in Figure 5) must dim automatically in response to the amount of light coming in the windows separately from the rest of the room. These responsive controls must be able to be calibrated from within the space. In order to meet these requirements, we recommend providing photocells separately controlled switching to control new, dimmable LED fixtures that are within daylight zones. Not only would this installation comply with the latest energy code requirements, it will offer increased energy savings over the existing installation.

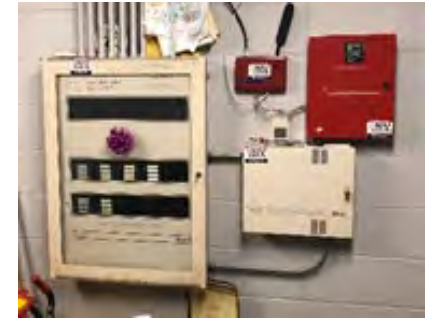
The existing fire alarm control panel (FACP) is a Simplex 4002 non-addressable system, shown at the left. This is a zoned system that has been discontinued by Simplex for many years. It is over 20 years old and past its expected useful life. The parts internal to the FACP are no longer manufactured and cannot easily be sourced. Due to the necessity of maintaining this system for future years, we strongly recommend a replacement of the head end fire alarm control panel with one that meets the requirements of, and is installed in accordance with, NFPA 72 and International Building Code. The new fire alarm system should be an addressable, emergency voice-alarm communications (EVAC) system with capacity for future building expansions. To allow the school district to monitor the site remotely, it should and be networkable to integrate it into the new IT infrastructure.

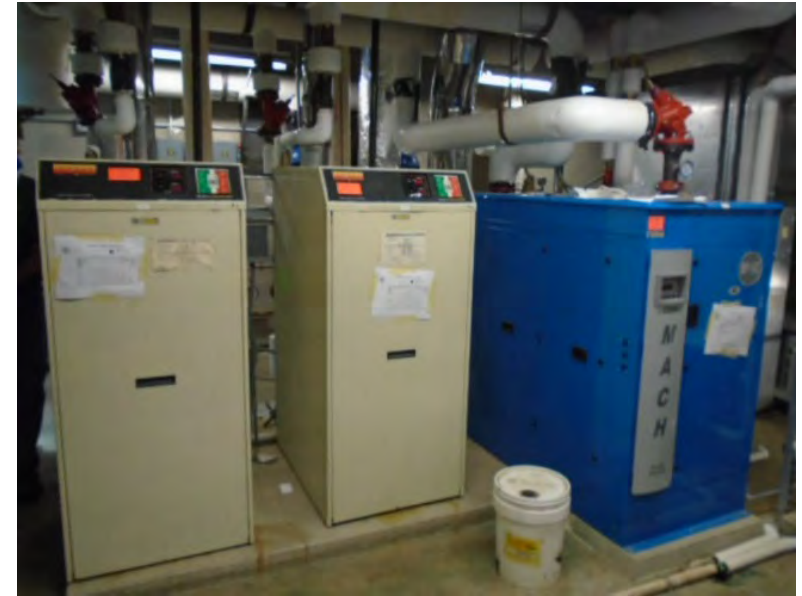
The existing heating water system does not contain glycol. Glycol is an important compound to have in hydronic heating systems that are exposed to freezing temperatures. It acts as an antifreeze, preventing the build up of ice in the system which can cause heating piping and coils to burst.

We recommend adding propylene glycol to the hydronic heating system in a solution that is 35% propylene glycol and 65% water. An air and dirt separator would be added to collect any particulate, debris, and rust within the water volume and keep the glycol and piping clean. A glycol fill tank would be installed to allow for ease of refilling the heating piping system when required.

FIM #	Heating Plant Improvements - Boiler & Pump Replacement, Glycol Addition, Air Separator Improvements
OFES-ME-2	<ul style="list-style-type: none"> • Remove two existing original boilers and boiler pumps • Install two (2) new fully modulating condensing boilers with integral primary boiler pumps • Install two (2) new system pumps • Add propylene glycol to the heating water system • Add a glycol fill tank and pump for ease of refill • Add air and dirt separator to collect entrained air and debris

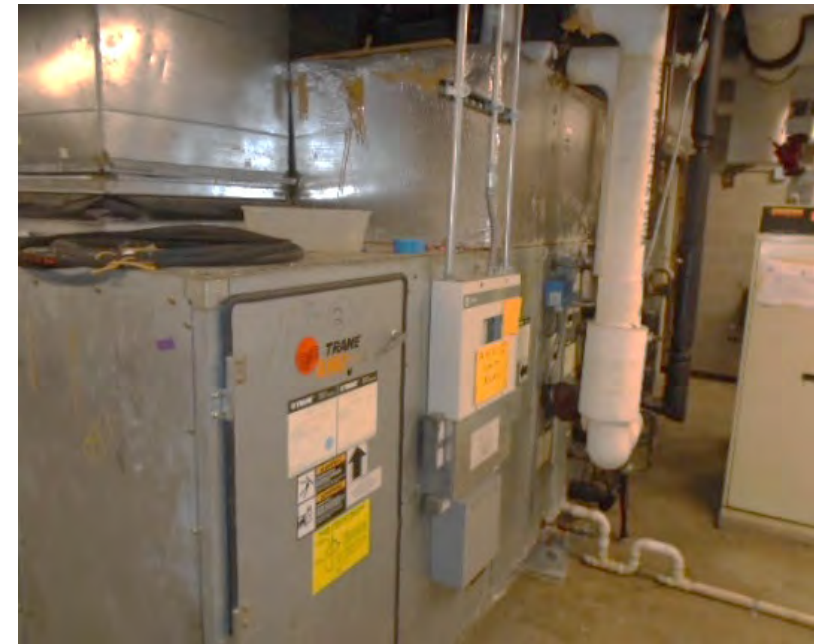
The Gymnasium Office staff complains of a vibration from the HVAC ductwork that makes it difficult to occupy the space. Most classrooms were originally designed with two corner diffusers and this configuration does not distribute air to the classrooms as well as it should, leading to hot and cold complaints. Also, the Music room was converted from one room to two but the HVAC was never upgraded for the space. In addition, the exterior building doors stand open during the spring and fall when the air handling units bring in cool outside air to cool the building and cause positive pressurization in relation to outside.

Nexus recommends the addition of vibration isolation to the ductwork in the Gym Office. Insulation may be added and the ductwork reinforced to prevent the sound and pressure issues from occurring and making this space usable again. Additional diffusers will be installed in each classroom where the air distribution is not adequate. In Addition, a VAV box and reheat coil will be added along with thermostatic control so that the remodeled music rooms will have thermostatic control. Lastly, the rebalancing of the HVAC air-side systems are recommended to establish a neutral building pressure to keep doors closed.

<p>FIM #</p>	<p>Miscellaneous HVAC Upgrades - Gym Office Air Noise, Additional Diffusers to Classrooms, Music Room Zoning Improvements and Rebalance HVAC System</p>
<p>OFES-ME-6</p>	<ul style="list-style-type: none"> • Provide vibration isolation to ductwork and air balancing for Gym Office • Provide new ductwork and diffusers to classrooms • Provide new VAV box and reheat coil to Music room • Provide the associated general and electrical construction work

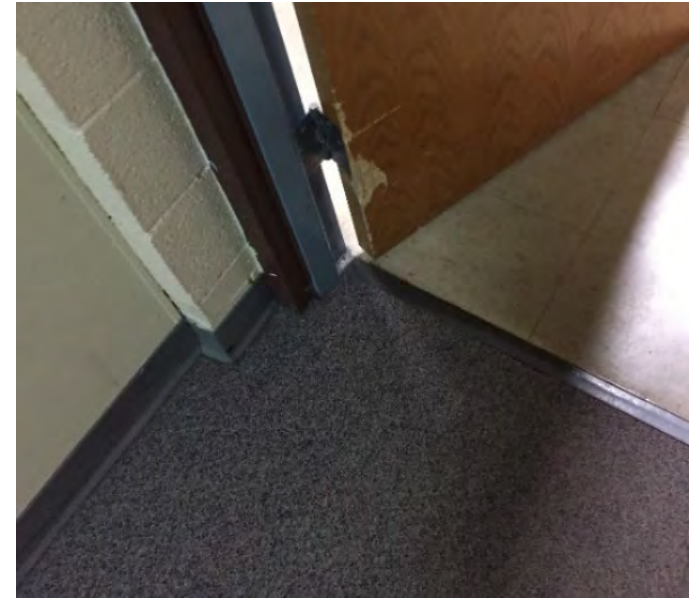
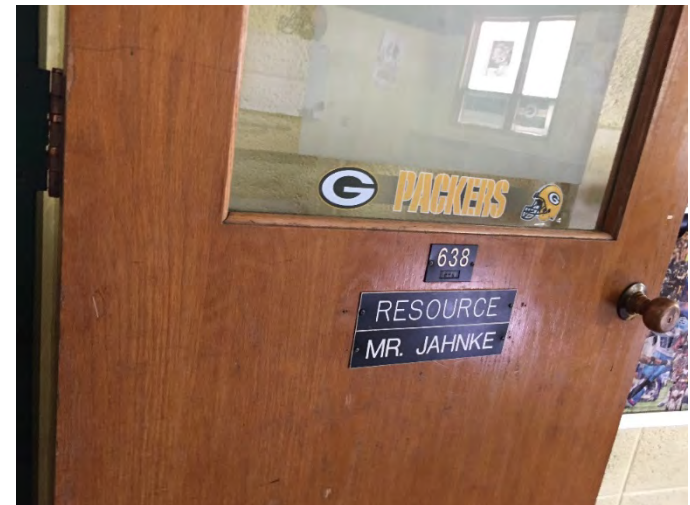
Throughout the school the interior wood doors and frames are in poor shape. The existing glass in the doors is not code compliant tempered (strengthened) glass.

A significant number of doors have non-ADA compliant knob door hardware. Knob hardware should be replaced with compliant leveler style hardware.

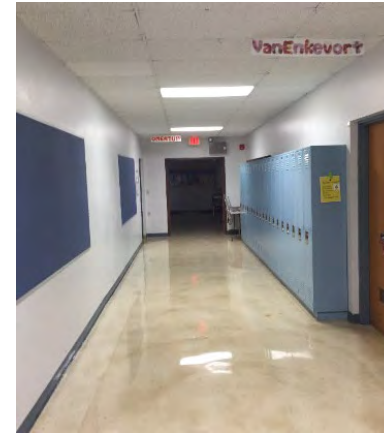
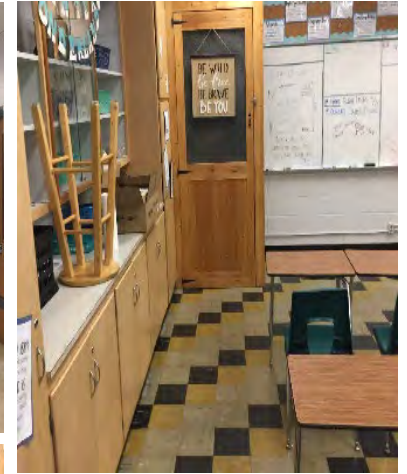
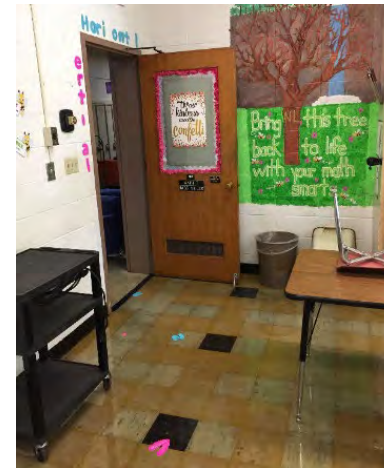
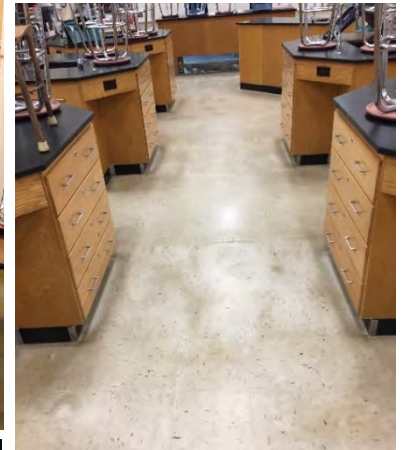
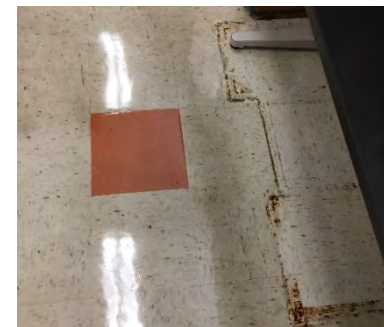
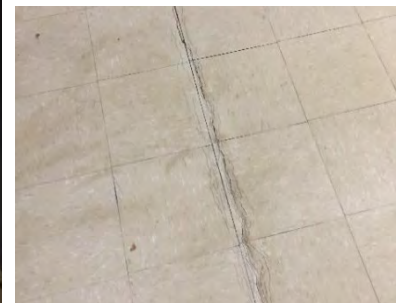
There are multiple locations where the VCT has cracks in it. VCT is a hard and brittle product. If there are cracks in the concrete below the VCT, it is likely to transfer through the VCT; if the cracking below the VCT is not addressed (filled or stopped) replacing the existing VCT with new VCT will likely result in the same type of cracking. A more flexible, resilient flooring product (like a solid vinyl or rubber) or polishing the concrete, is recommended.

There are areas of the VCT floor that are stained with rust spots. It appears there was metal furniture sitting on the floor, the furniture rusted and stained the flooring.

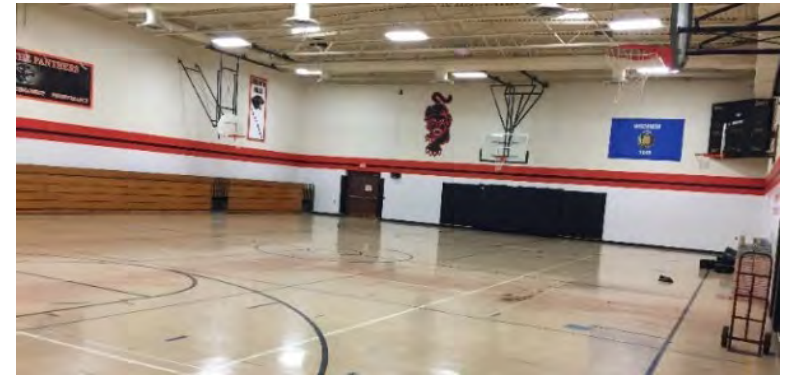
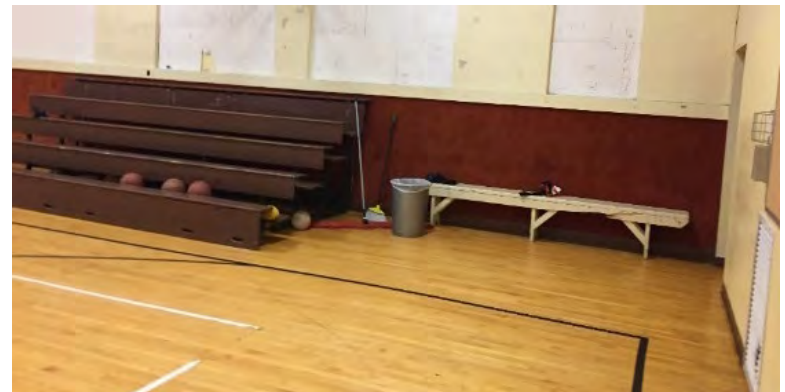
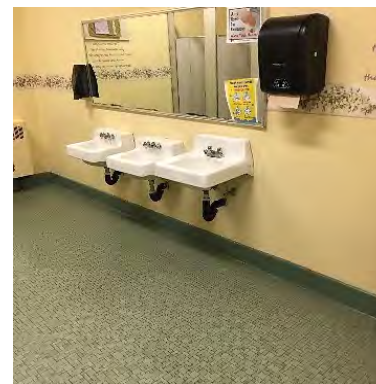
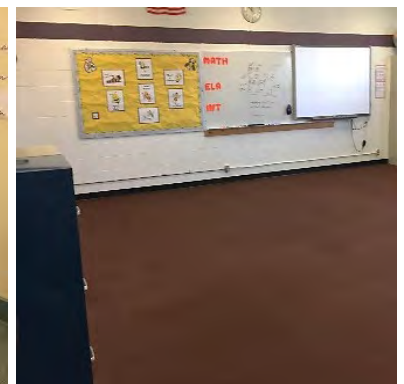
There are two separate gyms in the school. The older gym has a wood floor. The wood floor is in good condition. The recommendation would be to refinish the floor to maintain the quality and improve the longevity of the floor.

The newer gym floor is a rubber floor that is showing signs of wear and separation at the seams. The recommendation is to replace this floor with a more suitable wood floor to handle the activity and use of the space.

There is carpet throughout the building; there are areas where the carpet is worn and should be replaced. It should be verified if hazardous flooring material remains under the carpet.

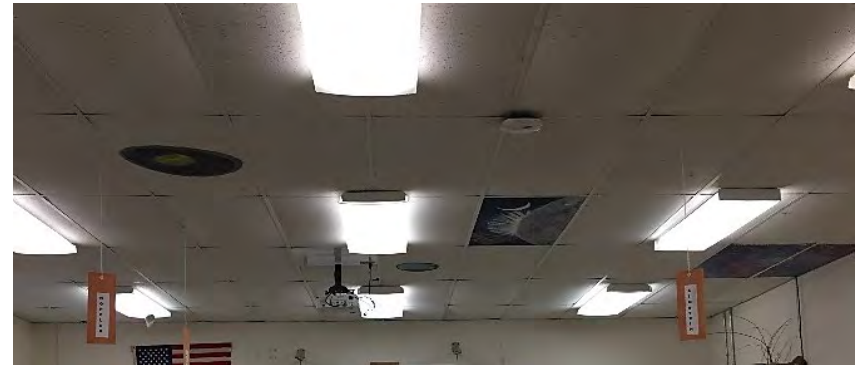
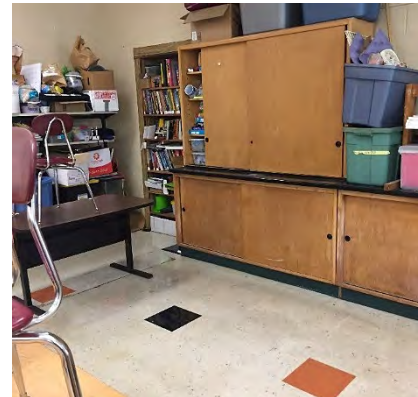
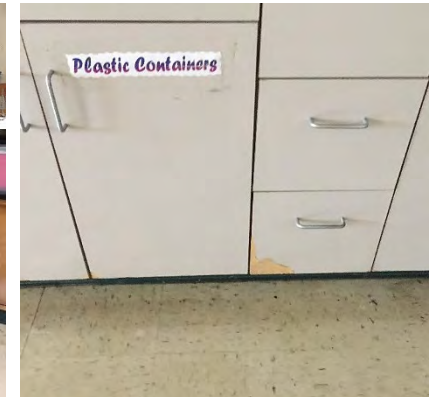
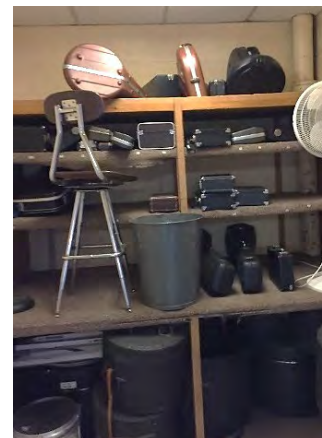
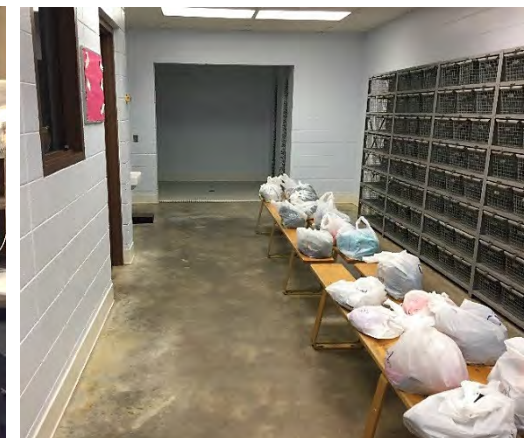
The classroom is old and worn. The sliding doors are difficult to use. The plastic laminate casework is chipping. The band storage is hand built wooden shelves covered in carpeting which is in disrepair. The casework should be replaced.

The existing boys' and girls' locker rooms consist of concrete floors and painted block walls. The lockers are small wire baskets. The recommendation would be to improve the flooring finish with an epoxy floor or similar product and upgrade the wire baskets to a more secure option.

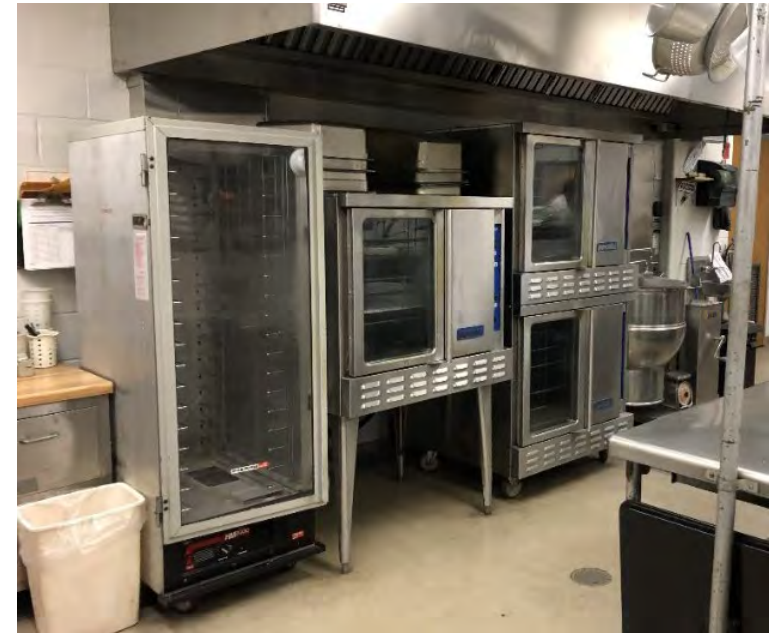
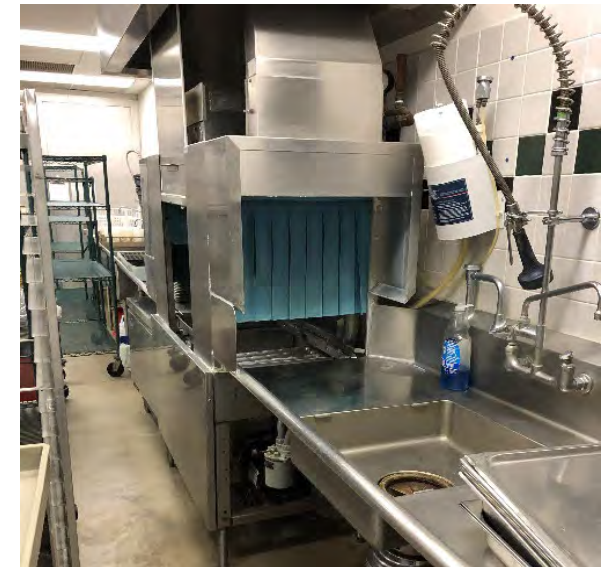
- Drop ceiling is showing signs of age with discolored tiles & grid.
- Walk-In Cooler epoxy floor is showing signs of cracking due to age.
- Walk-In Freezer door has been icing up (when in operation). This could be due to fault door heater, door gasketing, door sweep. Could also be a problem with heated air vent and / or defrost cycles for evaporator on unit.
- Existing two burner range has trouble keeping burners running.
- Larger island prep table and wood top (laminated) both have galvanized legs which are rusting due to age.
- Steam tables on main serving line do not hold water in pans (leaking).

- Replace ceiling grid and vinyl coated tiles – (see interior finishes recommendations.)
- Repair of epoxy flooring – patching where necessary – (see interior finishes recommendations.)

- Recommend having authorized refrigeration service company inspect existing walk-in doors and icing issues (see notes above addressing possible failures of existing box)

- Recommend having plumber check drop-in hot well unit (APW) in kitchen to see if drain value is not working properly. If leaking is integral with hot well equipment recommend replacing with new unit.

- Recommend replacing existing heated holding cabinet with new unit (in kitchen).
- Recommend replacing two burner cooktop unit.
- Consider replacing dishwasher with new electric unit with integral booster heater (more energy efficient unit).

- Consider reconditioning galvanized legs on existing tables that are showing signs of rust (can be sanded and painted). They can be replaced if budget allows.

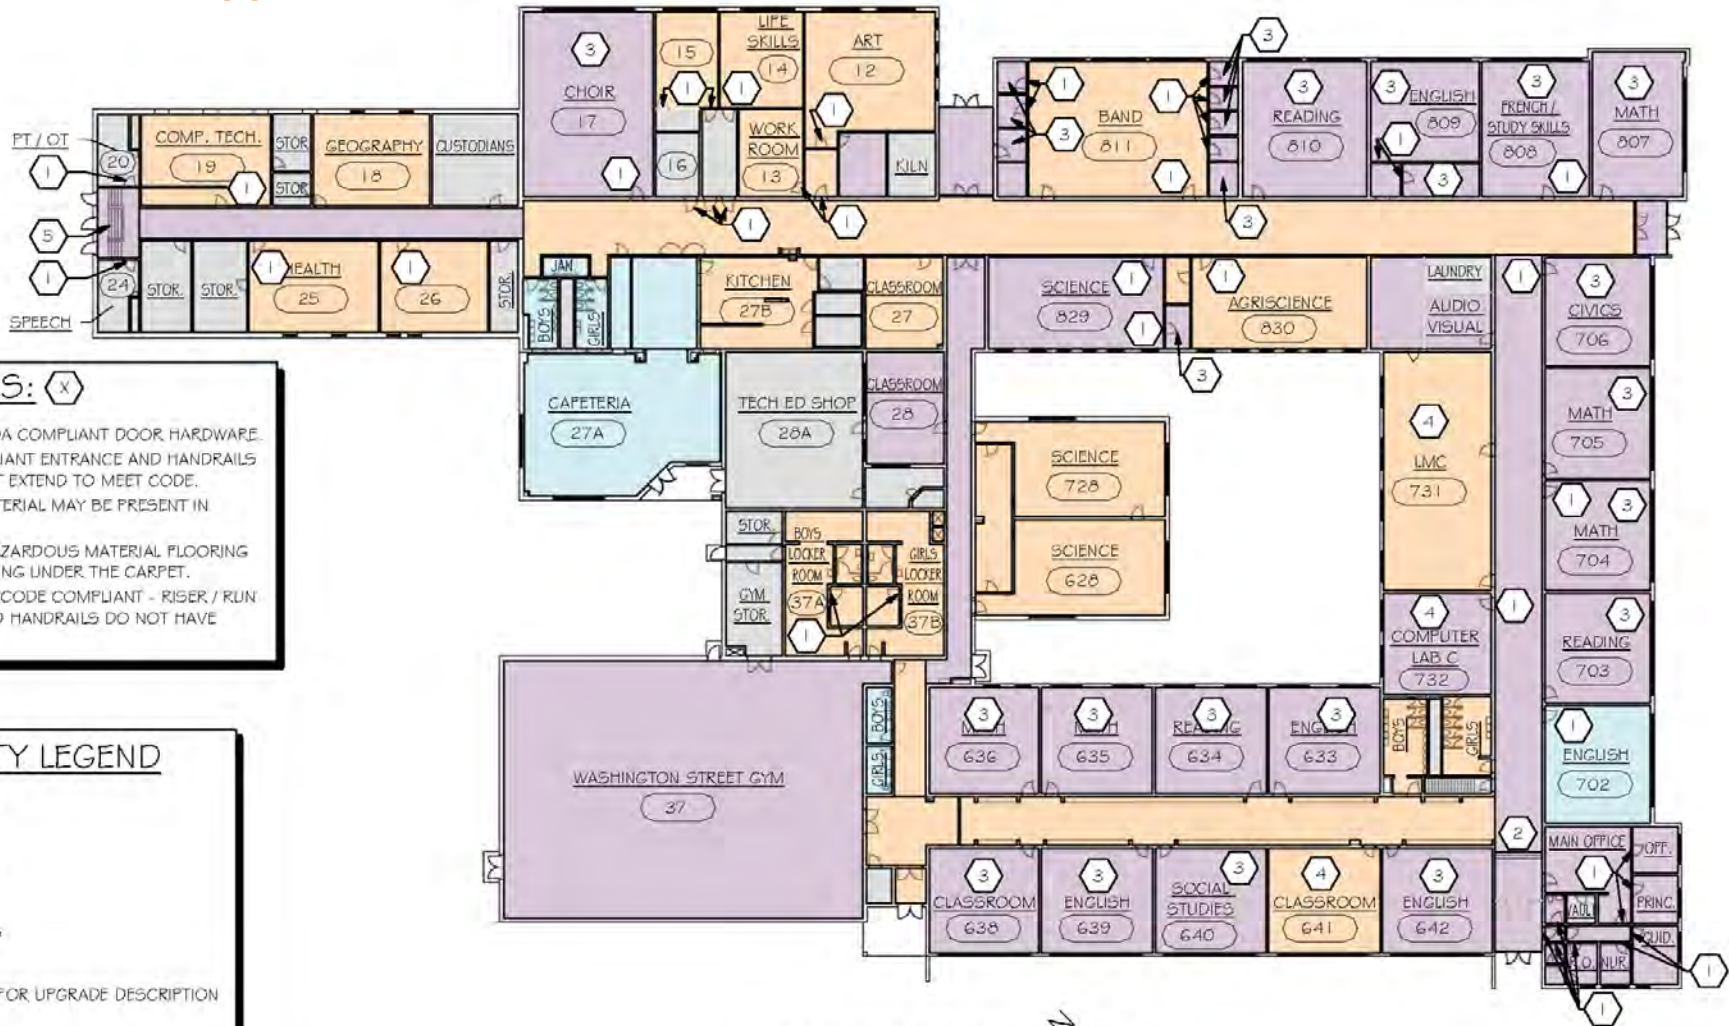
- 1 REPLACE NON-ADA COMPLIANT DOOR HARDWARE.
- 2 NON-ADA COMPLIANT ENTRANCE AND HANDRAILS AT STAIR DO NOT EXTEND TO MEET CODE.
- 3 HAZARDOUS MATERIAL MAY BE PRESENT IN FLOOR TILE.
- 4 MAY CONTAIN HAZARDOUS MATERIAL FLOORING REQUIRING ABATING UNDER THE CARPET.
- 5 STAIRS ARE NOT CODE COMPLIANT - RISER / RUN DIMENSIONS AND HANDRAILS DO NOT HAVE EXTENSIONS.

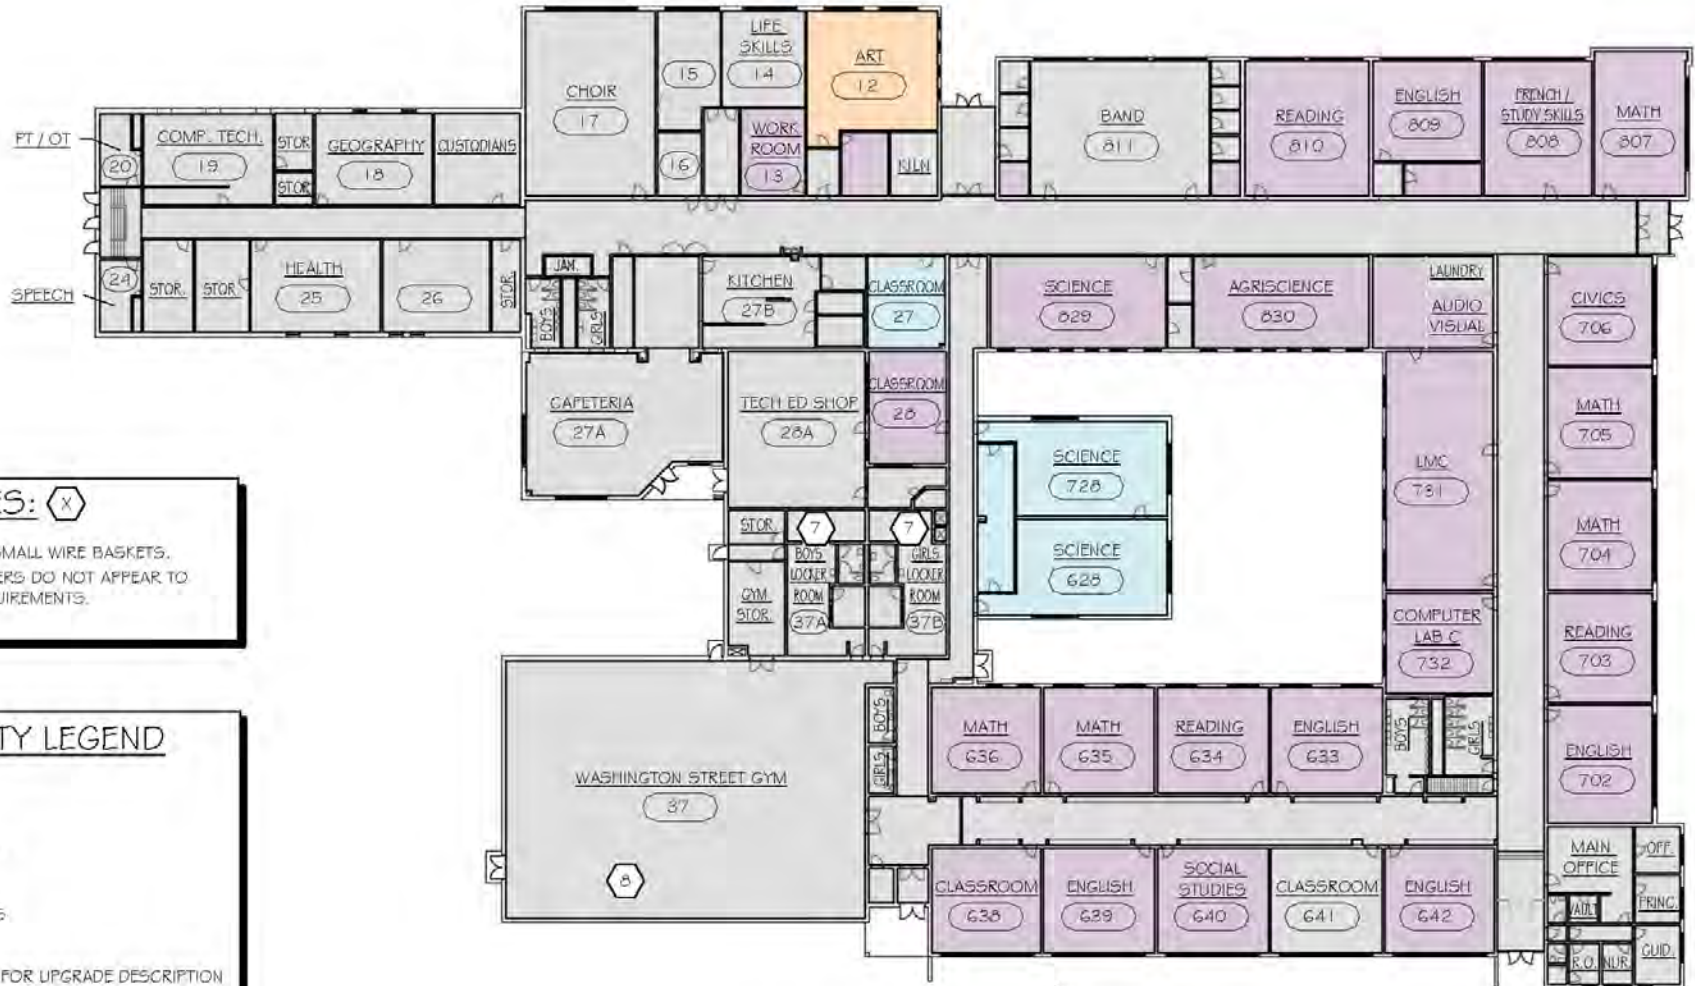
- 7 LOCKERS ARE SMALL WIRE BASKETS.
- 8 WOOD BLEACHERS DO NOT APPEAR TO MEET ADA REQUIREMENTS.

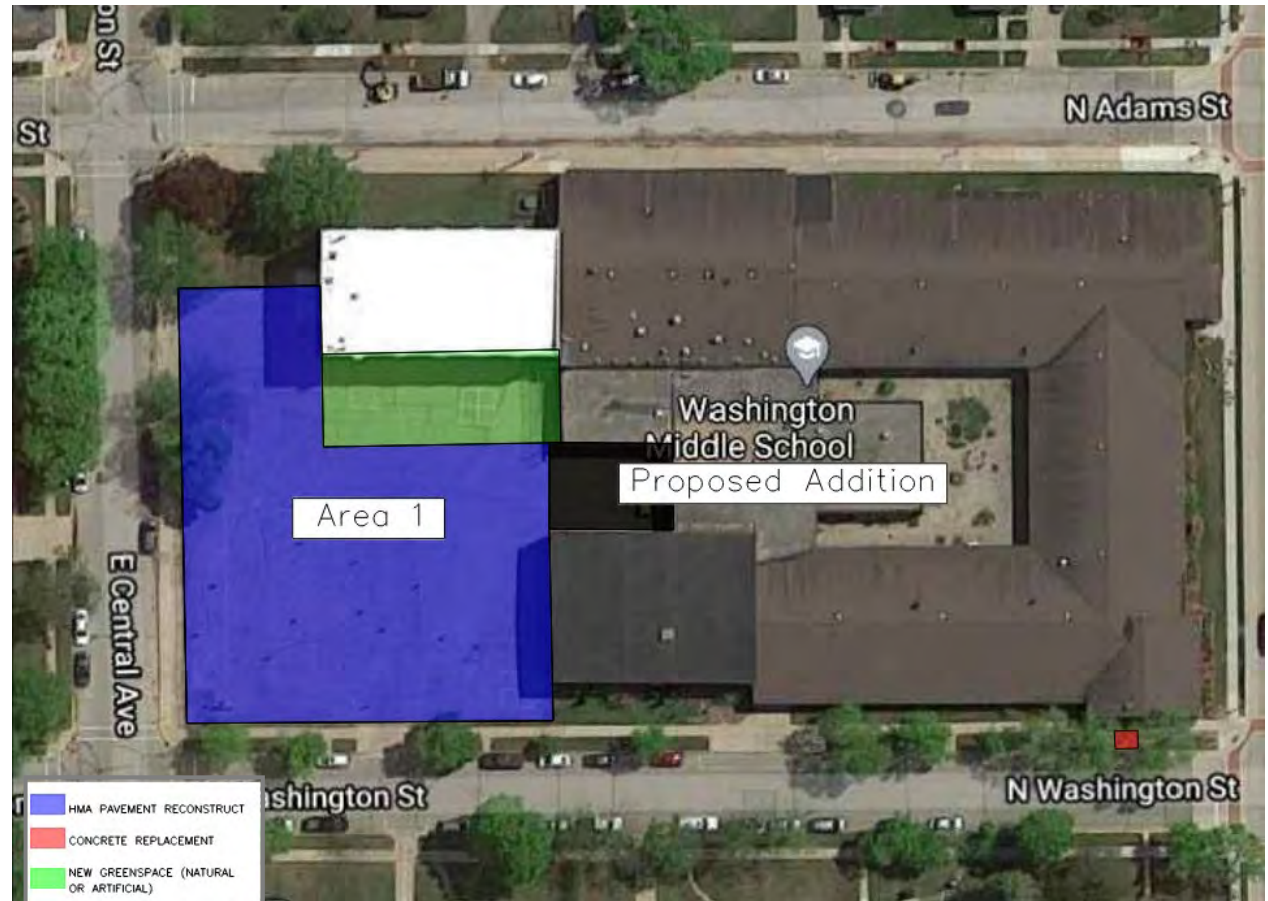
The map below shows the areas listed in the following recommendations for Washington Middle School. Areas not shaded were found to be in good condition, with no improvements being recommended at this time.

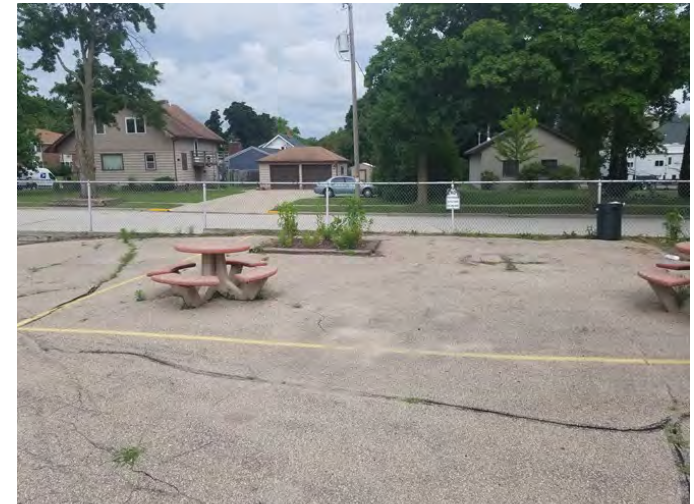
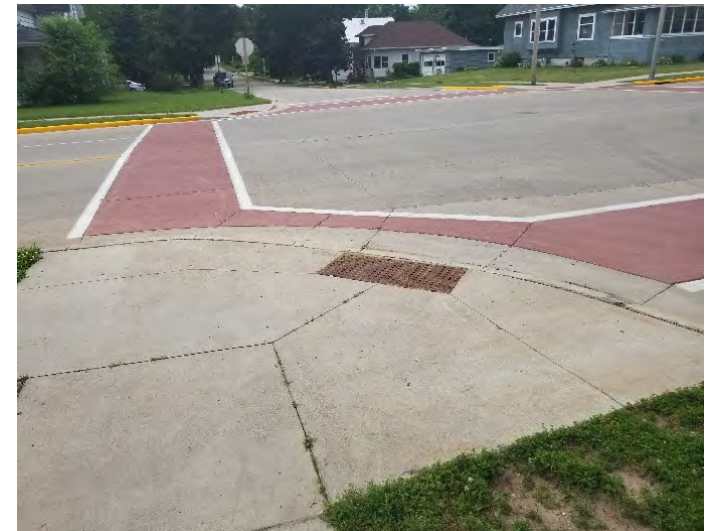
Area 1

Area 1: Paved play area on west side of school.

The existing pavement has numerous thermal cracks which have worsened over multiple freeze-thaw cycles. There are some areas of localized base failure, which are evident by the fatigue cracking present. The base failure is a small portion of this area, approximately 13%. Edge failure and surface weathering are also present.

FIM #	Site and Civil Improvements
WMS-SC-1	<p>Area 1:</p> <ul style="list-style-type: none"> • Remove the existing pavement and 12 inches of base and subgrade. • Add 12 inches of dense base aggregate, stormwater management, and 3.5 inches of asphalt. • Add 6-foot or 16-foot black vinyl chain-link fence as needed.
WMS-SC-2	<p>Site Concrete:</p> <ul style="list-style-type: none"> • Remove and replace all areas of damaged or spalling concrete. • Add the detectable warning fields in required location.

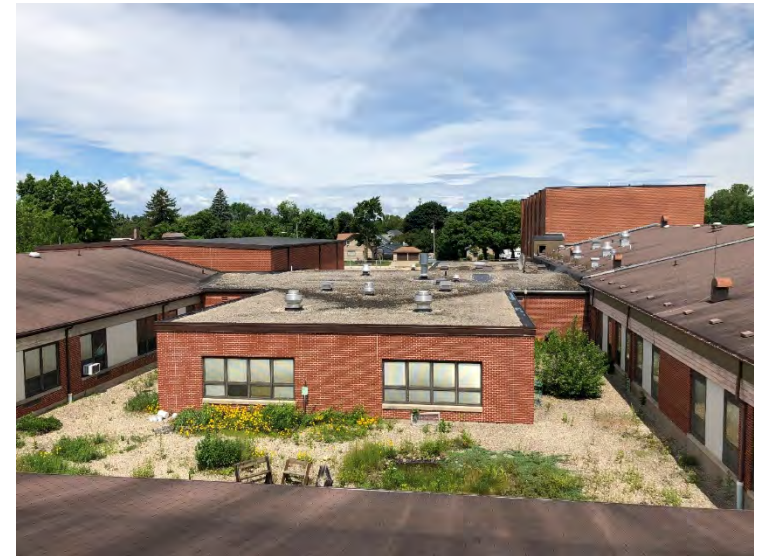
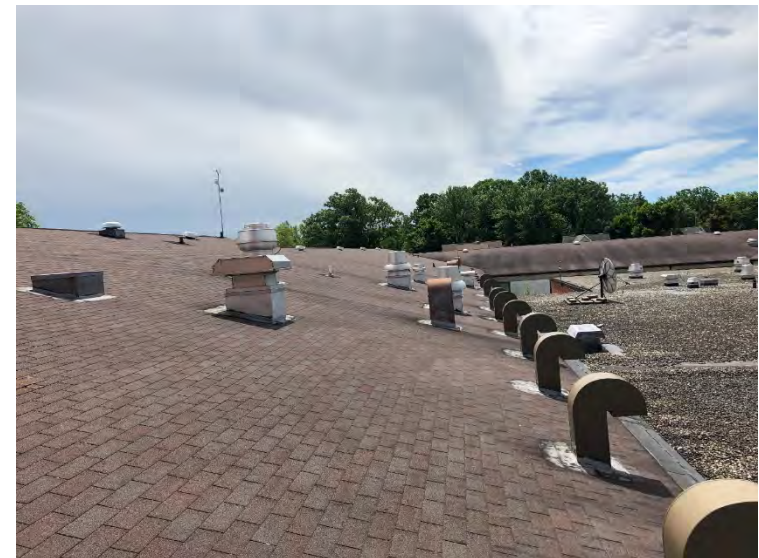
The roof system is in good condition. Interior moisture staining was observed; however, this is probably pre-existing. The wall flashing membrane is loose along the parapet wall perimeter.

WMS-BE-4	<p>Repair Loose Wall Flashing at Upper PVC Roofing Area</p> <ul style="list-style-type: none"> • Repair loose wall flashing membrane.
WMS-BE-5	<p>Replace Deteriorated Panels Covering Windows in Old Gym</p> <ul style="list-style-type: none"> • Install new aluminum composite metal panel system. Incorporate an appropriate substrate with an AWB and install ACM panels with proper perimeter flashing and sealant system.
WMS-BE-6	<p>Repair Cracked Masonry, Replace Window Seals & Gaskets where Deteriorated, Splash Blocks and Gutter Repairs</p> <ul style="list-style-type: none"> • Remove sealant, rout out cracks, seal, and apply elastomeric coating system. • Replace window seals. • Install splash blocks or connect downspouts to storm sewer system
WMS-BE-7	<p>Install Weep Holes in Lintels where None Exist</p> <ul style="list-style-type: none"> • Recommend installing weep holes and check for through wall flashing membrane

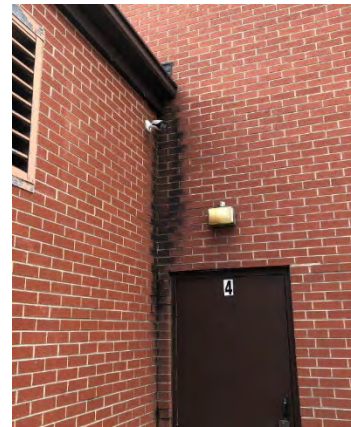
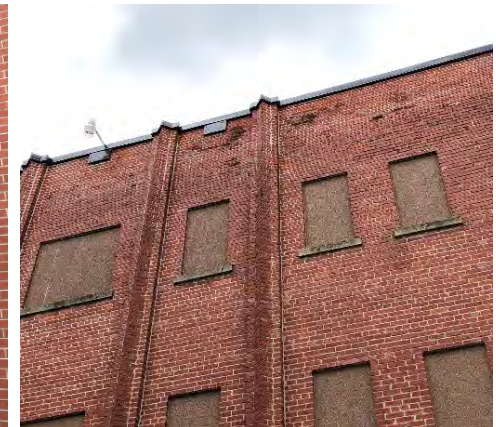
Splash Blocks

No splash blocks are installed at grade at downspouts along east elevation on north side of building at new gymnasium. Moisture has been known to leak into building along grade.

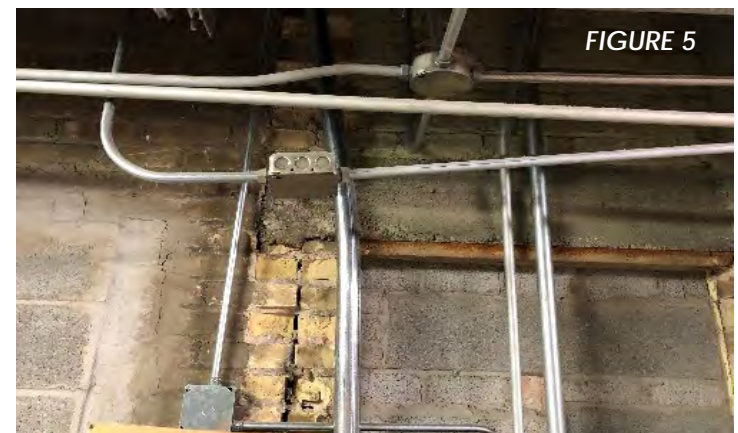
In the first-floor mechanical room, existing junction boxes/raceways are not properly supported per NEC section 300.11, shown right in Figure 5. We recommend providing raceway and junction box supports per code to prevent damage to the conductors or raceway.

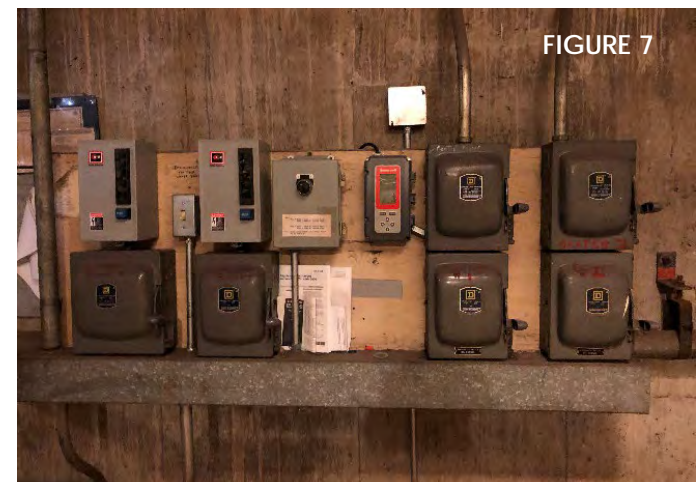
FIGURE 7

Most existing distribution and branch electrical equipment is original to the building. This electrical equipment includes, but is not limited to, disconnect switches, branch panelboards, and distribution panelboards. Examples are shown in Figure 6 and Figure 7 at right. These pieces of equipment are approaching or exceeding their BOMA life expectancy of 30 years. Note that during the survey it was noted that the existing boiler room in the basement has much of this obsolete equipment.

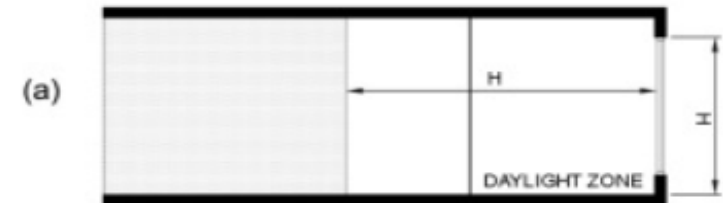
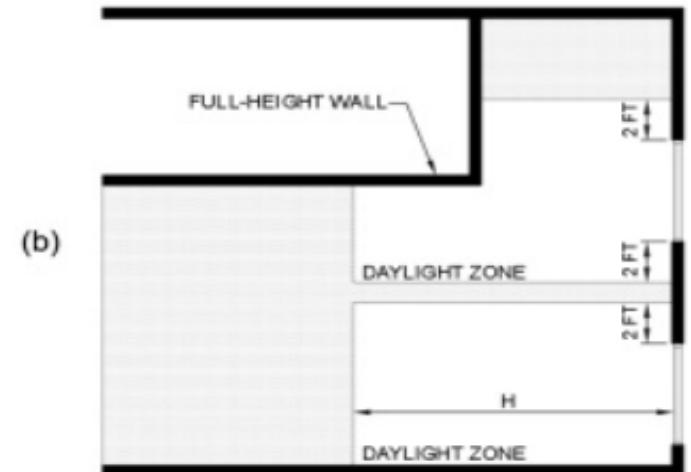
FIGURE 9

Classrooms throughout the building are controlled by a single switch. Per IECC 2018 Section C405.2.3, spaces with over 150W of lighting must have separate daylight-responsive controls. This means fixtures in the daylighting/side-lit zone (defined in IECC Figure C405.2.3.2, shown in Figure 9) must dim automatically in response to the amount of light coming in the windows separately from the rest of the room.

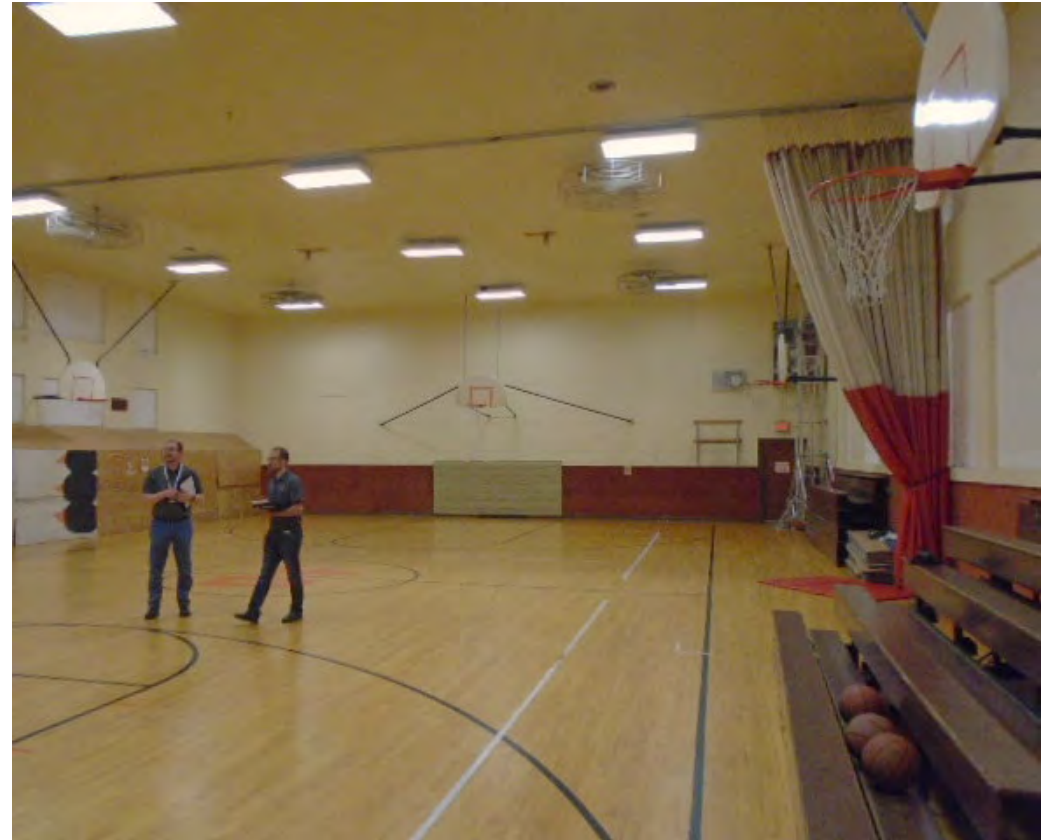
Existing Upper Gymnasium

It is evident that the existing 'old' second floor gym is not a functional multi-purpose space. It is located above classrooms space, which can cause noise and distraction concerns. The space is not ADA accessibility, as it does not have compliant stairs or an elevator for access for those in wheelchairs or leg scooters. It also is not located centrally to the building for P.E. use.

Adding a multi-purpose space between the 'new' first floor gym and the existing commons, allows for an activity zone in the building that can be used together or separately for school physical education classes, after school activities or community events. There are several middle school sports and activities that need a place to practice and gather, this would give them that space.

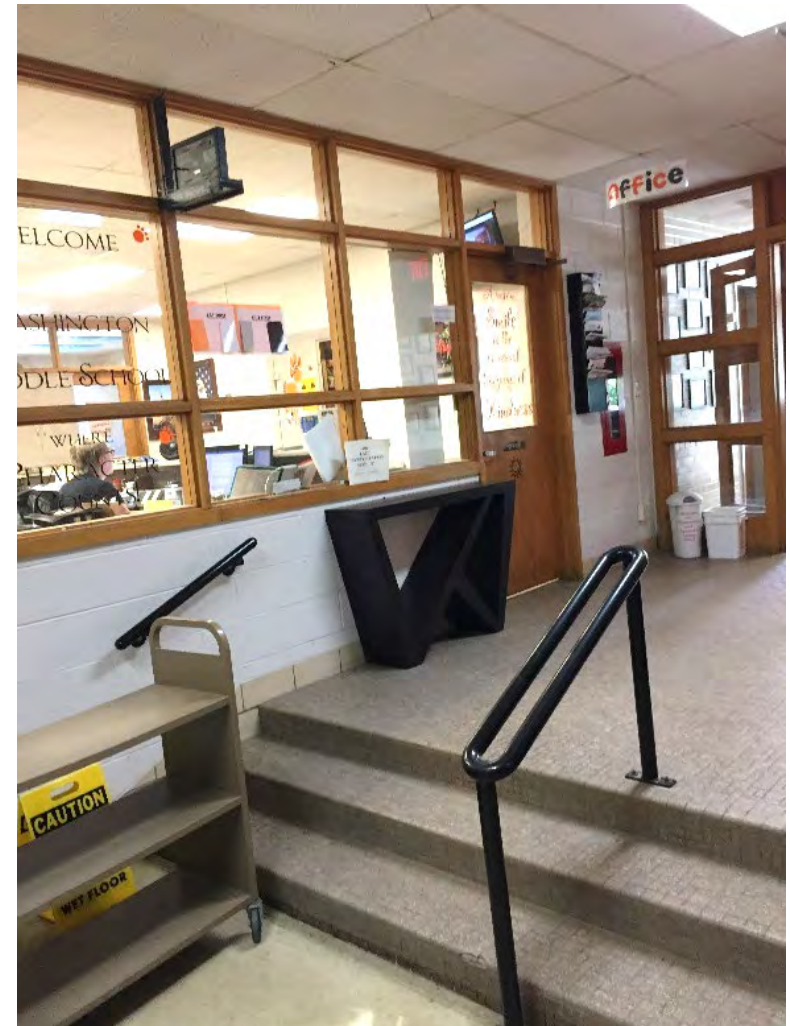
Existing Office Main Lobby

Furthermore, the main entrance does not have ADA compliant access to the remainder of the school, from the main office there are stairs to the main school level. If a visitor requiring ADA access comes to the main entrance, they would be required to go back outside, down the sidewalk and come back in a different entrance that is at the main school floor level. This is not a safe and secure procedure, and it is not a 'customer service' friendly entrance. An ADA ramp should be added when remodeling the main office and the adjacent classroom. This allows visitors to enter the school at one location. Remodeling this space allow for creating a more functional main office and add a community and volunteer space near the main office and secure entrance.
