Oconto Falls School District **FACILITY ASSESSMENT**

Oconto Falls School District
FACILITY ASSESSMENT

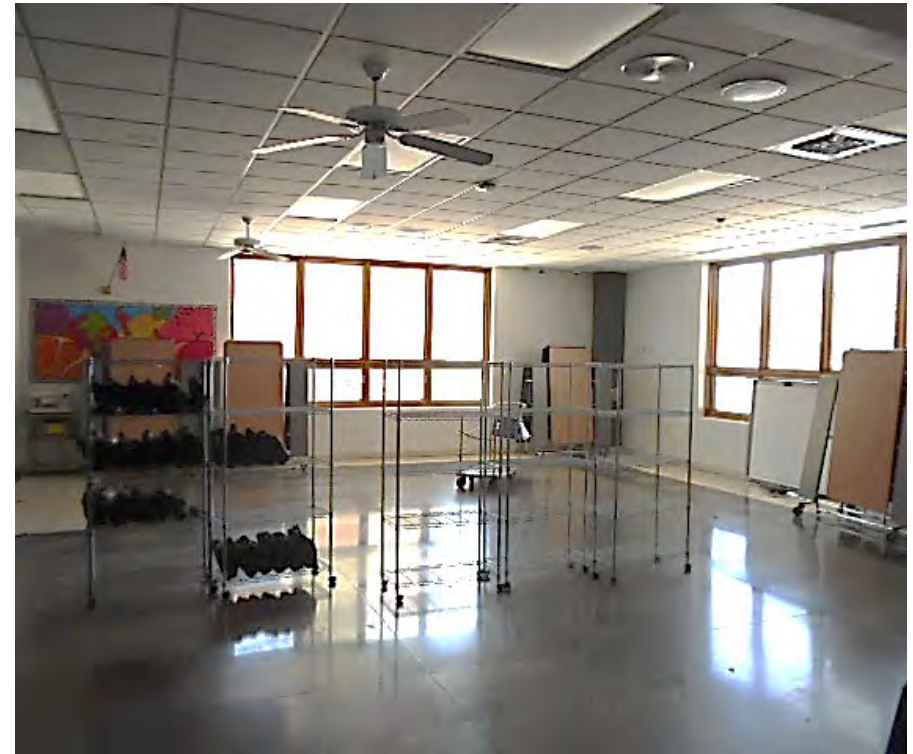
Existing Cafeteria/Commons

The existing Cafeteria/Commons is small per industry design standards and the queuing of the serving line spills into the Corridor. Also, there is not a true Receiving Area for the building and deliveries are brought in off the street through a set of exterior double doors through a Vestibule.

It is recommended to relocate the Commons to the end of the building, below the Upper Gymnasium. This would allow the kitchen and receiving to have direct access to the exterior to allow for deliveries. The space allows for ample storage adjacent to the kitchen for cooler, freezer, and dry goods. The commons would be a large open space with ample cueing and space for the food serving line. In addition, locating the Commons in a larger space and still near the parking lot will allow for playground access as well as use for Community Events and can be secured from the rest of the building at night or on weekends.

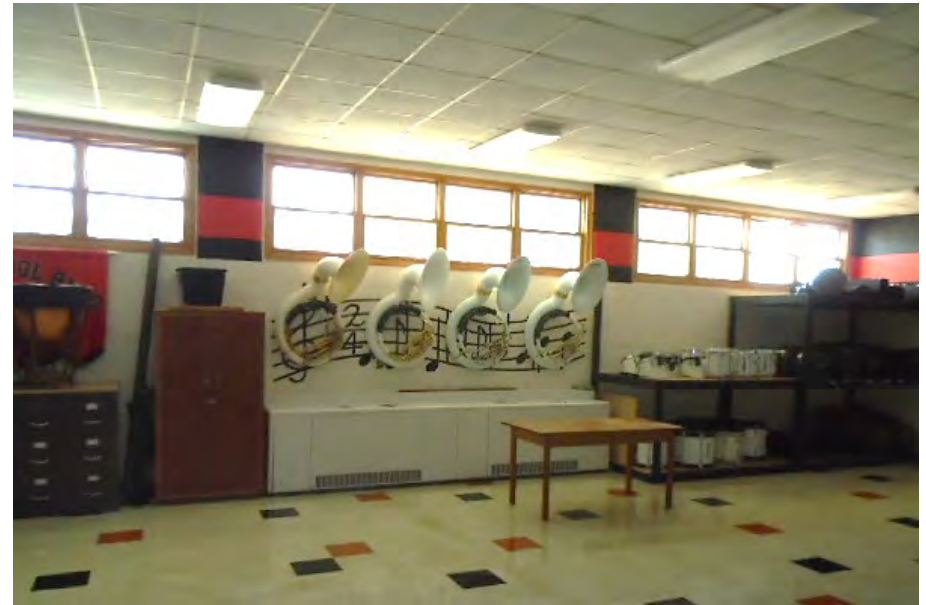
Existing Music Room

As part of the optimization of spaces in the building, there is an opportunity to take advantage of the existing Upper Gymnasium which is a high bay space. We believe the music department should be relocated to the upper level of this building. There is adequate space for both band and choir along with their practice rooms and storage. The music department will sit above the cafeteria and this area of the building is separate from the academic classroom' pods; this is appropriate for a potentially noisy music space.

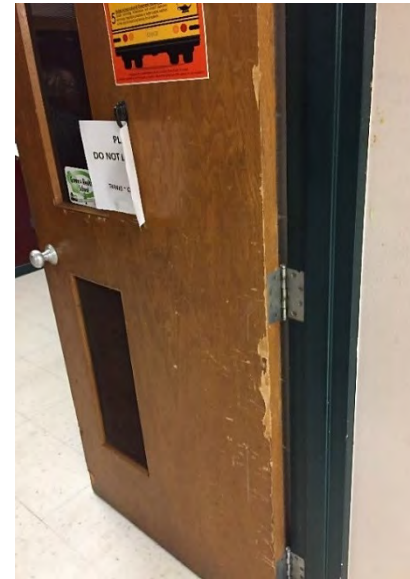
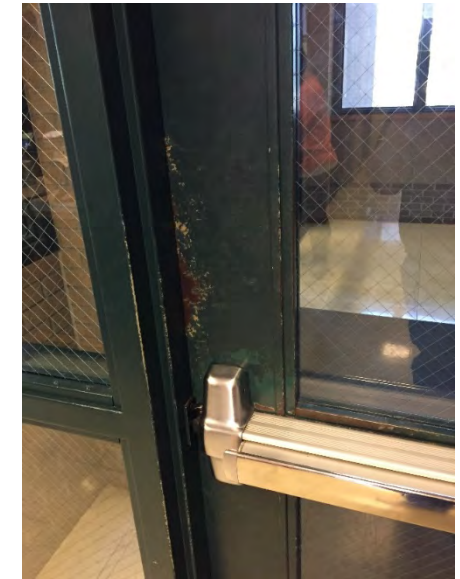
In the older portion of the building there are a few doors that are damaged and worn and need replacing.

A few doors have non-ADA compliant knob door hardware. Knob hardware should be replaced with compliant leveler style hardware.

The exterior doors and frames are a mix of aluminum hollow metal. The hollow metal doors and frames are showing wear and rust. The recommendation is to replace the hollow metal doors and frames with aluminum and FRP doors and frames for durability, maintenance, and longevity.

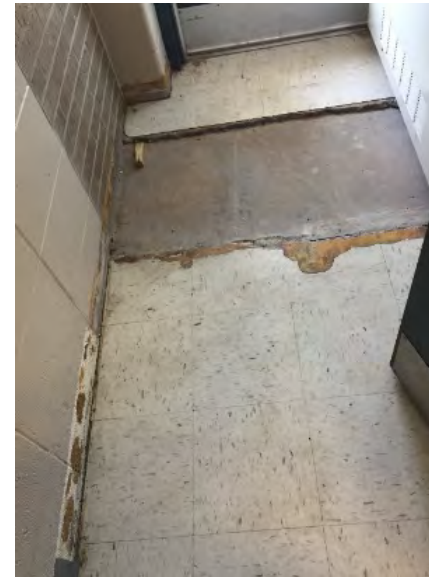
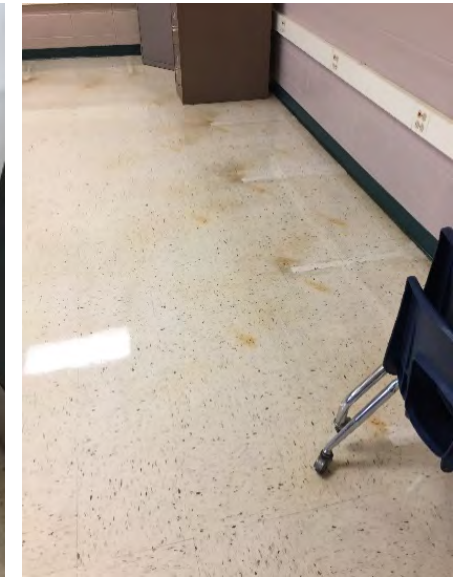
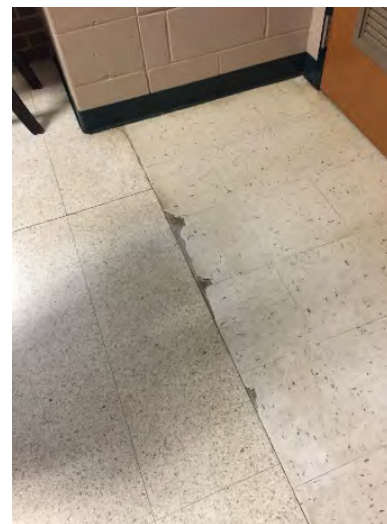
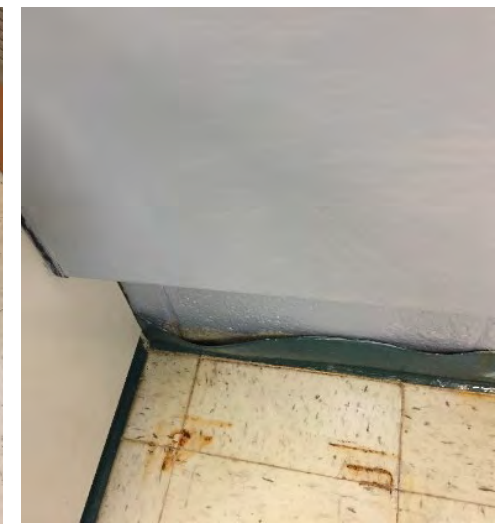
Flooring Replacement

The majority of the flooring is VCT (vinyl composition tile). This floor product requires regular stripping and waxing. If the product is not stripped on a regular basis prior to applying the new wax, the dirt will get trapped in the flooring. VCT flooring throughout the school is discolored and appears 'dirty', there are few areas where this 'dirty' appearance is evident. However, there are more areas of the VCT floor that are stained with rust spots. It appears there was metal furniture sitting on the floor, the furniture rusted and stained the flooring.

There are multiple locations where the VCT has cracks in it. VCT is a hard and brittle product. If there are cracks in the concrete below the VCT, it is likely to transfer through the VCT; if the cracking below the VCT is not addressed (filled or stopped) replacing the existing VCT with new VCT will likely result in the same type of cracking. A more flexible, resilient flooring product (like a solid vinyl or rubber) or polishing the concrete, is recommended.

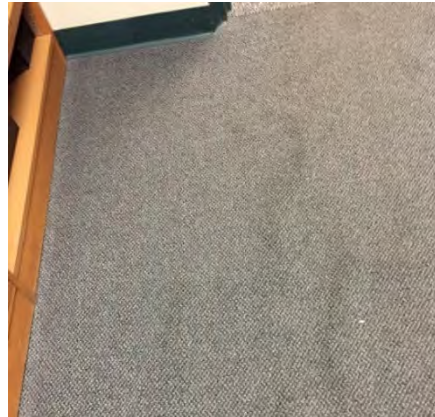
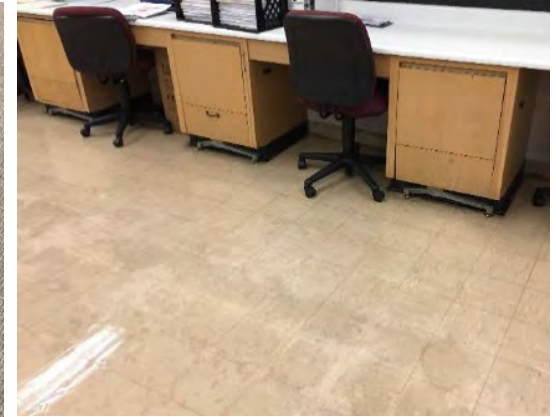
Flooring Replacement

There is carpet throughout the building; there are areas where the carpet is stained and should be replaced with carpet tile. Carpet tile allows the school to replace stained or damaged tiles individually rather than replacing the entire room of carpet.

The terrazzo and terrazzo tile throughout the building is in good shape. There is some settlement cracking. The cracks can be filled and with a joint filler that would prevent dirt from collecting in the cracks and improve the appearance.

There is a small percentage of flooring that is 9" x 9" flooring tile. This size tile typically tests positive for containing hazardous material (asbestos). This would need to be verified by an environmental testing adjacency. Abating this tile and replace with a new flooring product is recommended.

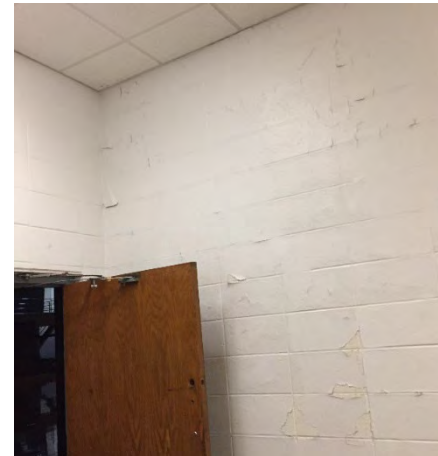
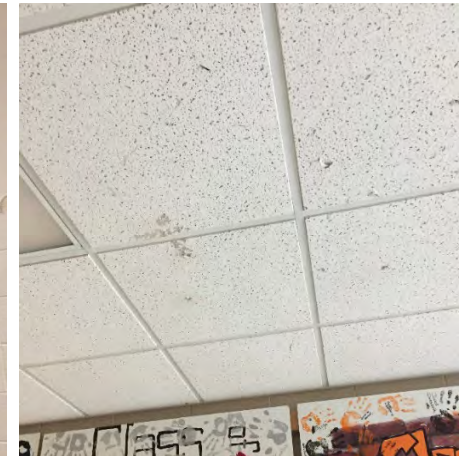
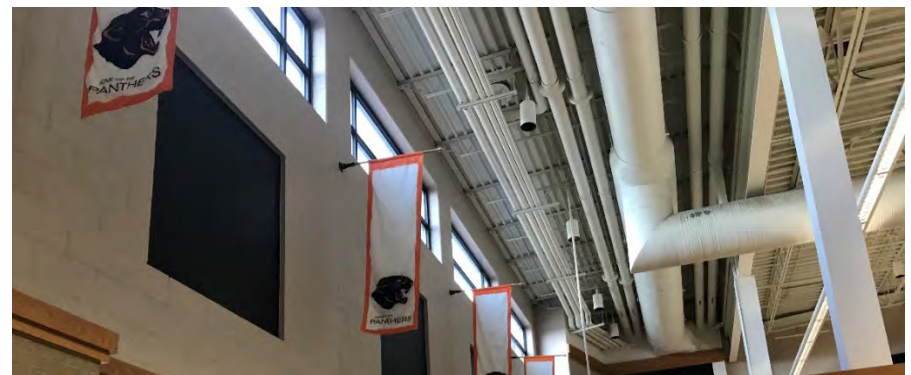
Ceiling Replacement

The majority of ceilings are 2 x 2 ceiling tiles and are in good shape. There are a few areas where the tiles are damaged and should be replaced with new tiles, the ceiling grid can remain.

The shop spaces and the commons have exposed ductwork with peeling paint. This indicates the ductwork was not properly cleaned and prepared to receive the paint; the paint should be removed, the ductwork cleaned and prepped and repainted in the commons. Once the ductwork in the shop spaces has the painted removed and the ductwork cleaned, the ductwork does not need to be repainted in the shop areas. Unpainted ductwork in a shop space is acceptable.

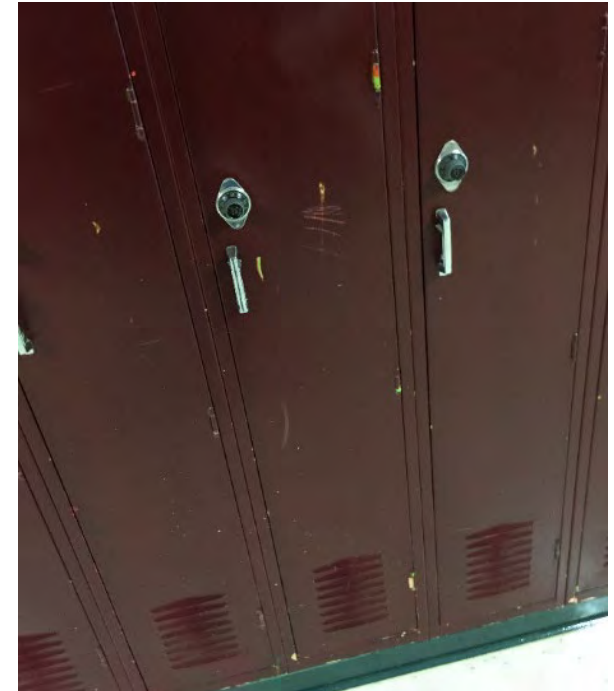
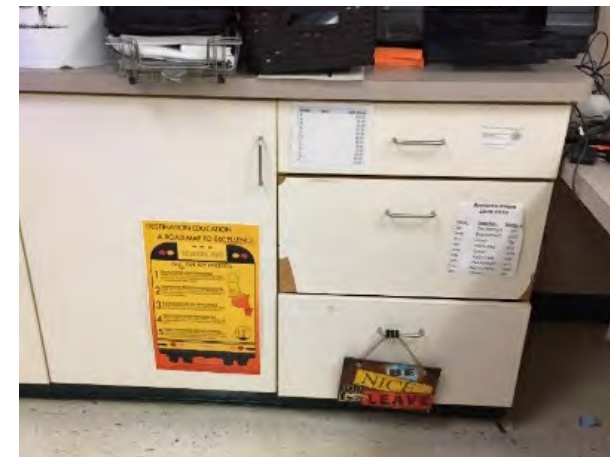
Casework Upgrades

The District has an on-going maintenance plan to address upgrading and adding casework to classrooms. There were several classrooms that were designed without casework, metal storage was often used and resulted in rust spots on the VCT floors. The District has been removing the metal storage, replacing the flooring and adding plastic laminate casework. There are still classrooms and casework that need to be addressed.

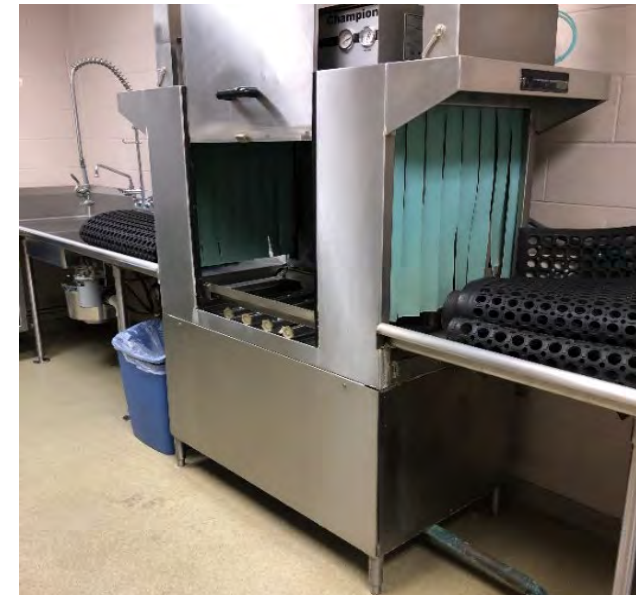
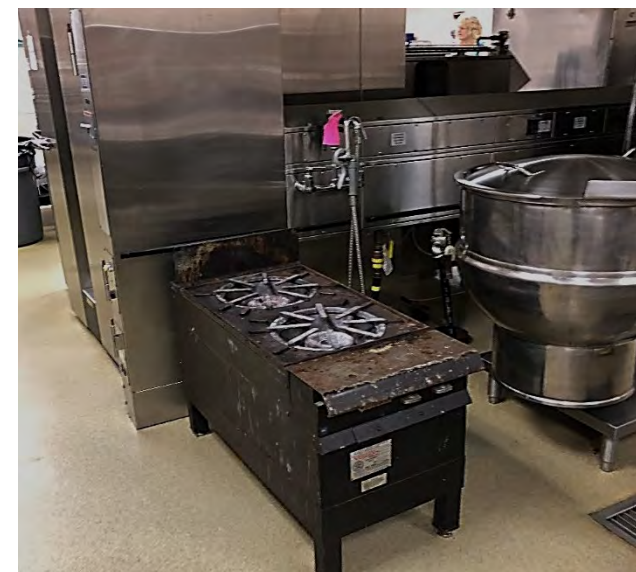
- Kitchen epoxy floor showing some signs of wear with cracking at covered base in some locations (by walk in cooler – freezer).
- Dry storage room light fixtures did not have lens covers over bulbs.
- Walk-in Freezer door was icing up (at time of walk thru). This could be due to faulty door heater, door gasketing, door sweep, door out of adjustment. Could also be a problem with heated air vent and / or defrost cycles for evaporator on unit.
- Bakers table has laminate top with galvanized base that is showing signs of rusting.
- Existing mixers: 60 qt. and 20 qt. do not have bowl guards (potential safety hazard).

- Ice maker is outdated and needs to be replaced.
- Some existing cooking line equipment is approx. 20 years old including 10 burner range and 2-burner hot top units. Combi oven and double stack convection oven appear to be newer items.
- Existing soiled dish table has a 1 HP disposer which is undersized for the amount of scrapping needed.
- Existing dishwasher has trouble maintaining temperatures.

- Repair of epoxy flooring – patching where necessary – (see interior finishes recommendations.)
- Recommend adding lens covers to light fixtures in dry storage room – (see interior finishes recommendations.)
- Recommend having authorized refrigeration service company inspect existing walk-in doors and icing issues (see notes above addressing possible failures of existing box)
- Recommend replacing ice maker
- Consider painting base cabinet section of bakers table or replacing with new (open base type).
- Consider replacing 60 Qt. Mixer (new unit with bowl guard for safety)
- Consider replacing 20 Qt. Mixer (new unit with bowl guard for safety)
- Consider replacing 10-Burner Range
- Consider replacing two burner cooktop unit.
- Recommend replacing disposer at soiled dish table with higher HP unit.
- Consider replacing dishwasher with more energy efficient unit.

FIM #	Recommended Food Service Improvements
OFHS-INT-6	<p>Replace Kitchen Equipment Where Required:</p> <ul style="list-style-type: none"> • Repair epoxy flooring – patching where necessary – (see interior finishes recommendations.) • Add lens covers to light fixtures in dry storage room – (see interior finishes recommendations.) • Have authorized refrigeration service company inspect existing walk-in doors and icing issues (see notes above addressing possible failures of existing box.) • Replace ice maker. • Paint base cabinet section of bakers table or replace with new (open base type.) • Replace 60 Qt. Mixer (new unit with bowl guard for safety.) • Replace 20 Qt. Mixer (new unit with bowl guard for safety.) • Replace 10-burner range. • Replace two burner cooktop unit.

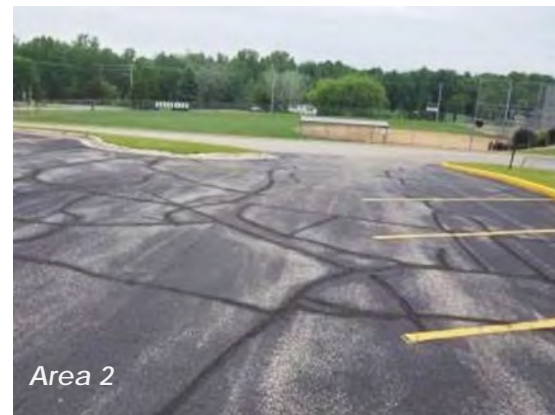
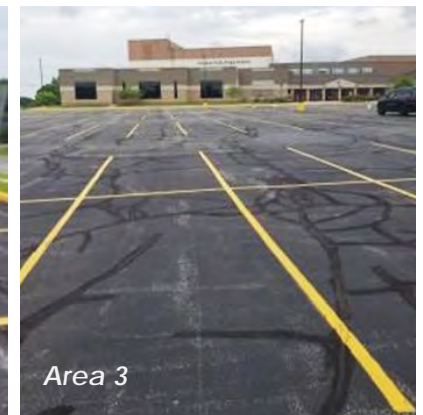
Area 3: North Parking Lot

The existing pavement has numerous thermal cracks which have worsened over multiple freeze-thaw cycles. There are some areas of localized base failure, which are evident by the fatigue cracking present. The base failure is a small portion of this area, approximately 10%. Edge failure and surface weathering are also present.

FIM #	Site and Civil Improvements
OFHS-SC-1	<p>Area 1: North Drive</p> <ul style="list-style-type: none"> • Remove existing pavement and base. • Reconstruct the existing drive with 12" of dense graded base and 3.5" of HMA Pavement.
OFHS-SC-2	<p>Area 2: West Parking Lot</p> <ul style="list-style-type: none"> • Remove the existing asphalt to expose the base material. • Inspect the base material and repair it with base course patching as needed. • Pave 3 inches of new asphaltic surface and paint all pavement markings.
OFHS-SC-3	<p>Area 3: North Parking Lot</p> <ul style="list-style-type: none"> • Remove the existing asphalt to expose the base material. • Inspect the base material and repair it with base course patching as needed. • Pave 3 inches of new asphaltic surface and paint all pavement markings.
OFHS-SC-4	<p>Area 4: North Delivery Area</p> <ul style="list-style-type: none"> • Remove the existing asphalt to expose the base material. • Inspect the base material and repair it with base course patching as needed. • Pave 4 inches of new asphaltic surface and paint all pavement markings.

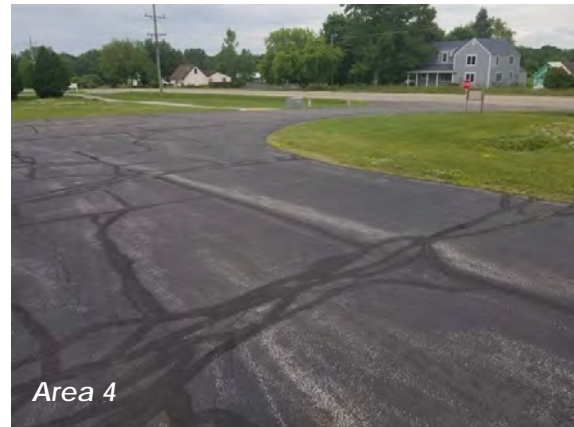
Area 4

The existing pavement has numerous thermal cracks which have worsened over multiple freeze-thaw cycles. There are some areas of localized base failure, which are evident by the fatigue cracking present. The base failure is a small portion of this area, approximately 10%. Edge failure and surface weathering are also present.

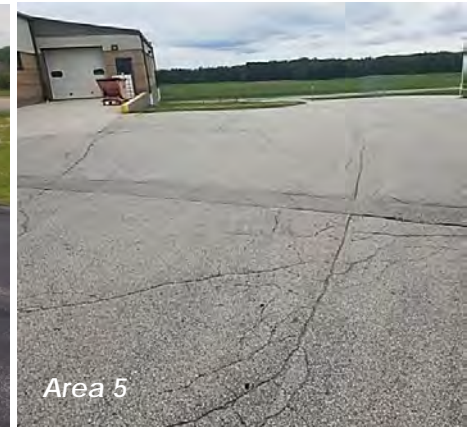
Area 5

The existing pavement has numerous thermal cracks which have worsened over multiple freeze-thaw cycles. There are some areas of localized base failure, which are evident by the fatigue cracking present. The base failure is a small portion of this area, approximately 10%. Edge failure and surface weathering are also present.

OFHS-SC-5	<p>Area 5: South Drive</p> <ul style="list-style-type: none"> • Remove the existing asphalt to expose the base material. • Inspect the base material and repair it with base course patching as needed. • Pave 3 inches of new asphaltic surface and paint all pavement markings. • Add the detectable warning fields in required locations.

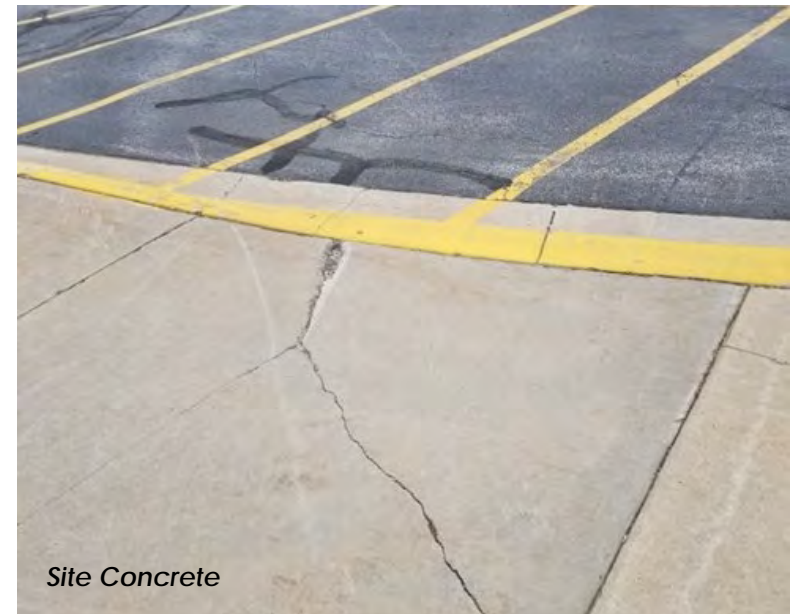
Site Concrete

Throughout the site there are sections of sidewalk that have spalled along the edges and it will continue to worsen as the sidewalk ages. There are also areas where the sidewalk had cracked and is uneven, posing a trip hazard. ADA panels (detectable warning fields) need to be added where sidewalk path directs pedestrians onto a vehicle traveled surface.

OFHS-SC-6	<p>Site Concrete:</p> <ul style="list-style-type: none"> Remove and replace all areas of damaged or spalling concrete.
OFHS-SC-7	<p>Stormwater Management:</p> <ul style="list-style-type: none"> If more than one acre is disturbed for reconstruction, stormwater management will need to be performed.

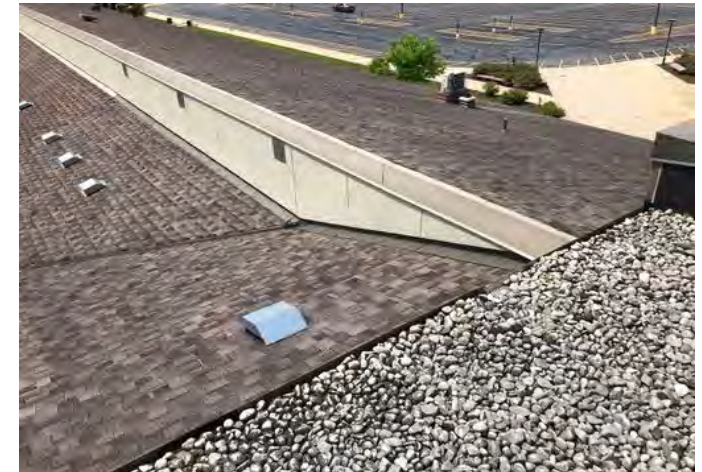
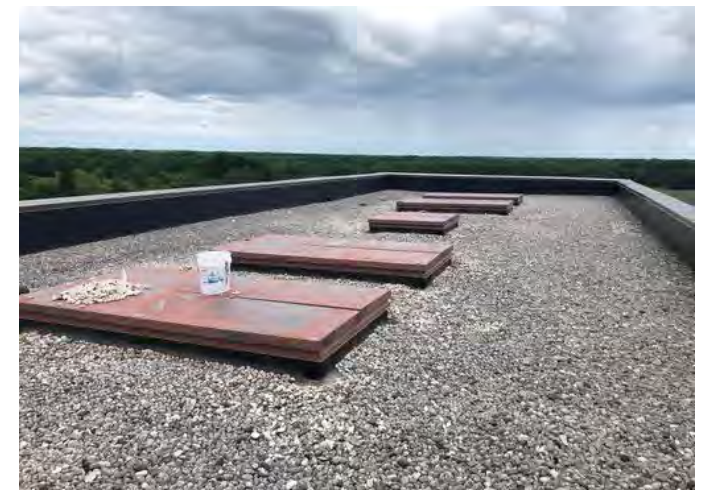
Sloped Roof Ventilation at west entrance on north side of building.

There is a 1/2 of an aluminum ridge vent butted up against the shingle or EIFS wall transition. It appears this may be due to condensation ventilation of the soffit below.

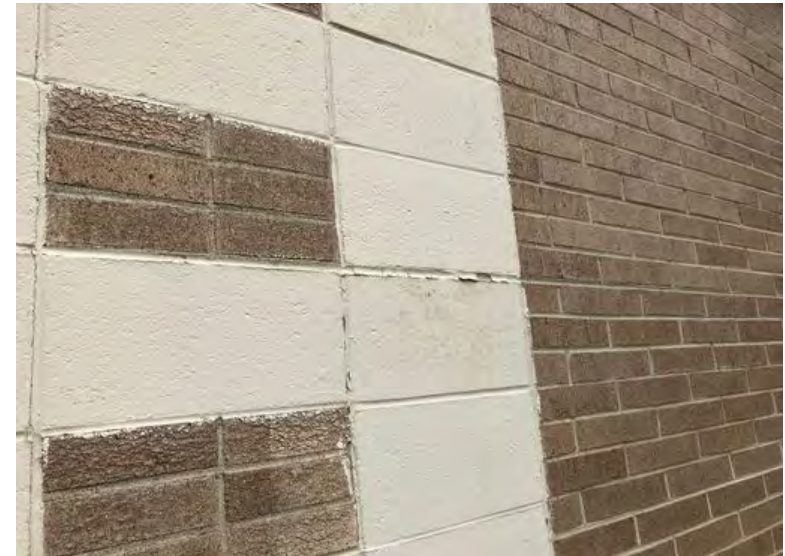
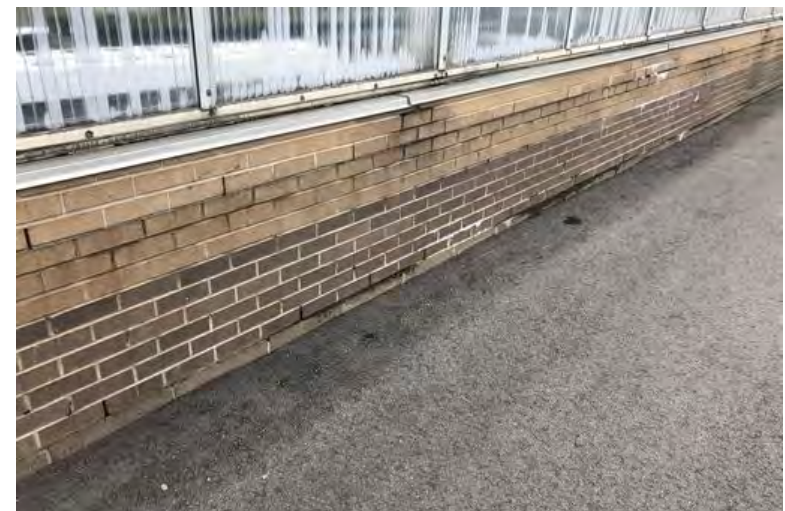
Masonry Cracks on West Elevation at Alcove

There were cracks observed at several locations along the west elevation in the middle alcove.

OFHS-BE-10	<p>Remove and Replace AC Unit Sealant, Windowsill Flashing and Control Joint Sealant, Install EIFS Flashing, Repaint and Seal Masonry with Peeling Paint, Repair Masonry Cracks</p> <ul style="list-style-type: none"> • Remove sealants and install backer rod, prime, and reseal. • Cut out EIFS and install kickout flashing at eave/EIFS transition to divert water out away and into new gutter system. • Sand painted masonry down to substrate. Remove all sealant joints and backer rods. Install new back rod, prime, and sealant. Install elastomeric sealant over CMU surfaces and sealant joints. • Repair cracks by cutting in new control joints and replace any cracked bricks with new bricks. Install backer rod, prime, and sealant.
OFHS-BE-11	<p>Replace Windows at West Elevation at Alcove</p> <ul style="list-style-type: none"> • Replace windows with new, thermally efficient windows.

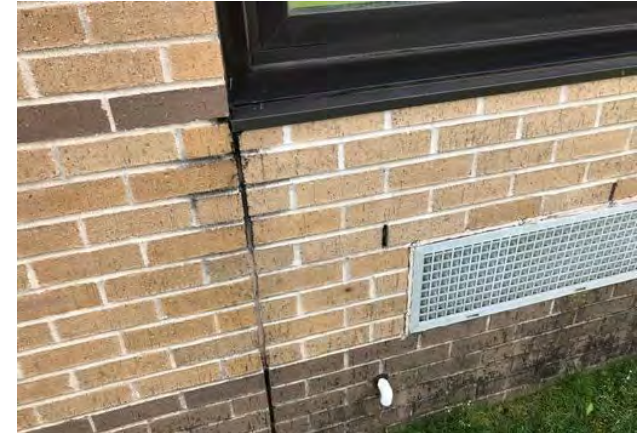
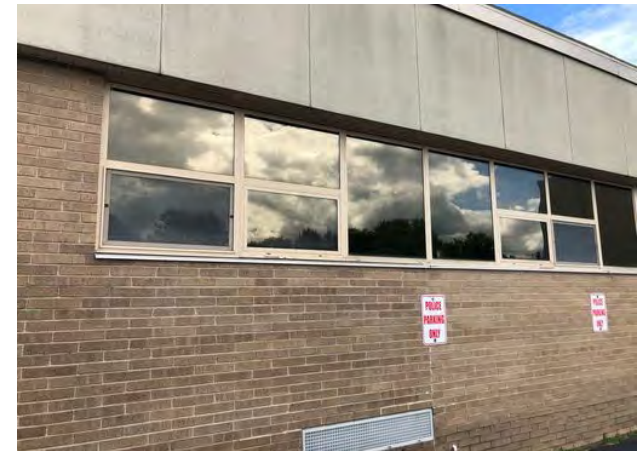
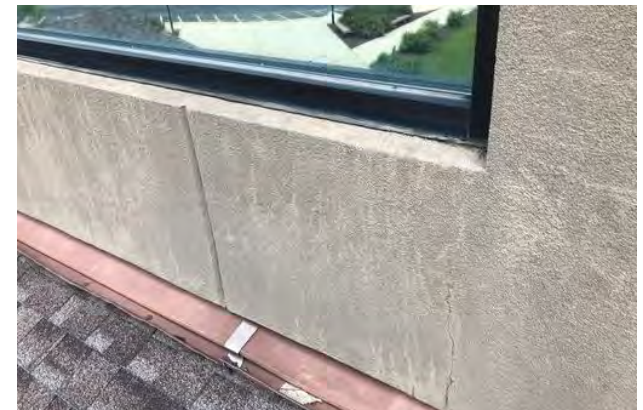
2nd Story Windows - West Elevation on North Side of Building

Perimeter window/EIFS interface sealant is in a failed condition and requires replacement.

OFHS-BE-4	Repair and Reseal EIFS Cladding where Deteriorating, Repair EIFS Sealant at 2nd Story Windows on North Elevation <ul style="list-style-type: none"> Powerwash EIFS surface to remove dust and debris. Rehabilitate areas where the finish coat and brown coat have delaminated. Apply new coats of EIFS material to insulation substrate to match existing texture. Install an elastomeric coating the same as the precast concrete panels to prevent future moisture infiltration. Replace perimeter window to EIFS sealants.
OFHS-BE-5	Repair Masonry at West Side of Sloped Roofing, Modify Greenhouse Masonry Wall with Moisture Problems <ul style="list-style-type: none"> There has been sealant applied which is a temporary fix that will require maintenance. Recommend eventually removing bricks and replacing. Install proper ventilation intake and exhaust at greenhouse and provide proper masonry drainage to include through wall flashing at base of greenhouse and weeps at bottom of masonry wall.

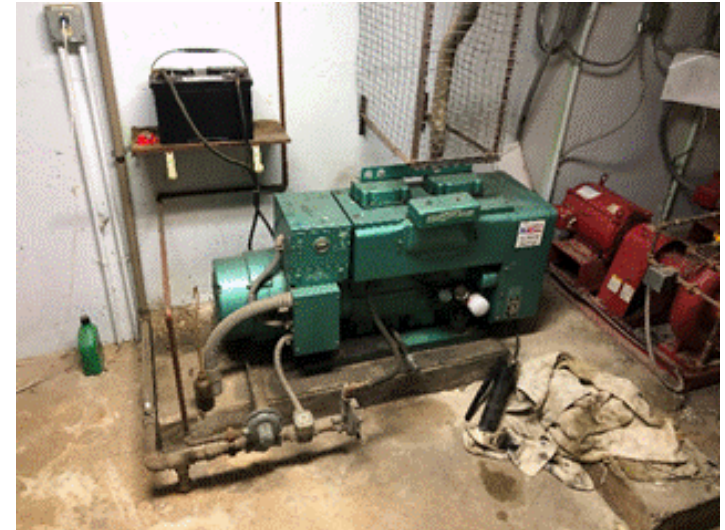
The building is currently served by two backup generators. One is a 10-kW generator in an existing generator room (Figure 2), and the other is a 60kW generator in Mechanical Room M917A (Figure 3). Based on the panelboard schedules, we were unable to determine if life safety (NEC 700), legally required standby (NEC 701), and optional standby (NEC 702) loads are mixed. While the loads may have been compliant when installed, if any work is performed on the emergency power system, the three load types must be segregated per NEC 700.10 (B).

Figure 2: 10kW Generator

We recommend performing a study on the existing emergency power installation to evaluate the current infrastructure (generators, transfer switches, fire pump, and panelboards) and determine what work will be needed to bring it into compliance with current NEC code requirements.

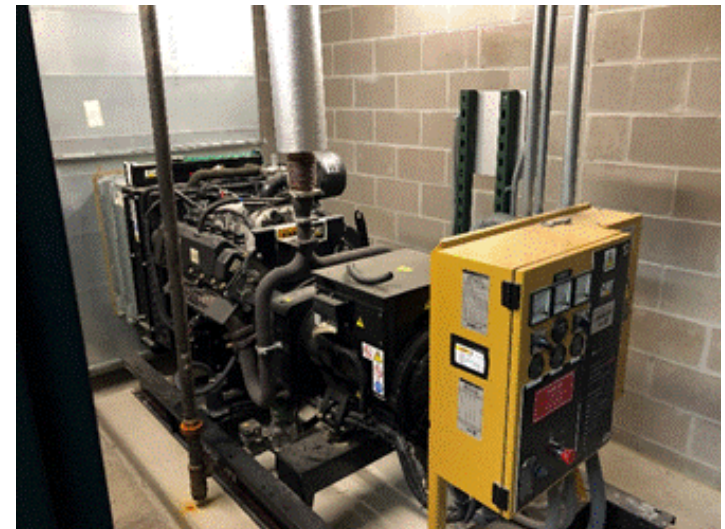
Figure 3: 60kW Generator

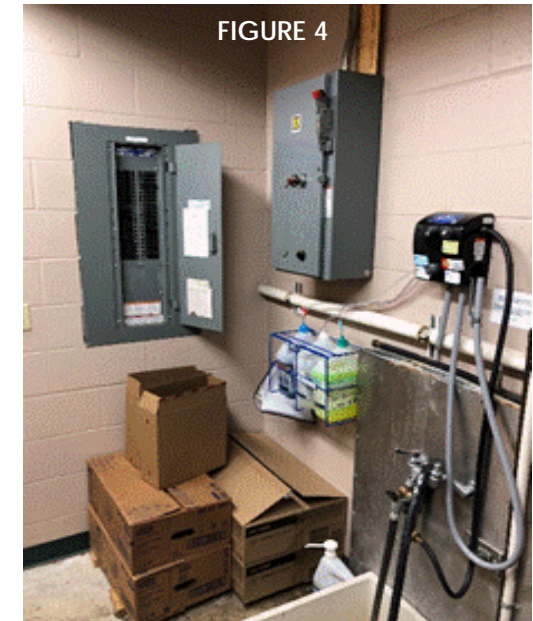
FIGURE 4

In Men's Room 112, the existing panelboard and disconnect switch are located near the washdown/mop sink area but in NEMA 1 enclosures (see Figure 4, right). Per NEC Table 110.28, this enclosure should be type 4X for this installation.

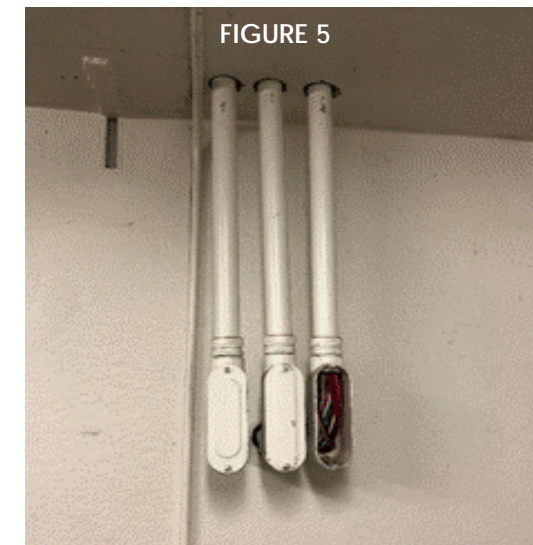
FIGURE 5

Raceway in Gym AV Room 800A is missing a cover on one of its elbow fittings (Figure 5, right).

We recommend replacing this to prevent incidental conductor damage.

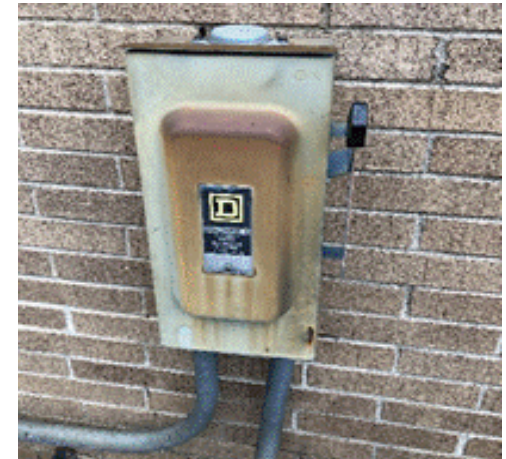
FIGURE 6

The existing exterior equipment disconnect switch for the condenser unit is showing signs of degradation, as seen the left in Figure 6. Per NEC Table 110.28, this enclosure should be type 3R for this installation.

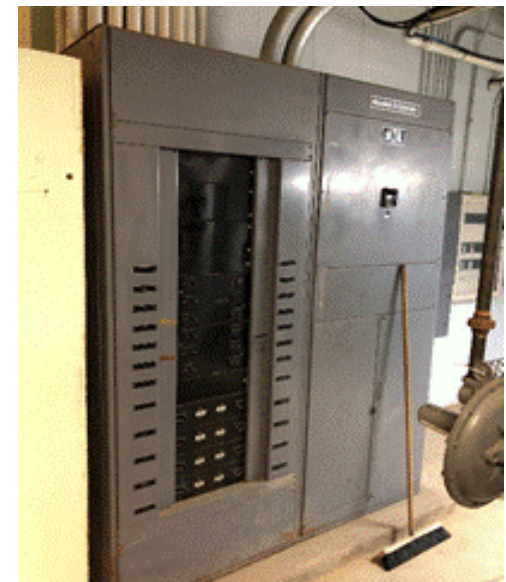
FIGURE 7

Existing distribution and branch electrical equipment is original to the building. This electrical equipment includes, but is not limited to, disconnect switches, branch panelboards, and distribution panelboards. These pieces of equipment have exceeded or are approaching their BOMA life expectancy of 30 years. In particular, equipment in the basement generator room is original to the building (Figure 7, right) and should be replaced.

Assuming equipment has been properly maintained, we do not necessarily recommend full equipment replacement throughout the building. However, we recommend a thorough inspection and evaluation of all electrical equipment installed as part of the original building and 1995 building addition. This will limit the chance of failure by identifying equipment or parts that may need cleaning, re-torquing, or replacement. Additionally, this offers an opportunity to re-evaluate the availability of replacement parts for continued maintenance. Repair or maintain deficient equipment when applicable, but if equipment is defective or cannot properly be maintained because of the inability to source parts, replace immediately.

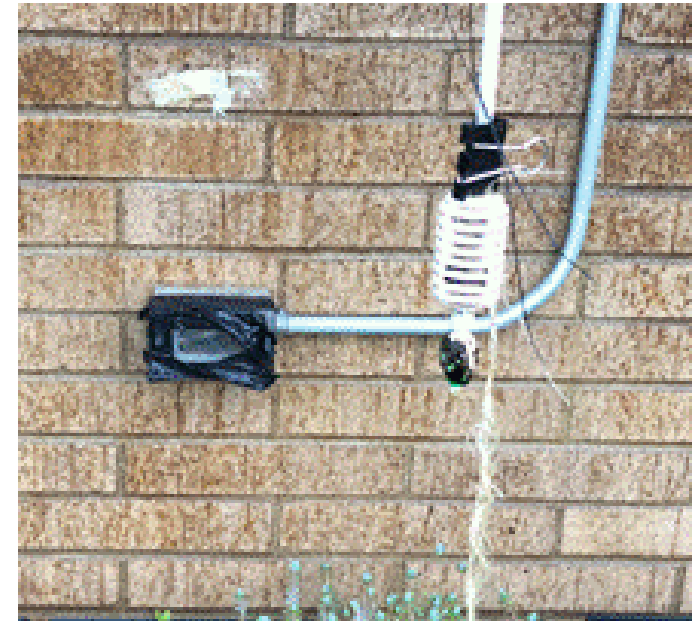
FIGURE 8

An existing weatherproof receptacle has duct tape securing the cover to the backbox, as seen left in Figure 8.

We recommend replacing the existing receptacle and weatherproof cover.

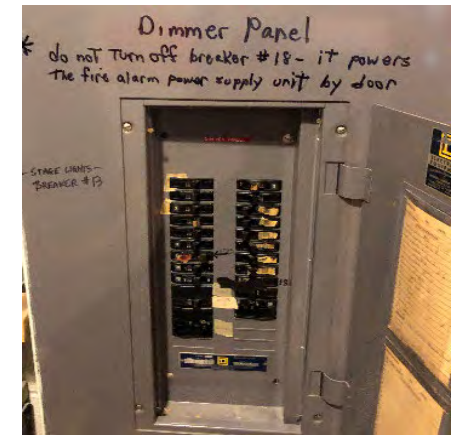
FIGURE 10
(right)

Auditorium 309A utilizes high pressure sodium fixtures controlled at a breaker panel shown to the right in Figure 10.

We recommend replacing these fixtures with equivalent LED fixtures and local dimming controls. See Figure 7 for breaker panel control.

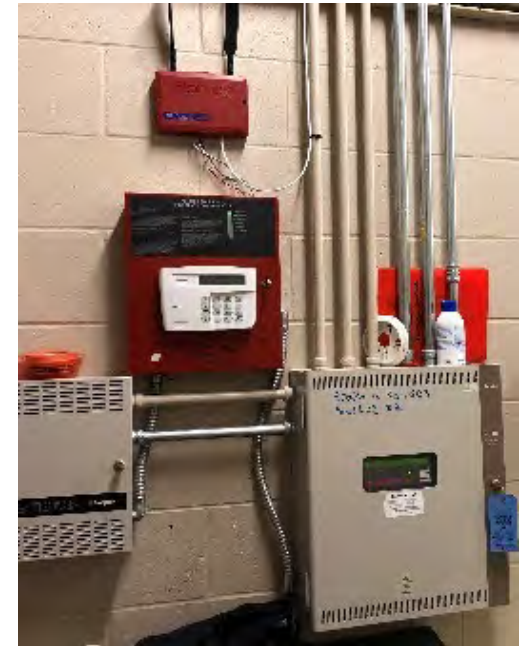
FIGURE 5: Existing Simplex 4010 Fire Alarm Control Panel

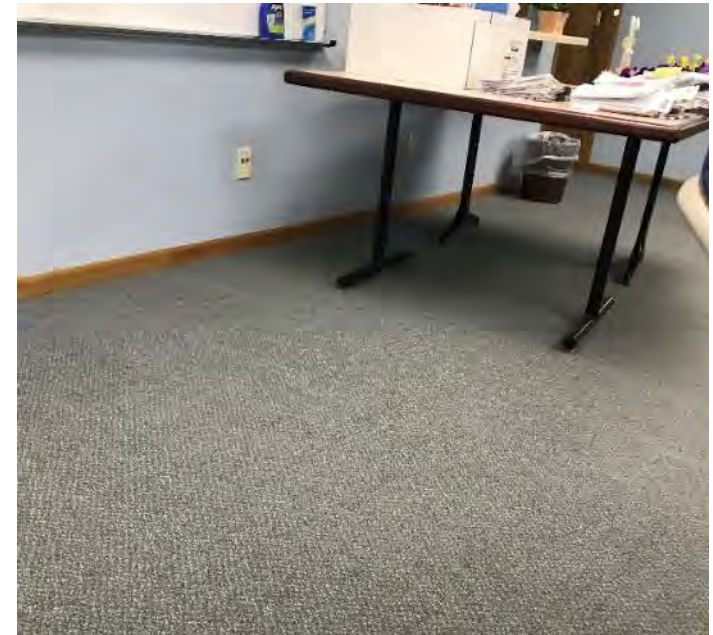
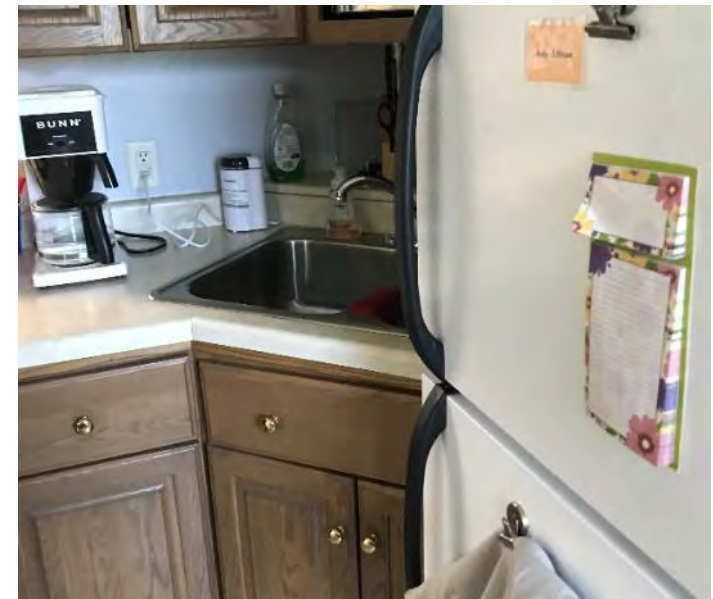
- Door hardware appears to be ADA-compliant levers.
- The basement is not accessible. Since it is used for storage and as a mechanical space, this is not an issue.
- The sink in the bathroom that is marked as accessible should have an ADA-compliant pipe wrap installed, as well as a vertical grab bar.
- The sink in the kitchen does not offer appropriate clearances (no shroud at the sink for a front approach, no side approach clearances).

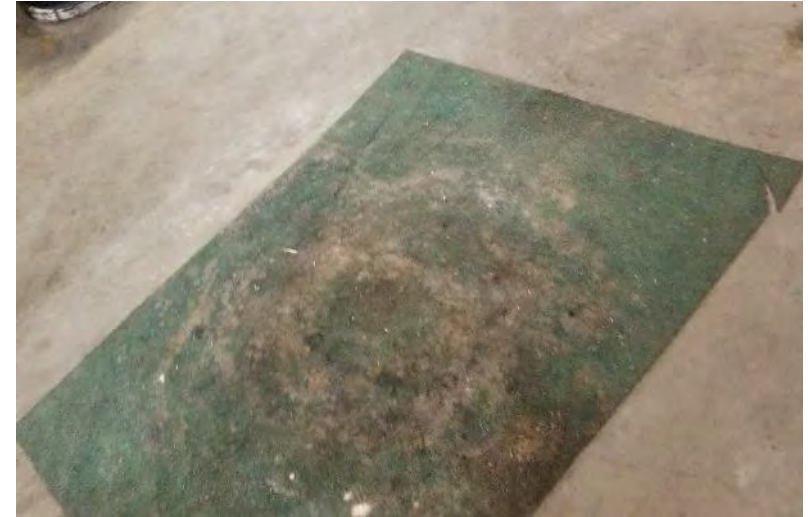
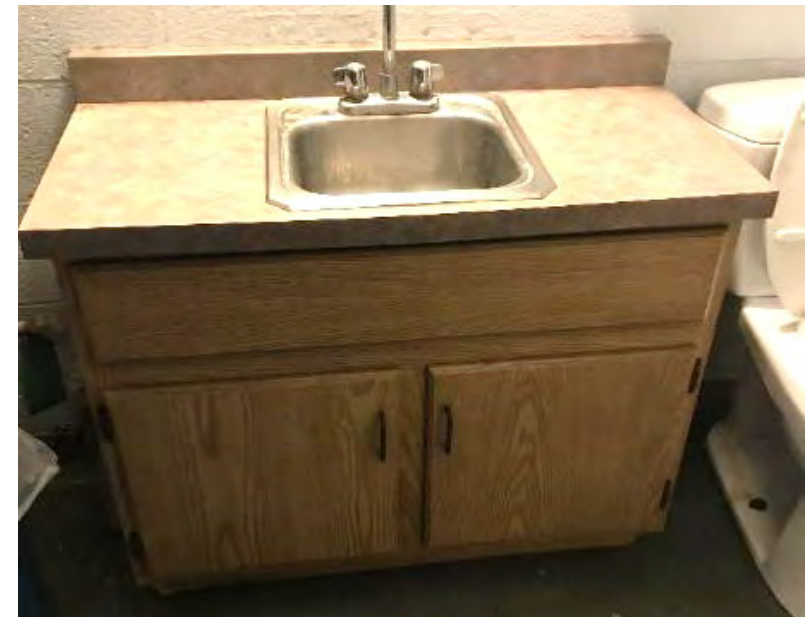
- Interior finishes throughout this space are dated and in generally poor condition.
- A full renovation of the interior spaces could be performed, but the space was reported to be too small and not efficient for the current use.
- A new garage could also be constructed on the existing lot if it is a priority for the district.

- Door hardware and the restroom are not ADA compliant.

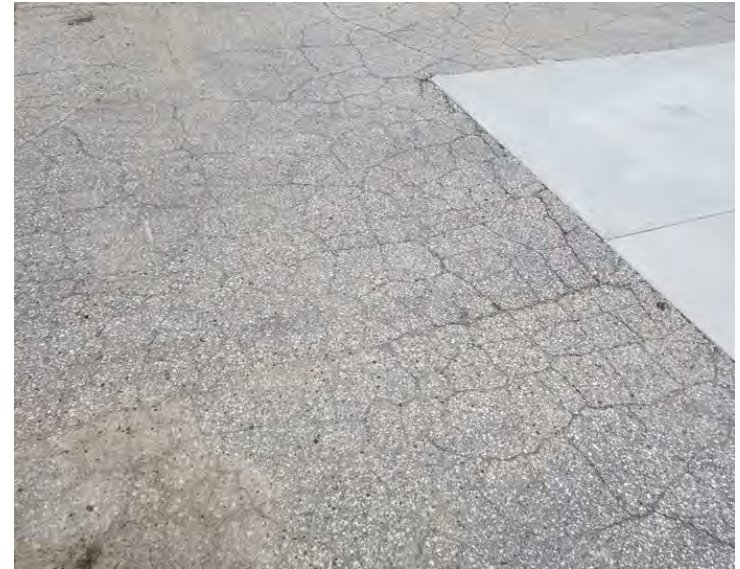
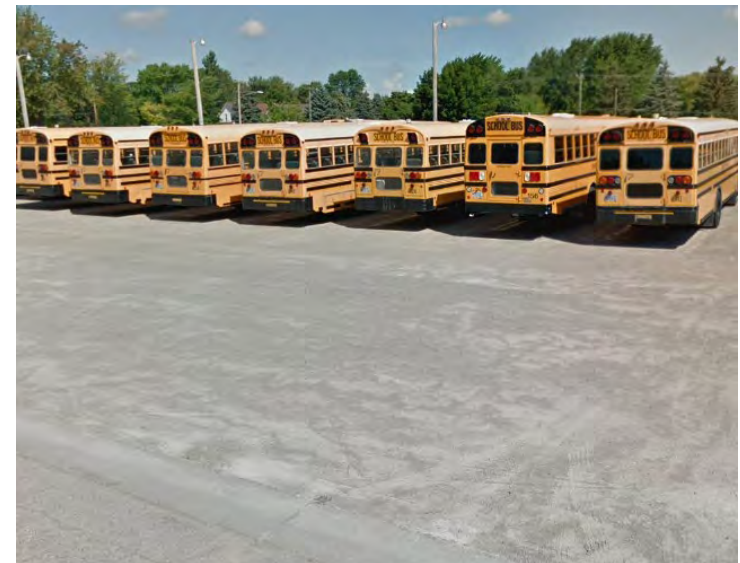
Area 1: Parking Lot Surrounding Bus Garage

The existing pavement has numerous thermal cracks which have worsened over multiple freeze-thaw cycles. There are some areas of localized base failure, which are evident by the fatigue cracking present. The base failure is a small portion of this area, approximately 12%. Edge failure and surface weathering are also present.

FIM #	Recommended Site and Civil Improvements
DW-SC-1	<p>Area 1: Parking Lot Surrounding Bus Garage</p> <ul style="list-style-type: none"> • Remove existing pavement. • Inspect the base material and patch where necessary. • Place 4 inches of asphalt and install pavement markings.
DW-SC-1a	<p>Concrete Pavement Alternative:</p> <ul style="list-style-type: none"> • Remove existing asphalt pavement. • 12" Base and subgrade removal. • 8" Dense graded base and 8" reinforced concrete. • Pavement markings.

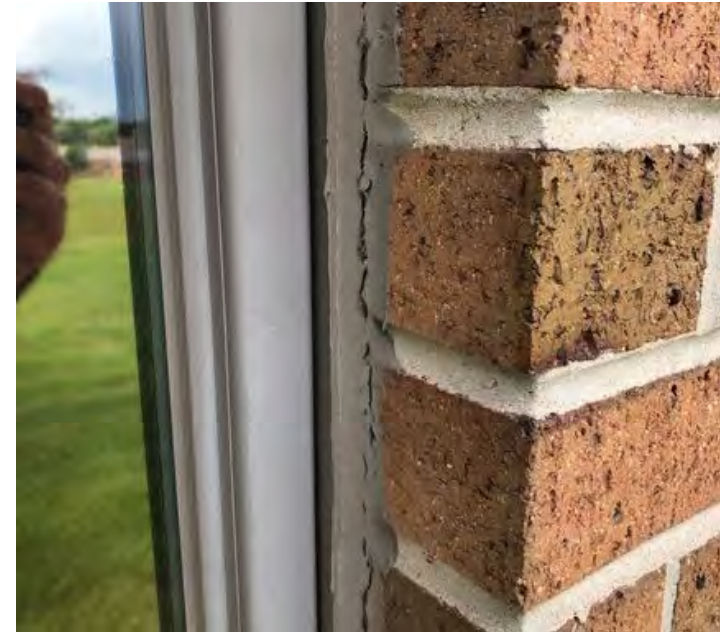
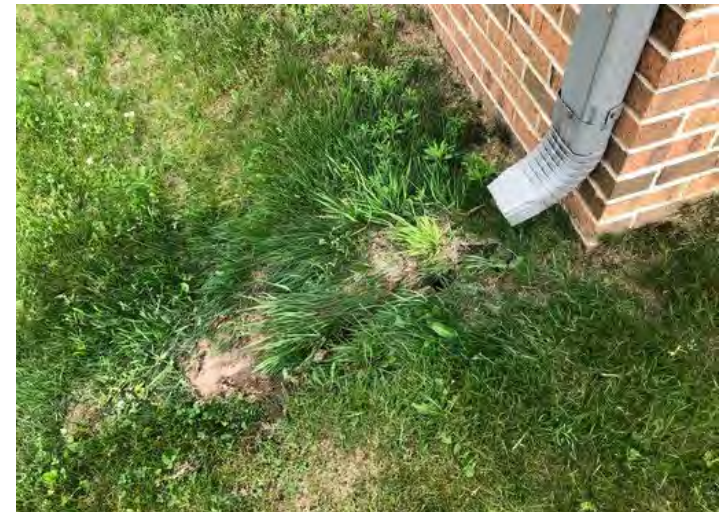
- No splash blocks are installed at the base of the rood downspouts. Water infiltration into the lower level has been reported occasionally. Splash blocks should be installed at the base of downspouts, or downspouts should be extended.
- There are several locations around the perimeter of the building where moisture in the form of efflorescence was observed on the underside of the metal soffit panels. Investigate attic/roof system for possible condensation issues and perform roof ventilation calculations. Install proper intake and exhaust ventilation to prevent condensation.
- The shingled roofing system is in good condition and does not require any attention at this time.

Window sealants were observed to be in a failed condition at the perimeter of windows and doors.

- One control joint was missing sealant.
- Existing sealant should be cut out, removed, and replaced at all windows and exterior doors.

FIM #	Recommended Building Envelope Repairs
DW-BE-1	District Office - Replace Window Sealants, Repair Roof Drainage and Roof Ventilation <ul style="list-style-type: none"> • Cut out and remove existing sealant, install new backer rod, prime as necessary, and install new sealant at window and door perimeters. • Install splash blocks at base of downspouts, and/or extend down spouts. • Investigate attic/roof system for possible condensations issues and perform roof ventilation calculations. • Install proper intake and exhaust ventilation to prevent condensation.
DW-BE-2	Bus Garage – Replace EPDM Roofing System <ul style="list-style-type: none"> • Replace roofing system with new insulation and fully-adhered EPDM membrane. • Incorporate a thermal barrier and vapor retarder prior to installation of roof insulation and membrane. • Incorporate slope into the roof system design to improve drainage. • Adhere all insulation layers down, fully adhere new EPDM membrane, properly install edge details and gutter.

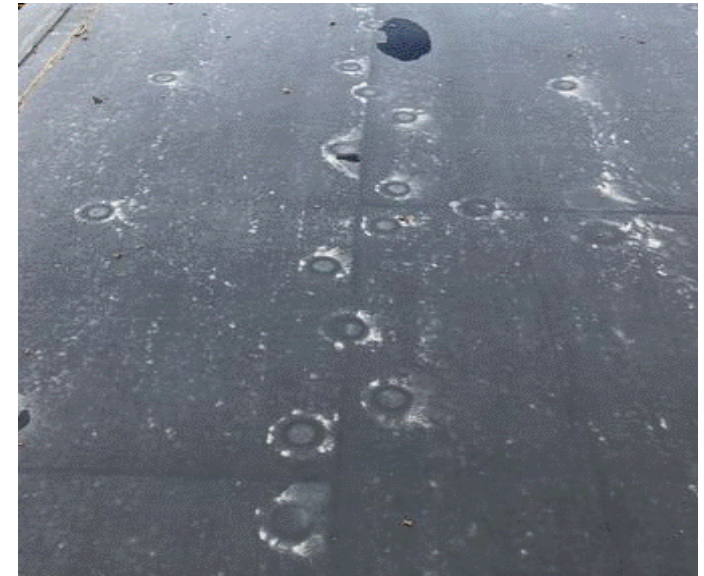
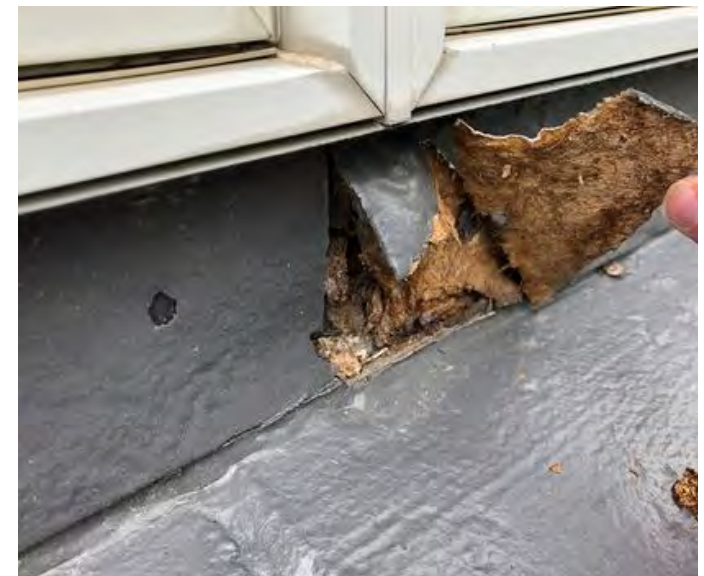
The existing roof is an Ethylene Propylene Diene Tetrapolymer (EPDM) rubber roofing system, typical for this style of building. Ponding is evident along north perimeter edge at gutter. Insulation fasteners are poorly installed, some traversing board edges. Flashings are poorly installed with field fabricated flashing membrane. Roof edge detailing is poorly installed. It is recommended to replace this roof system with new insulation and fully-adhered EPDM membrane. Incorporate a thermal barrier and vapor retarder prior to installation of the roof insulation and membrane. Incorporate slope into roof system design to improve drainage. Adhere all insulation layers down. Fully-adhere new EPDM membrane, properly install edge details and gutter.

Laminated plywood siding is installed over all window openings. Siding panels are deteriorated from unsealed edge treatment and failed sealant joints. Siding requires replacement. Fasteners are overdriven through the outer face of the siding and there is poorly installed perimeter edge sealant installation. Replacement of window openings with new fixed or partially operable windows is recommended. Alternatively, remove existing siding and install new aluminum composite metal panel system. Incorporate an appropriate substrate with an air/weather barrier, and install aluminum composite metal panels with proper perimeter flashing and sealant system.

Replace overhead doors. Overhead doors are beginning to rust and are non-energy efficient. Installing new insulated doors and weather-stripping is recommended. New doors should be insulated, energy efficiency doors with new weather stripping to prevent air infiltration and heat loss.

DW-BE-3	Bus Garage – Replace Wood Siding, Replace Overhead Doors, Repair Masonry <ul style="list-style-type: none"> • Remove existing wood siding and replace with aluminum composite metal system. Incorporate an appropriate substrate with weather barrier. Install panels with proper perimeter flashing and sealant system. • Replace overhead doors with new insulated, energy efficient doors and weather stripping. • Remove concrete masonry units that have been displaced and reset into original position. Tuckpoint.
